Transmission Report

Volume 11, No. 2

April 2020

6L80, 6L90 Transmission Tech Advisory: Consider an Updated Converter in Your Next Rebuild

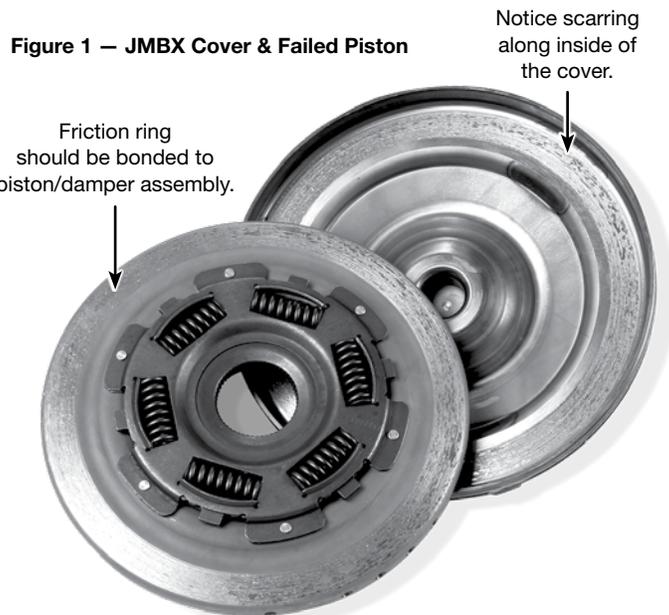
Most full-size trucks and SUVs with a 6L80, 6L90 use a JMBX full-size (300mm) style converter. It's a single-disc, non-captive clutch unit that is somewhat similar to late 300mm 4L60-E converters. When cutting the JMBX open, converter rebuilders report that a high percentage of units show extreme damage due to the clutch piston and front cover crashing into each other (**Figure 1**).

The OE cover and piston are damaged to the point of not being reusable — this is where all of the metal you find in the transmission comes from! At this point, the converter rebuilder is faced with either finding another core that he hopes will have good components or purchasing a Sonnax forged cover (**GM-CC-13**) and forged piston (**GM-DA-17P**). This drives up the price of the rebuilt converter, but ensures that this kind of failure won't happen again.

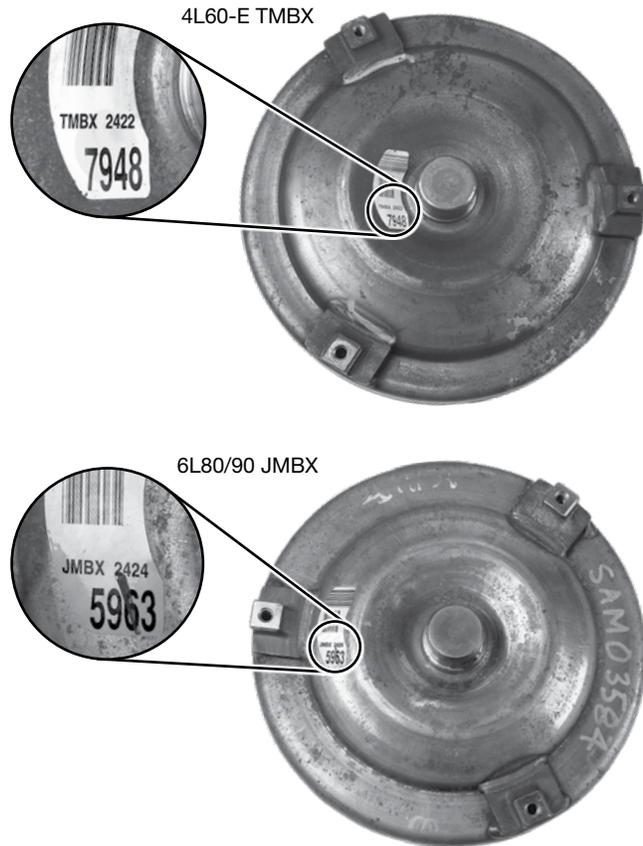
Figure 2 — 4L60-E TMBX & 6L80/90 JMBX Front Covers

To be honest, we aren't 100% sure of the real reason for JMBX cover and piston failure, but we do have a theory. As we have all learned with other units, very often the root cause of a converter clutch failure stems from a failure within the electro/hydraulic controls from the transmission. That certainly holds true for the 6L80, 6L90. If there are worn valves or faulty inputs or controls, it's easy to see how the clutch could start to shudder and quickly fail. But in the 6L80 JMBX, we started to look very closely at the converter itself to see if we could determine a root cause. In doing this, we evaluated another GM unit — the 4L60-E TMBX — to see if we could pick up any clues. Looking at the two different front covers from the OUTSIDE, they are very similar, with just a few minor differences (**Figure 2**).

Both covers have very similar profiles and thicknesses, and you would not expect that one would be any more prone to flex or distortion than the other. But it's interesting to note that there is a very low cover/piston failure rate for the 4L60-E TMBX converter. The TMBX and the JMBX have similar covers and use the same woven carbon friction material, yet the JMBX fails catastrophically at a very high rate and the TMBX cover rarely fails. Why is that? To give you a sense of scope, for every single forged replacement cover that Sonnax sells for the 4L60-E TMBX, we sell many, many more for the 6L80/90 JMBX.

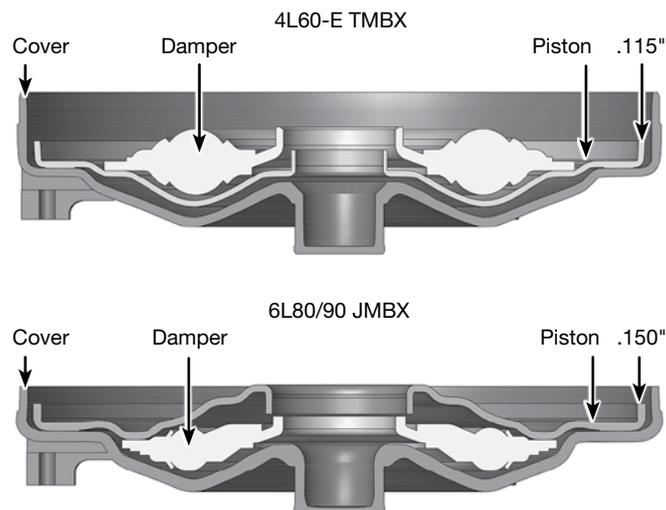
Figure 3 — 4L60-E TMBX & 6L80/90 JMBX Converter Cover Cross Sections

A sectioned image of the 4L60-E TMBX and 6L80, 6L90 JMBX (**Figure 3**) shows the external profiles of the respective front covers are very similar. But look at the clutch pistons and spring dampers — they are markedly different. It's a little tough to see, but the thickness of the pistons is also different. For the 4L60-E TMBX, the pistons are .115" thick, and for the 6L80, 6L90 JMBX, the pistons are significantly thicker at .150". Comparing the two cross sections, you also quickly see that the orientation of the spring dampers is different. In the TMBX, the damper is on the transmission side of the clutch piston, and in the JMBX, the damper is located on the engine side of the piston. To achieve this flip-flopped damper orientation in the JMBX, the profile and shape of the piston is radically different from the TMBX.

Our theory as to why 6L80, 6L90 converters fail like they do is related to the shape and thickness of the

JMBX piston. The thought is that the “bowl” shape of the TMBX is better suited towards a more even apply, and because it’s thinner, the TMBX piston has the ability to flex and better conform to the front cover. One needs to realize that the stamped covers are not all that flat to begin with. It appears that GM has put a very minor taper into the cover and possibly the piston as well. The taper may exist so that the clutch surface goes flat when the cover is welded together — we’re not sure. Remember, this is just a theory.

In any event, precise coordinate measuring (CMM scans) of a variety of JMBX covers shows that the covers are “wavy” and have undulations on the clutch surface, especially opposite of the welded cover pads. This “wavy” nature of the clutch surface is made worse with many miles of usage. The bottom line: The very thin (.020”) woven carbon friction material can’t survive the way the JMBX piston applies. The thicker JMBX piston can’t conform to the cover (like it can in the 4L60-E TMBX), and at a commanded slip rate of approximately 50 RPMs in lockup, there is ultimately metal-to-metal contact that occurs between the front cover and the piston. Once there is any metal-to-metal on the TCC surface at all, it’s usually a short time before debris wipes out the clutch completely.

transmission clutch packs — it’s the exact same in the torque converter. The Sonnax forged covers and pistons are designed to be flat and will stay that way through the forces of converter welding, miles of driving and varying input torque from the engine.

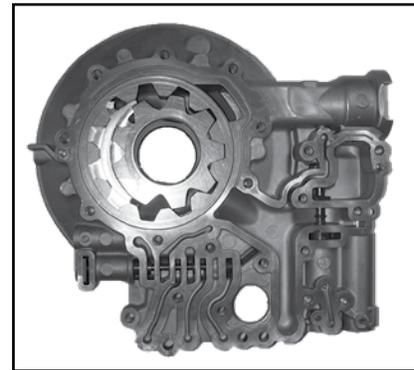
Figure 1 — Gen. 1 & Gen. 2 Gerotor-Style Pump

It's important to note, however, that the Gen 3. pump design is completely different than the previous generations. While Gen. 1 and Gen. 2 utilized a gerotor-style pump that mated directly to the converter hub (**Figure 1**), the Gen. 3 pump assembly uses a small secondary axis vane pump to drive a chain and sprocket mated to the converter hub (**Figure 2**). This structural change to the pump, of course, means that none of the Gen. 1 or 2 pump valves (**Figure 3**) interchange with the Gen. 3 design.

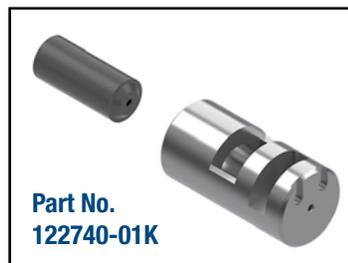
Figure 1 — B1/B2 Apply Control Plunger Valve Kit

Severe wear of the B1 and B2 apply control plunger sleeves can result in 1-2 and 5-6 flares as well as burnt B1 and B2 clutches. These sleeves are used in the same two valve body locations in both gas and diesel vehicles. Bore wear can be detected visually or by vacuum testing. Sonnax now has B1/B2 apply control plunger valve kit **122740-01K** (Figure 1) available as a drop-in fix.

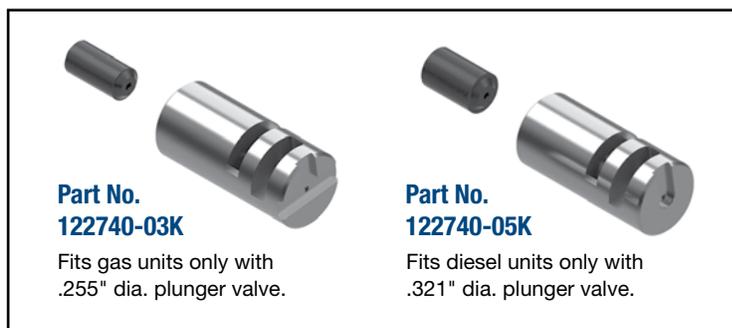
Figure 2 — Secondary PR Plunger Valve Kits

The secondary pressure regulator plunger valve sleeve is also commonly worn, resulting in TCC codes, converter shudder, overheating and low SLT pressure. While similar between gas and diesel applications, there is a size difference on the plunger valve to watch out for to avoid incorrect converter charge pressure. Sonnax now has secondary pressure regulator plunger valve kits **122740-03K** for the AS66RC (gas) and **122740-05K** (Figure 2) for the AS69RC (diesel) applications — both are drop-in fixes.

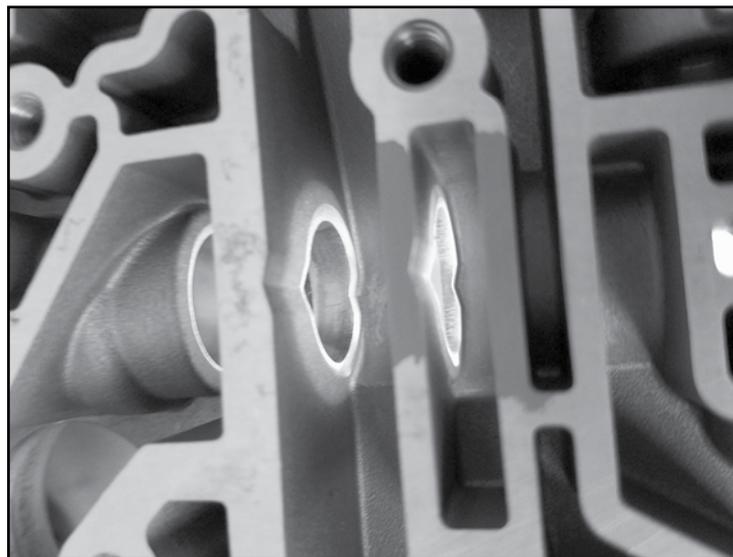
Figure 3 — AS69RC PR Valve Bore Wear

Another location that always shows extreme wear is at the pressure regulator valve. In this heavy-duty application, not only does the bore show significant wear, but the valve itself is prone to side-loading, with the soft anodization scrubbing off (Figures 3 and 4). Sonnax has developed oversized pressure regulator valve kit **122740-07K** for the AS66RC/AS69RC that features a hardcoat anodized valve with increased contact area at the wear-prone spool to prevent future wear. Effectively repairing this location requires reaming the bore to eliminate the wear that leads to high/low line pressure, poor shift quality and burnt clutches.
