# Nissan RE5R05A

POOR & NORMAL

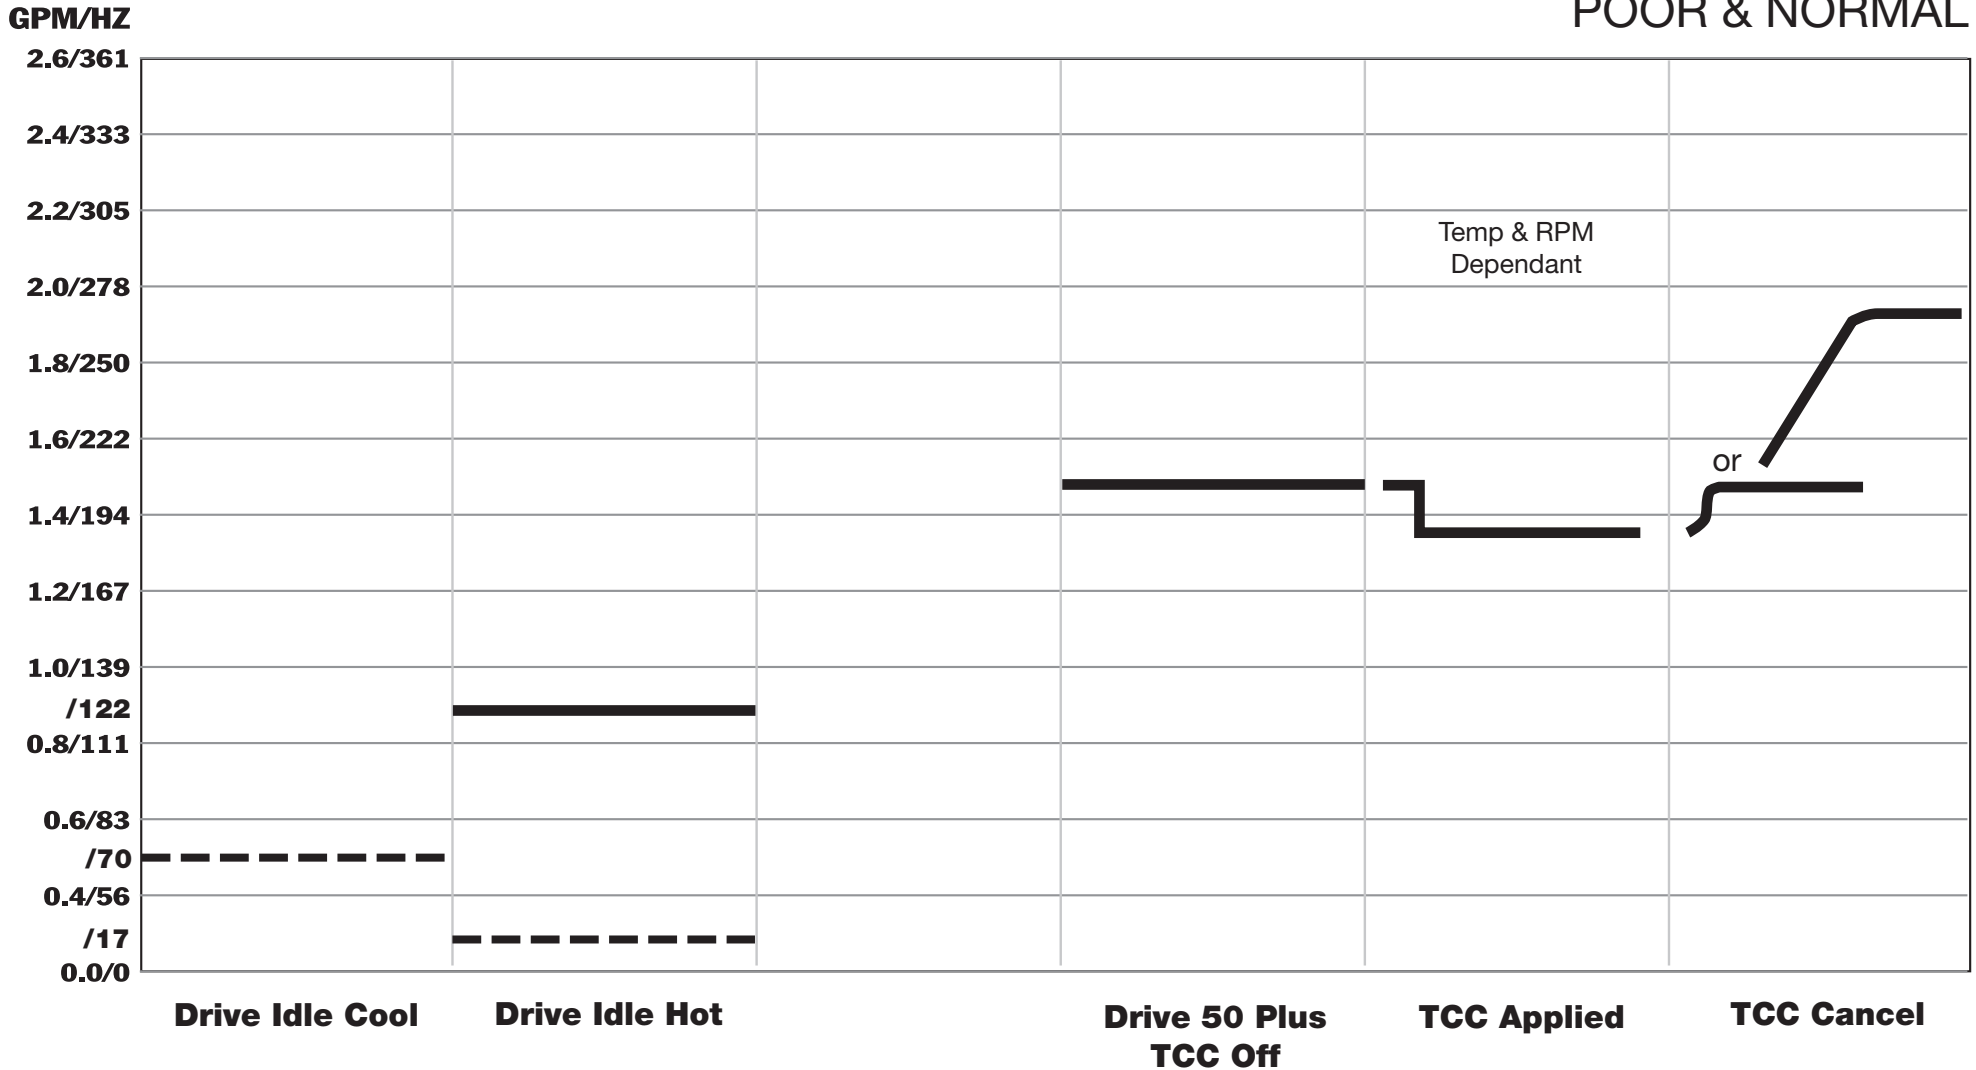
**Condition:** Restricted replacement radiator **-----**, causes the TCC shudder at operating temperature.  
**Correction:** Proper flow **—————**, replace or bypass transmission cooler in radiator.

*Notes: This example used Tru-Cool #4195 and bypassed radiator. Precaution: In cold climates use synthetic ATF if radiator is bypassed. Converter is three-path with TC clutch in cover.*
