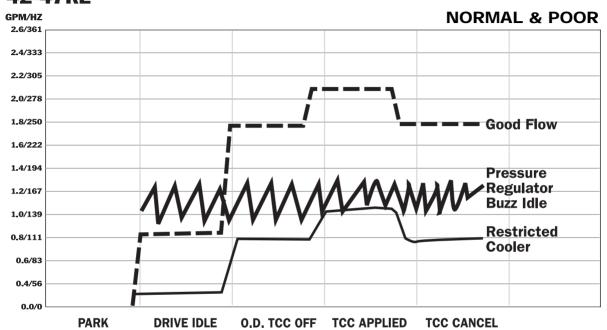
Condition: Repeated planetary failure, TCC lining failure.

Notes: Flow is less due to 5/16" vs. 3/8" cooler line on 42RE and 47RE units. Good cooler flow circuits have sharp increase/decrease of lockup control. Updated valves allow fluid in park to charge converter.

Correction: Replace cooler lines and/or radiator. Converter failure plugs lines and then overheats planets.
