Front Cover Hub

MB-HB-1K

Mercedes 722.6, 722.9

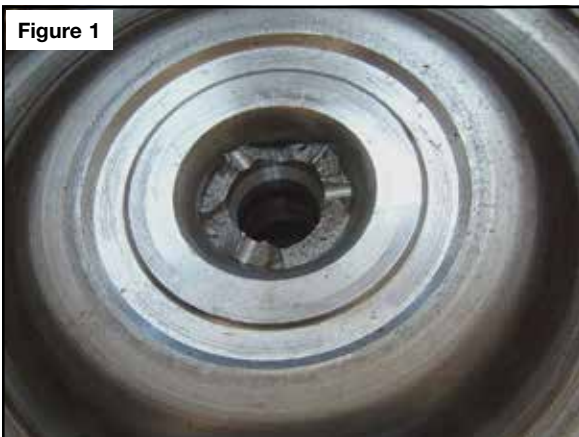
Figure 1

- Hold the cover in a three- or four-jaw lathe chuck (preferably four-jaw) by the O.D. of the pilot. If the cover insert is broken (**Figure 1**) place a dial indicator against the face of the cover adjacent to the broken insert and adjust until the cover runs true. If the insert is not broken, place your indicator against the bearing surface of the insert and adjust for trueness.
