Ford 5R110W

High Capacity Direct Clutch Apply Piston Kit

36965-01K

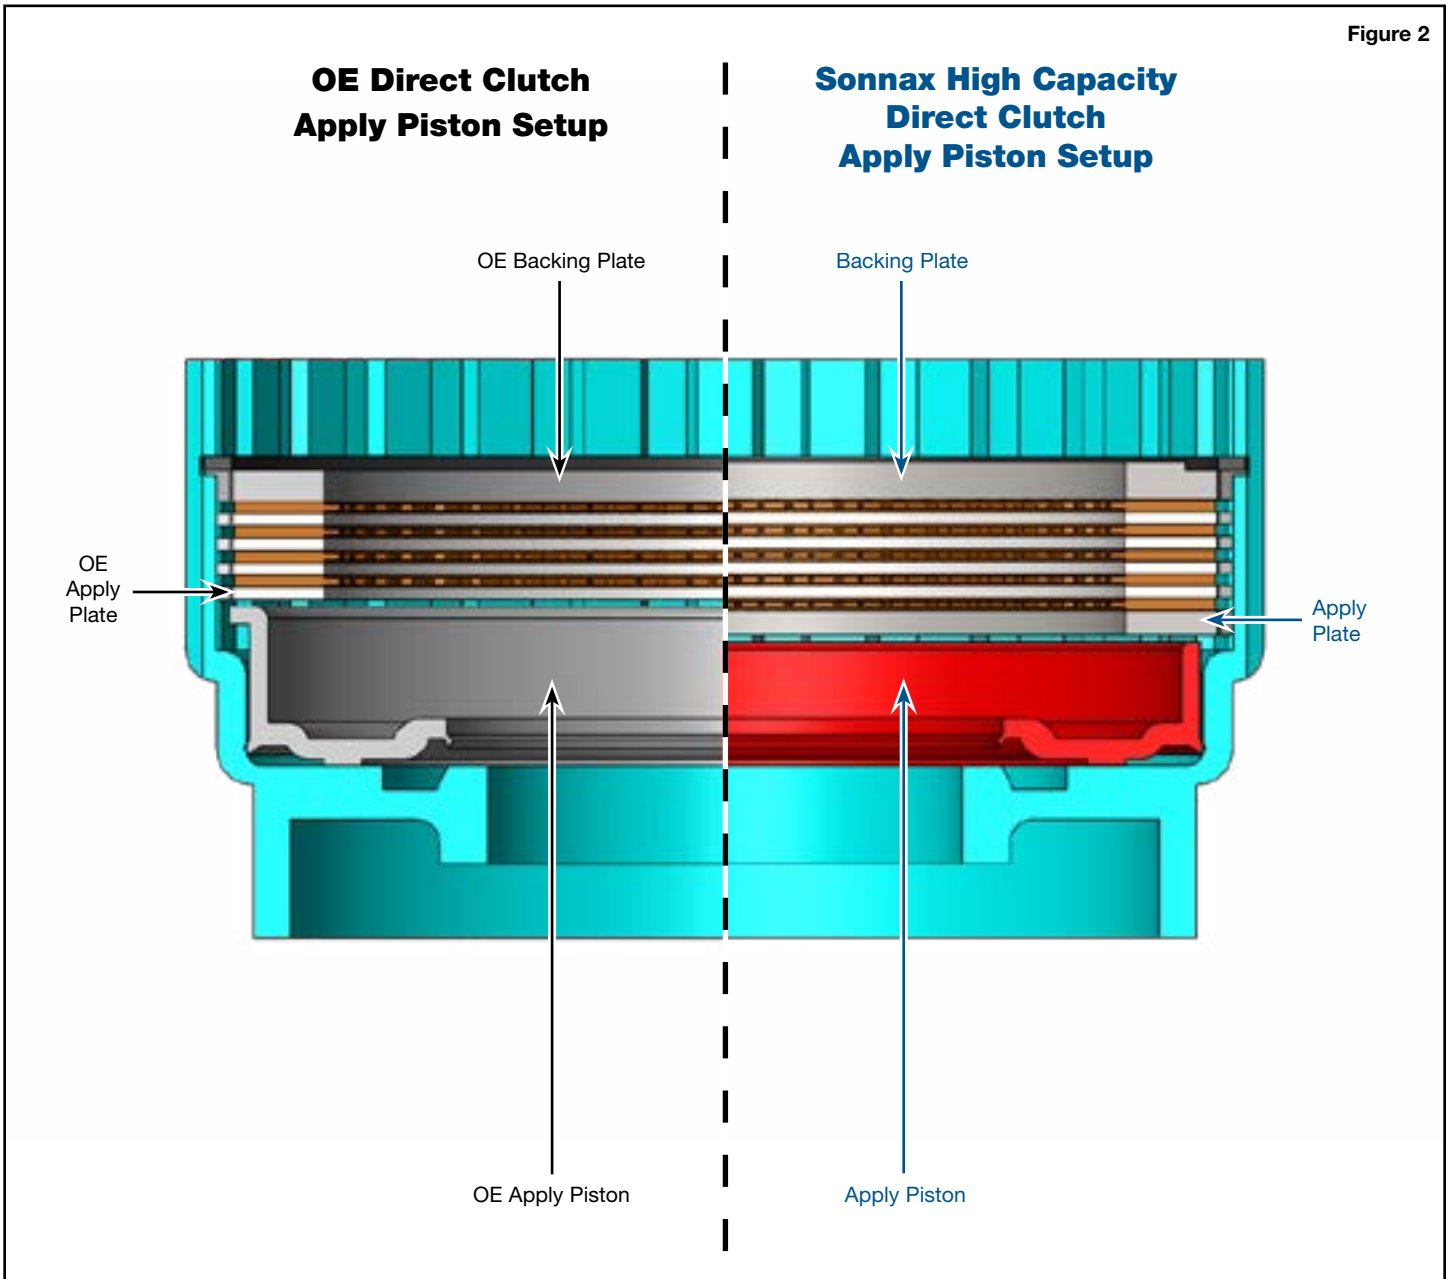
Figure 2

- Install Sonnax apply piston into housing assembly (**Figure 2**).
- Reinstall OE return spring.
- Install OE piston dam. Using appropriate tools, compress piston dam just far enough to allow OE piston dam retaining ring installation.

- Install Sonnax piston apply plate (**Figure 2**).
- Reinstall or replace OE steel plates and frictions following OEM-recommended methods and procedures making sure to include one additional friction.
- Install Sonnax backing plate (**Figure 2**).
- Reinstall or replace OE backing plate retaining ring.

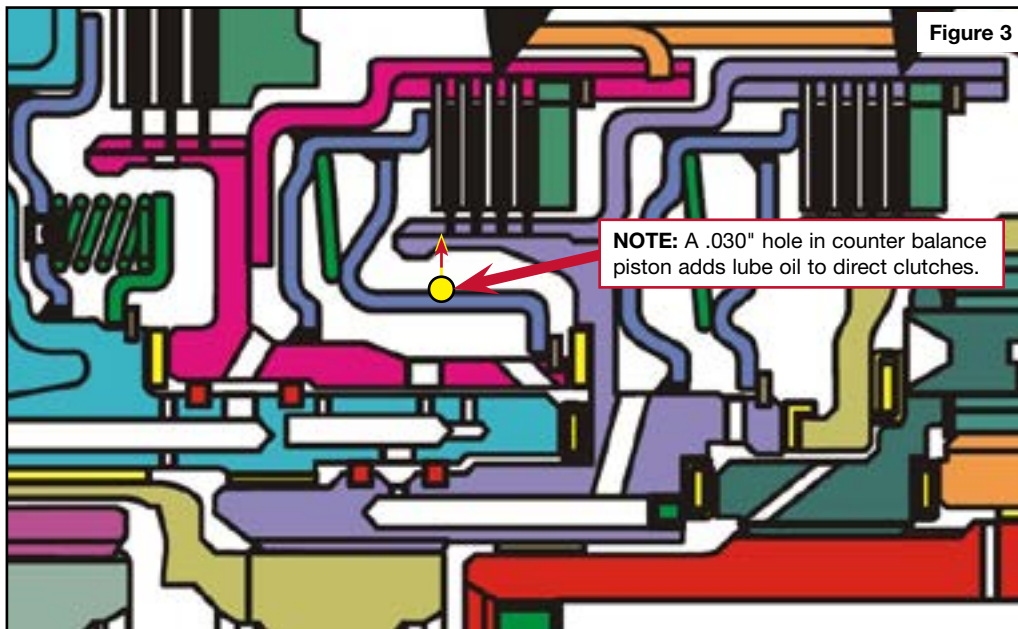
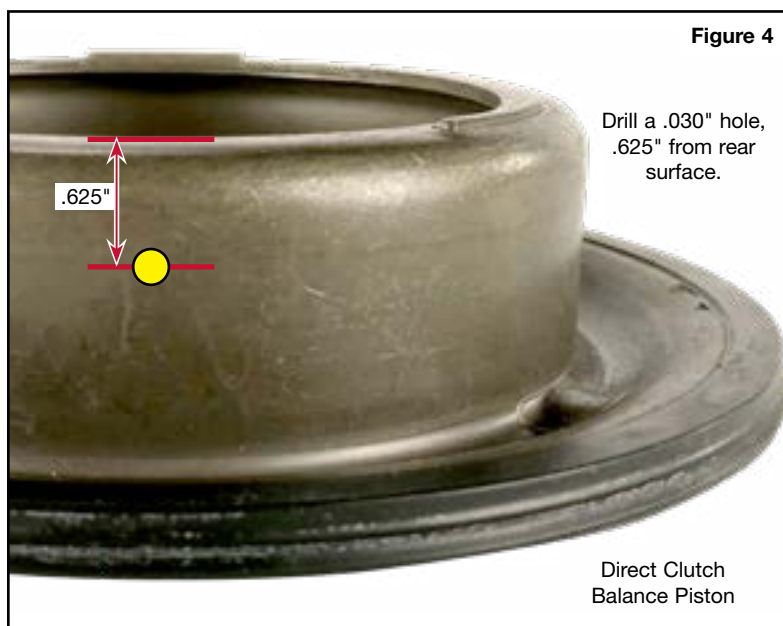
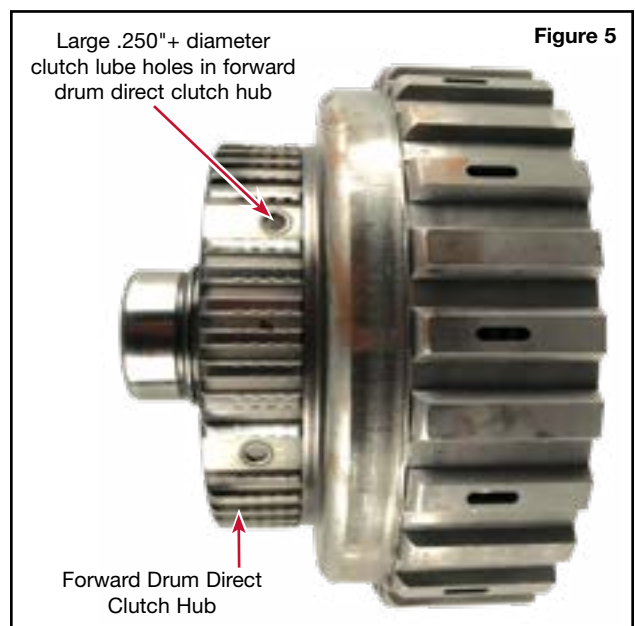
Overall failure rate of direct clutch and high prevalence of failure seen in higher revving smaller displacement gas applications indicates a possibility of insufficient open clutch lube oil.

Due to large diameter clutch lube holes in forward drum, direct clutch hub (Figure 5), intended clutch lube oil may exit rear holes thereby reducing lube oil to front holes and front friction discs. Modification outlined below (Figures 3 & 4) supplies extra direct clutch lube oil in line with front lube holes in forward drum direct clutch hub.

OPTIONAL: Direct clutch lube modification to direct counter balance piston.
