GM 4L80-E Late Single Stator

Stator Repair Plate

GM-WA-40

Instructions

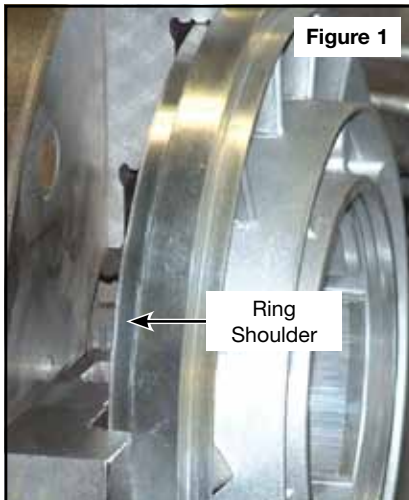
Figure 1

- a. Chuck the stator in a lathe from the impeller side, holding onto the machined surface on the outer ring shoulder (Figure 1).
- b. Machine a new surface on the stator body casting forward of the inner blade mount points. Machine in far enough to be used as a new lathe chuck holding point, but avoid contacting the stator blades (Figure 2).

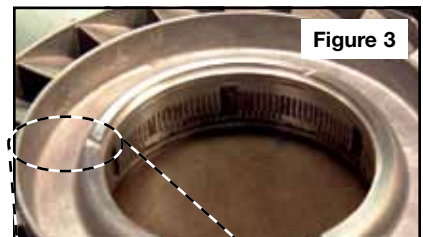
Figure 3

- a. Verify the O.D. of the repair plate, which should measure about 3.975".
- b. Machine a bore to a snug fit no more than .001" to .002" bigger than the plate O.D. A light press fit is acceptable. Machine deep enough to contact the outer stator race.
- c. Machine a chamfer (approximately 30°) at the top of the bore for a weld relief. The chamfer should be to depth of the oil groove (Figure 3).

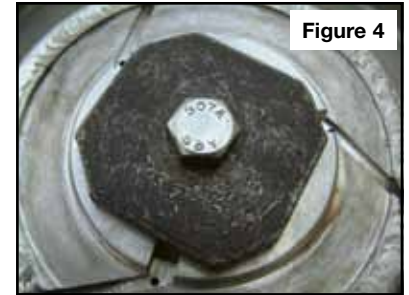
Figure 4

- c. Reinstall the inner stator race, stator cap and retaining ring. If the ring cannot be installed, the outer race is not seated in the bore.
- d. Install a holding fixture to hold the repair plate. A 3/8" x 2-1/2" (9.53mm x 57.15mm) bolt and two oversized flat washers will work (**Figure 4**).

NOTE: The repair plate will rise up on the opposite side of the spot weld if the plate is not held. Do not overtighten the fixture.

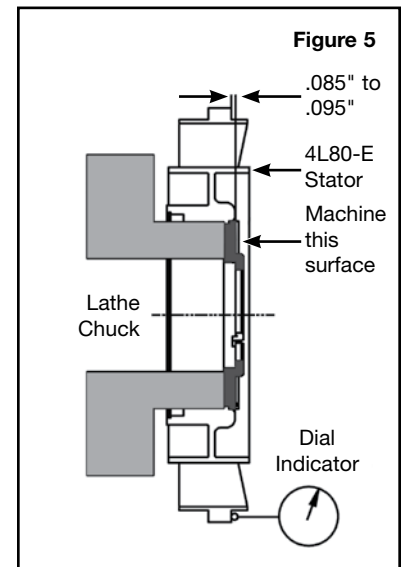
Figure 5

It is likely the surface that the needle bearing rests on has distorted, so additional material, approximately .015", is left to true this surface with a lathe.

- This surface must be held flat to .003" so as not to damage the bearing.
- This surface must be located .085" to .095" above the outer ring shoulder (**Figure 5**) to allow the correct stackup for the thicker **GM-N-20** bearing. This can be measured using a height gauge or with a straight edge and gauge blocks (**Figure 6**).
- In addition, the bearing surface area must be held parallel within .004" to the stator outer ring shoulder. Maintaining parallelism will prevent stator wobble and interference with impeller and turbine. The best way to assure the bearing surface is machined parallel to the outer ring shoulder is to chuck the stator on the I.D. and check outer ring shoulder runout with a dial indicator.

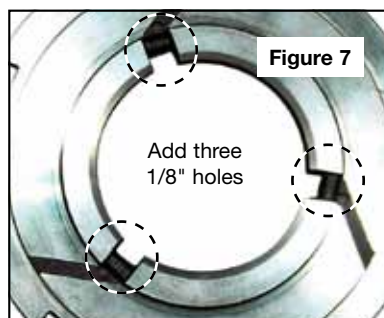
Figure 7

Add three 1/8" holes

- a. Add three 1/8" holes on the stator cap for improved oil flow (**Figure 7**). Some OE castings have this feature, some do not.
- b. When assembling the stator cap to the stator make sure the outer race or rollers are not lined up with the 1/8" holes.
