Mercedes 722.6

Front Cover Hub Assembly

MB-HB-1K

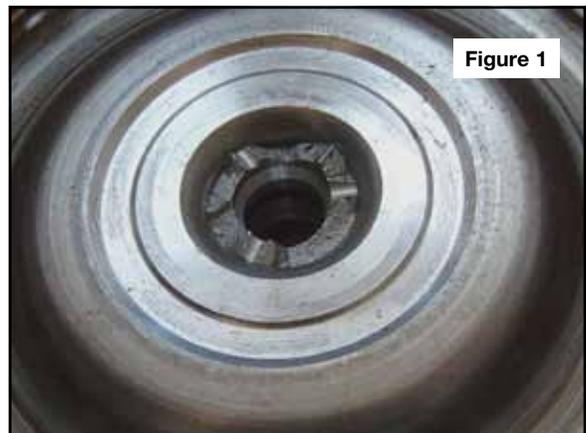
- Hold the 722.6 cover in a three- or four-jaw lathe chuck (preferably four-jaw) by the O.D. of the pilot. If the cover insert is broken as in **Figure 1**, place a dial indicator against the face of the cover adjacent to the broken insert and adjust until the cover runs true. If the insert is not broken, place your indicator against the bearing surface of the insert and adjust for trueness.
