096, 097, 098 Remanufactured Valve Body

Internal Manual Linkage Adjustment

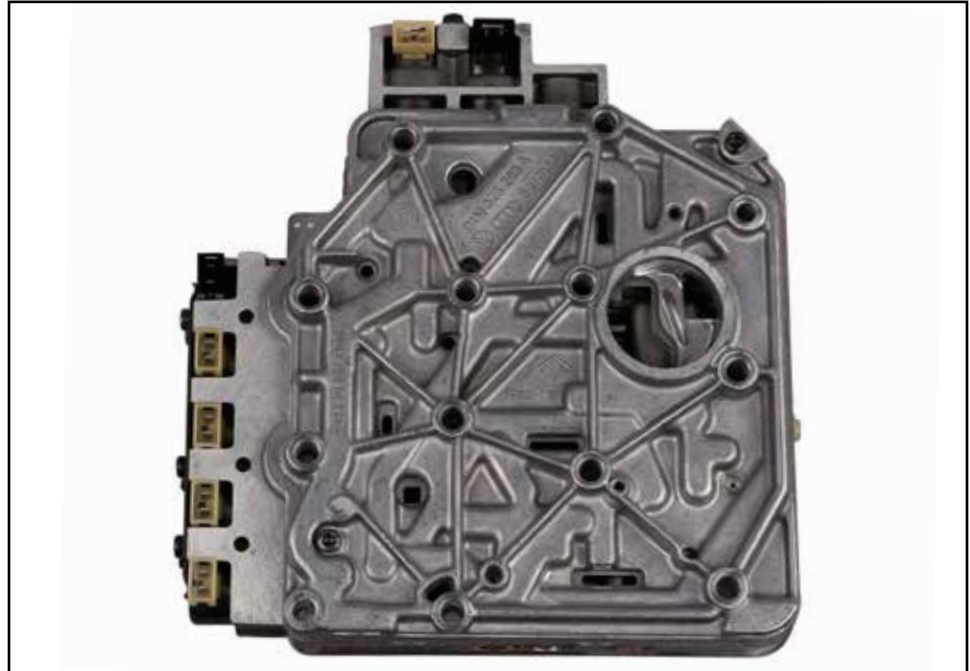
Whenever a valve body is installed into an 096, 097, 098, 01M, 01N or 01P transmission, the internal manual valve linkage must be adjusted to sync up the manual valve with the rooster comb and external linkage.

The manual valve only has to be out of adjustment a slight bit to encounter low pressure and delays into Drive or Reverse.

- Install the valve body, torque must be set at 45 in-lb.

Torque is critical. This needs to be done correctly before manual valve is adjusted to prevent valve drag.

- Place the linkage into the Park position.
- Loosen the small adjusting bolt between the manual valve link and the rooster comb so that the adjusting arm will move freely.
- Gently push the manual valve into the bore.
- While holding gentle pressure on the manual valve toward the bore, tighten the adjustment bolt.
