Critical Wear Areas & Vacuum Test Locations

4R44E-5R55E-ZIP
Zip Kit® Available

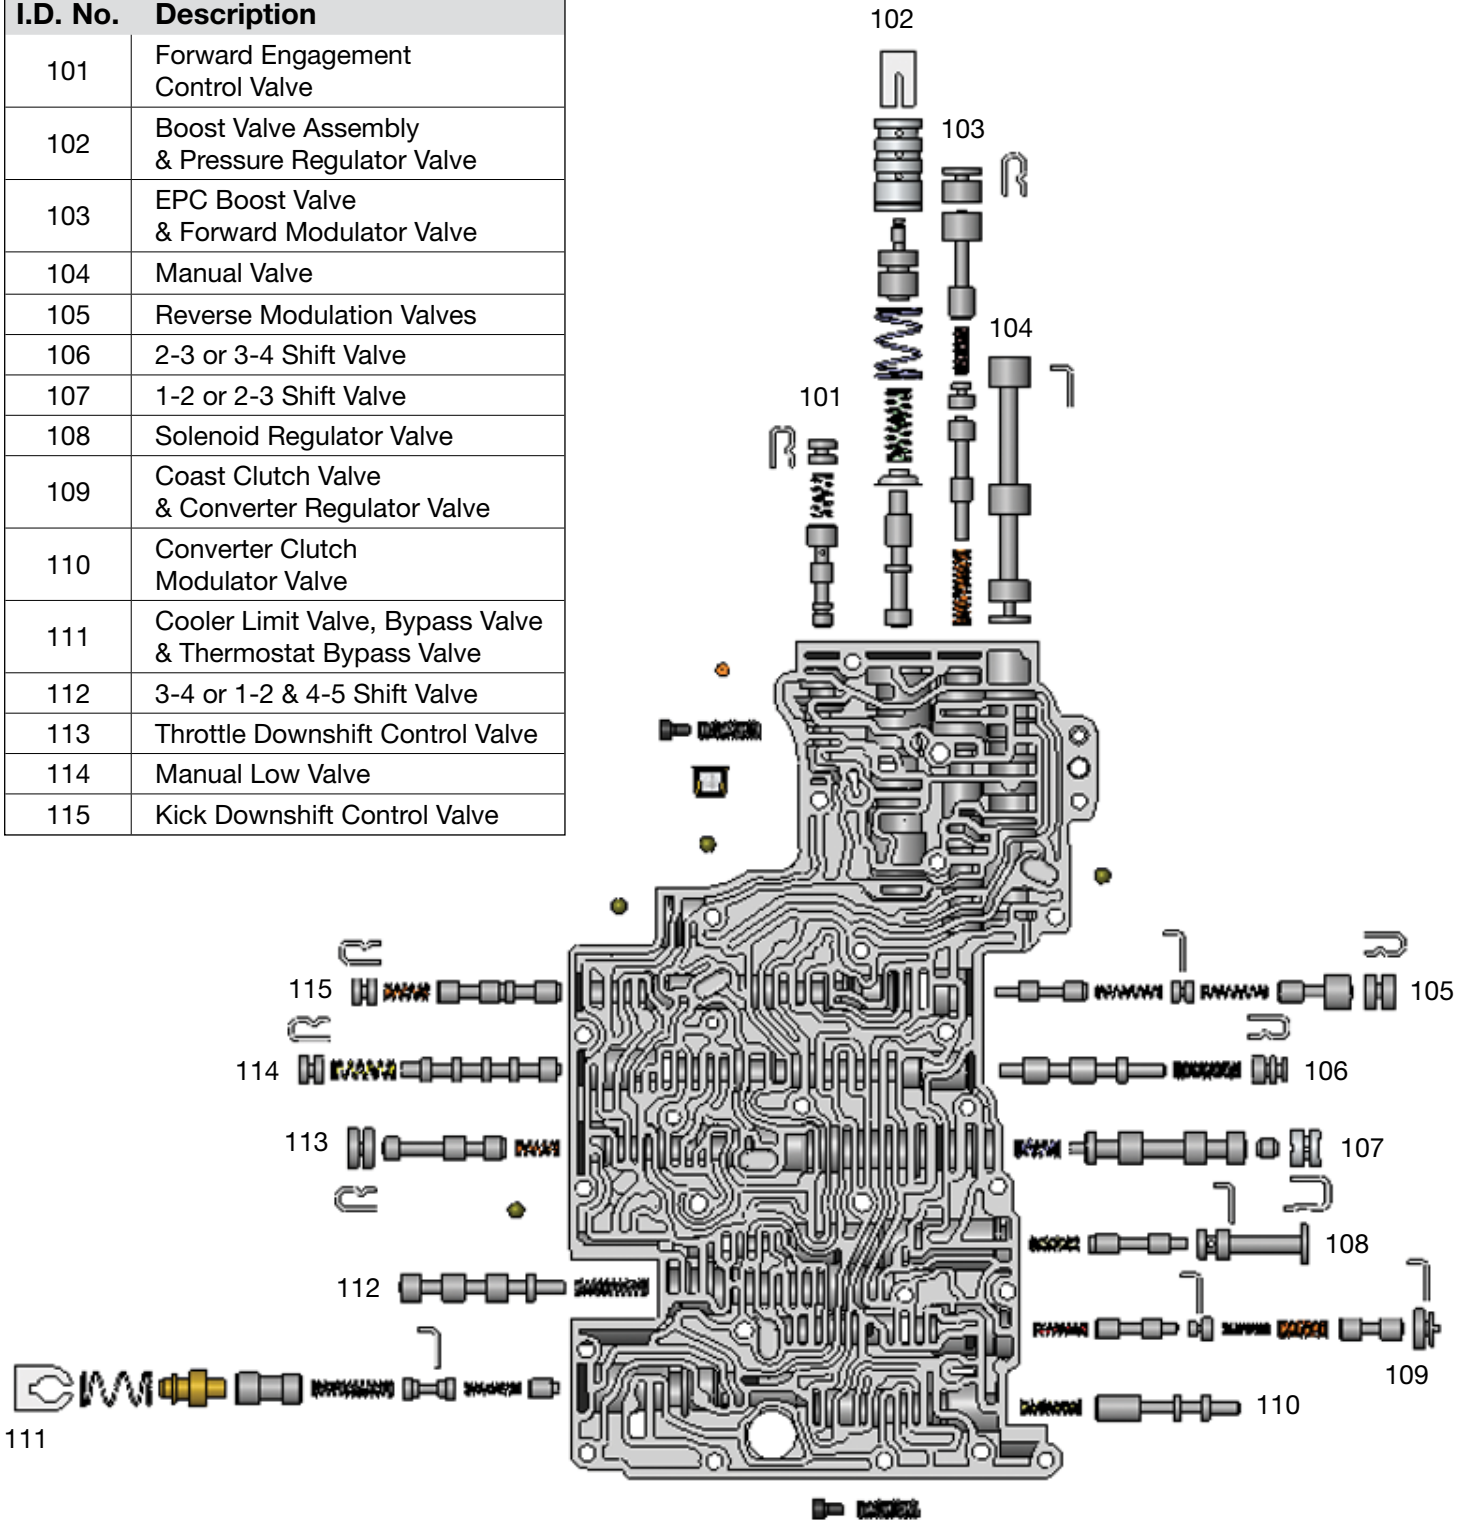
OE Exploded View

Boost Valve Assembly

- Delayed Reverse • Soft shifts
- Low line pressure • Poor modulator control

EPC Boost Valve, Forward Modulator Valve & Reverse Modulator Valve

- 2nd Gear starts • No Reverse • Poor shift quality
- Flare on 1-2 or 2-3 shift on 4R, or 2-3, 3-4 on a 5R
- Delayed Forward • TCC slip • Code P0741

Pressure Regulator Valve

- Delayed engagement • Poor shift quality
- Low/High line pressure • Overheating
- Low cooler flow at idle

Reverse Modulator Valve, Outer

- Delayed Reverse
- Burnt Reverse band
- Direct Clutch burned
- No Reverse

Reverse Modulator Valve, Inner

TCC Modulator Valve

- Code 1741
- No lockup
- Low cooler flow
- Engine stall on FWD engagement
- Poor converter fill & delayed engagements

TCC Regulator Valve

- TCC Regulator Sleeve • Code 628, 1741
- TCC surge • TCC apply concerns
- TCC cycling • High TCC slip RPM
- Overheated fluid • Overheated converter

Coast Clutch Valve

- No engine braking in D3 to low
- No 4th, 2nd or 5th (4R44E/55E)
- No coast clutch apply

Replace with **Sonnax Part No.**
37947-01K OE Ratio
37947-03K Increased Ratio

Replace with **Sonnax Part No.**
37947-11K Requires 37947-TL11

Replace with **Sonnax Part No.**
37947-54 or
37947-05K Requires 37947-TL5

Replace with **Sonnax Part No.**
37947-52

Replace with **Sonnax Part No.**
37947-53

Replace with **Sonnax Part No.**
37947-07K
Requires 37947-TL5

Replace with **Sonnax Part No.**
37947-09K Requires 37947-TL9

Replace with **Sonnax Part No.**
37947-33K Requires 37947-TL33
