# 4R70W ('95-HIGH MILEAGE)

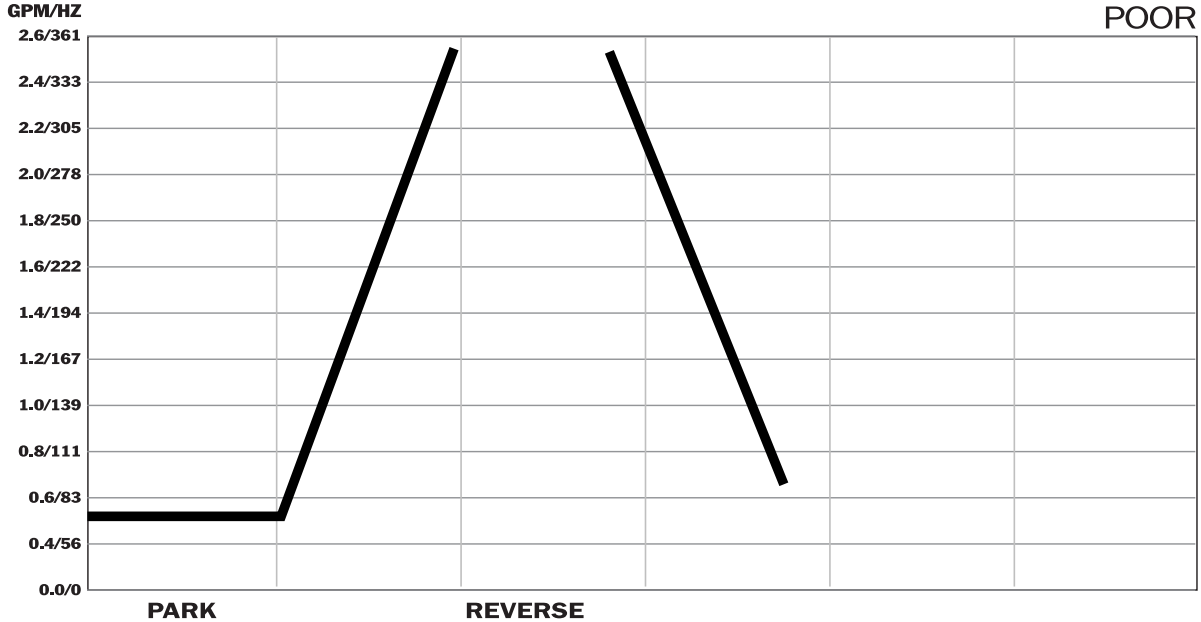
**Condition:** Aerated fluid (pump grabbing air), poor suction porting, gaskets, etc.

*Notes: Initial start, then reverse engagement. Can occur at end of 1-2 shift.*

**Correction:** New pump, Sonnax Bypass Clutch Control Sleeve & Plunger Valve **76948-04K**, pressure regulator valve and converter regulator valve.
