## Transmission Report

Volume 6, No. 2

June 2015

## 5R110W Pump Problems & Variations

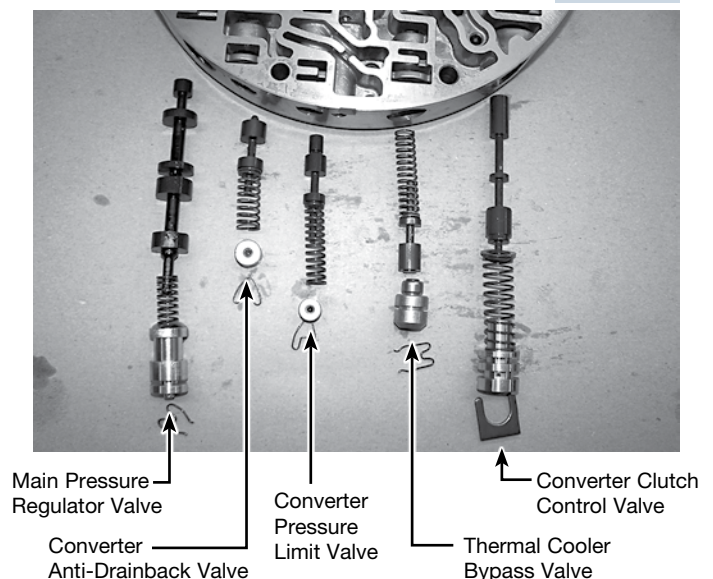
Figure 1

The solenoids for pressure control and torque converter clutch control are housed with the other solenoids, but they control the pressure regulator and the torque converter clutch via control valves located in the pump housing (**Figure 1**).

Valves Located in the 5R110W Oil Pump

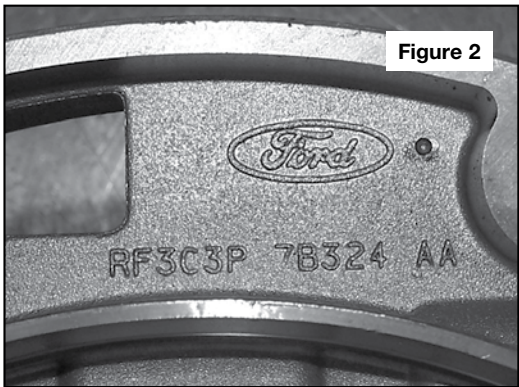
Gen. 1 Pump Body & Cover ID Location

- **Gen. 1** has these casting numbers on the front of the pump body and the rear of the pump cover: **RF3C3P-7B324-AA** or **-AB** (Figure 2).
- **Gen. 2** has these casting numbers on the front of the pump body and the rear of the pump cover: **5C3P 7A105-AA** and **RF5C3P-7B324-AA, -AB** or **-AC**. Directly above the casting number on the rear of the cover is another ID: **Al11Si3Cu** (Figures 3a and 3b).
- **Gen. 3** has identical casting numbers as the Gen. 2 on the front of the pump body and directly above the casting number on the rear of the cover. Look for an additional ID on the Gen. 3 pump body to tell these two generations apart. Gen. 3, 2008-later models without an external cooler filter with bypass have a **9C3P-7A103-AC** number near the bolt circle (Figure 4).

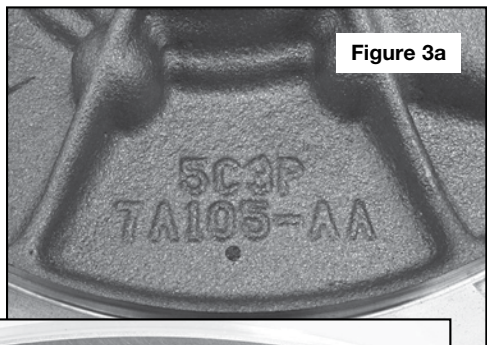
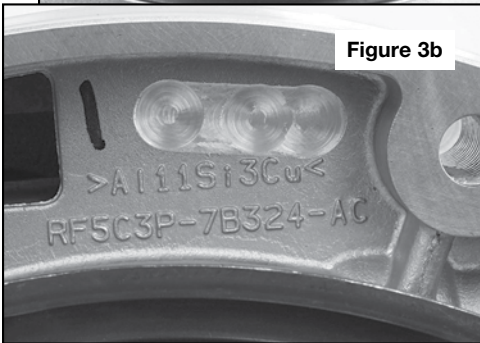
Gen. 2 & 3 Pump Body & Cover ID Locations

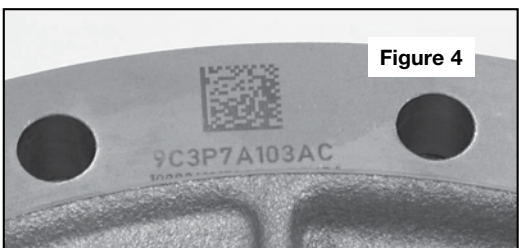
Figure 4

Gen. 3 Pump ID Location

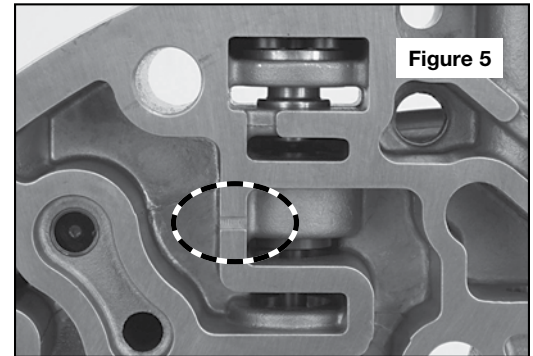
Gen. 3 Pump Cover Notch

The Gen. 3 pump found in the 2008-later units was redesigned to eliminate the external cooler filter and bypass assembly. A notch was cut in the pump cover for these versions to prevent low diode failure due to lack of lubrication when vehicles operate in  $-35^{\circ}$  F temperatures (**Figure 5**).

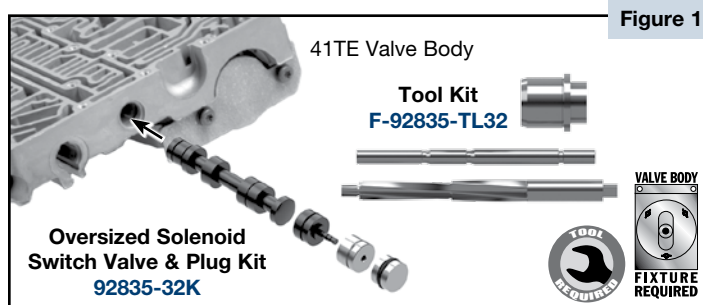
Figure 1

One of the more prevalent Sonnax product support phone calls revolves around the Chrysler switch valve and plug bore, and how to salvage the valve body by addressing bore wear with available Sonnax tools. This has been a long, strange trip – especially for the .420" dia. spool version, for which Sonnax offers multiple kit and reaming options. We took a much more straightforward approach on the .453" dia. valve, which we have now duplicated on the .420" version to better serve builders.

If the (inner) switch valve bore was accidentally reamed first, the bore would not be the right size to guide the reamer used for the (outer) plug portion of the bore, so any wear at the plug bore section could not be addressed. Since the outer portion of the bore typically wears faster than the inner portion, this results in a scrapped casting.

A similar system has recently been developed for the .420" dia. version. If wear at both the plug bore and switch valve bore is noted, use new reaming tool kit **F-92835-TL32** with the **VB-FIX**, then install oversized solenoid switch valve and plug kit **92835-32K** (Figure 1).

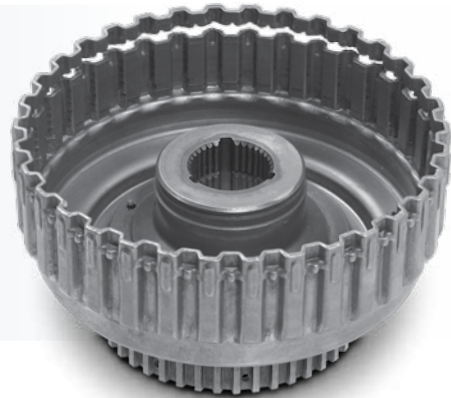
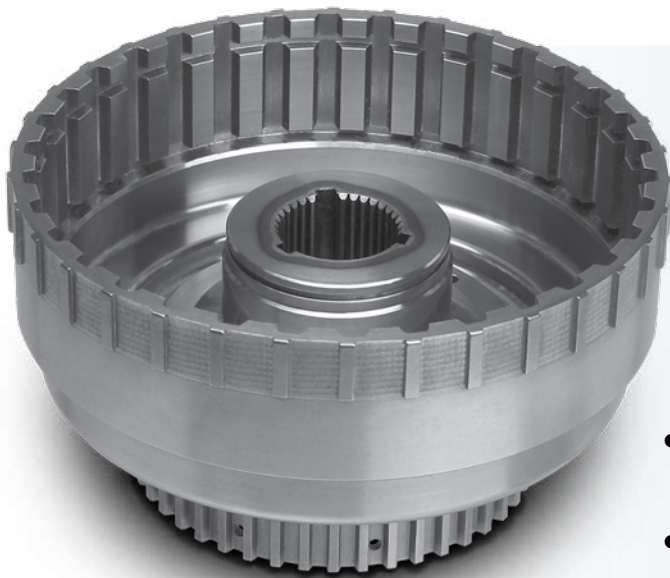
A common failure of the Ford 4R70W series transmission is breakage of the forward drum at the snap ring groove.

Pressure on the forward clutch piston creates a high stress load at the snap ring groove, causing the upper portion of the drum to split and break away.

The Sonnax forged forward clutch drum design provides increased strength in all areas, most importantly at the ring groove, preventing the breakage and resulting transmission damage associated with OE stamped steel drums.
