6T40 & 6T70 Drum Saver Kits

Unbeatable Protection Against 3-5-R Failures & Costly Comebacks

Transmission Report

October 2019

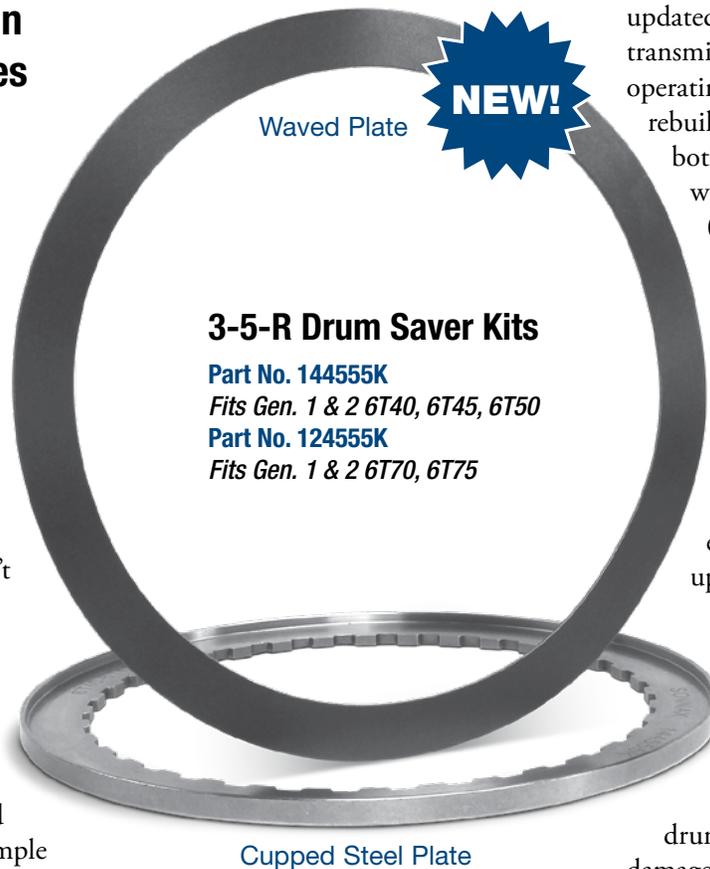
3-5-R Drum Saver Kits

Part No. 144555K

Fits Gen. 1 & 2 6T40, 6T45, 6T50

Part No. 124555K

Fits Gen. 1 & 2 6T70, 6T75

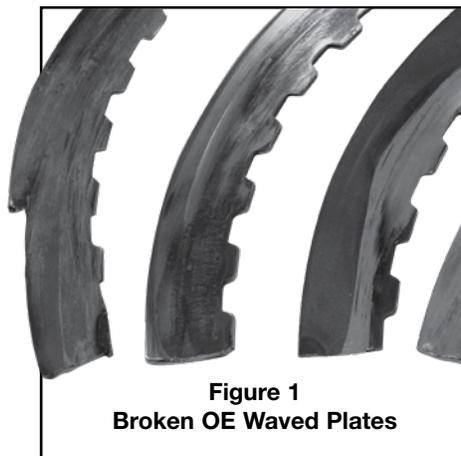
Many stress points for the waved plate can be eliminated by shot-peening. However, the design of the updated OE plate retains many of the stress points that allow it to break — namely all the teeth. Take a look at the broken plates in **Figure 1**. These are representative of EVERY broken OE plate Sonnax studied while researching a solution to this problem. Notice they are all separated exactly at a tooth corner

(a common stress point). Even OE plates that look OK to the eye can develop micro fractures here and be on the verge of failure. To prevent broken waved plates in 6T40/45/50 and 6T70/75 units, a different design is needed that eliminates these stress points once and for all.

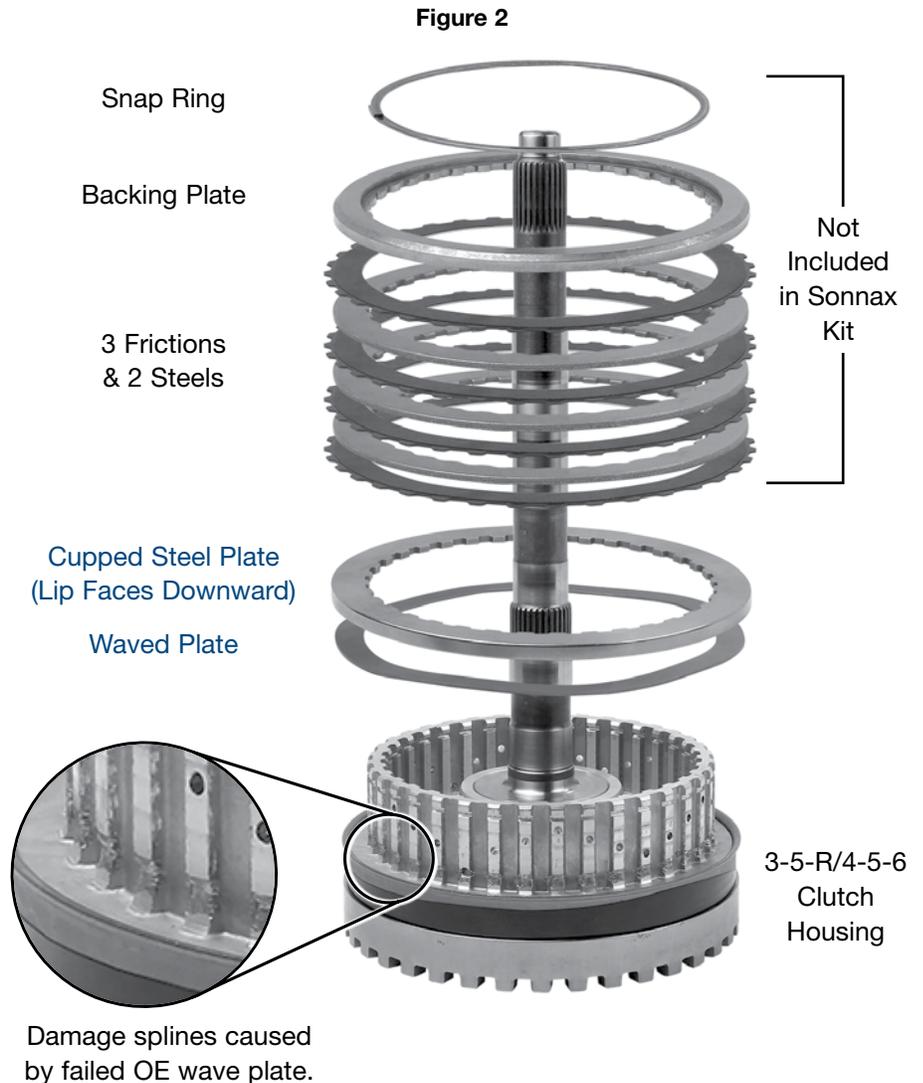
This is a billet piece — not a thin, stamped plate — and it fits together perfectly with the Sonnax waved plate. The cupped steel plate fits right over the top of the waved plate to secure it in place on the drum (**Figure 2**). It's the same thickness as the bottom steel in the clutch pack (which is discarded in favor of the Sonnax steel), giving you perfect clutch clearance every time — PLUS great heat dissipation.

there's usually nothing to be done except source and install a new drum and OE waved plate, then cross your fingers. Because there are no teeth on the Sonnax waved plate, it can ride near the damaged spline area without interference; there is no danger of hanging up (**Figure 2**) like an OE plate would. This is so much faster and easier — not to mention less expensive — than buying a new drum and having to spend time transferring the shaft and piston over. Plus, you've got the best waved plate you can get in there to make sure your rebuild really lasts.

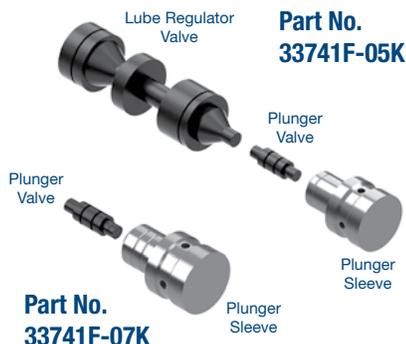
- Installing Sonnax torque converter lube regulator plunger valve kit **33741F-07K** can restore correct clearances and maintain proper hydraulic control of the lockup clutch
- Hardcoat anodized aluminum valve combats premature wear
- Direct replacement, requires no tools and minimal bore preparation prior to assembly
- Sonnax also offers a new oversized version: **33741F-05K**

These transmissions can have complaints associated with a worn plunger valve and sleeve, including increased RPM during acceleration, no lockup and engine stall on engagement. This is due to the wear at the inside of the lockup control plunger valve sleeve allowing oil to escape, which affects the timing and quality of the lockup clutch apply and release action.

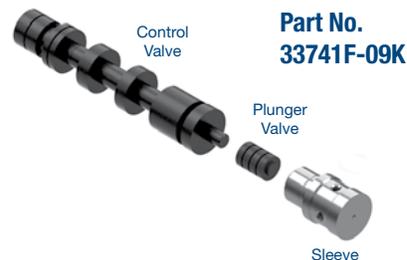
Oversized Lockup Control & Plunger Valve Kit

- Reconditioning the bore and installing Sonnax oversized lockup control and plunger valve kit **33741F-09K** restores optimal oil pressure management within the TC clutch apply/release circuits
- Hardcoat anodized aluminum valve combats premature wear
- Oversized valve reproduces OE pressure regulator function

The lockup control valve in these units operates under the direct command of the lockup control solenoid routed through a select switching valve and is also influenced via apply and release feedback balance passages. A worn bore, valve spool(s) or plunger valve assembly can cause loss of critical pressure to the sump, lube circuit or directly into apply or release passages, resulting in jerking on coastdown, harsh engagement and high engine RPM due to no lockup.

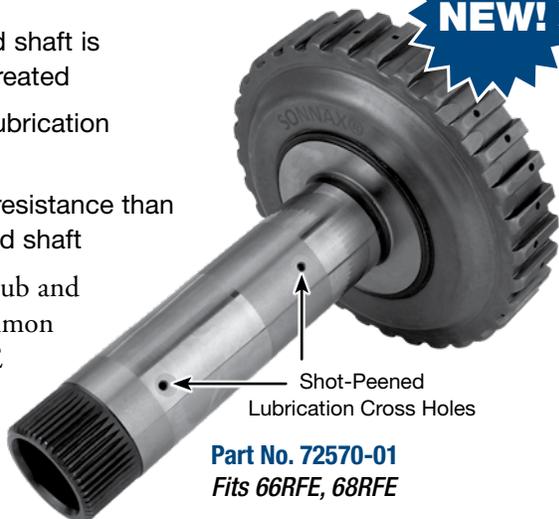
Part No. 72570-01
Fits 66RFE, 68RFE

Sonnax heavy duty overdrive clutch hub and shaft **72570-01** is a critical upgrade to protect any vehicle at any power level. Sonnax cryogenically treats the OE hub and shaft to make the base steel more stable, then shot-peens the lubrication cross holes to greatly reduce crack formation and increase load capacity.

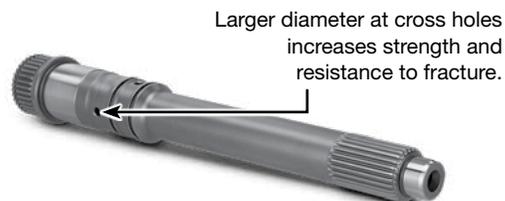
Part No. 72670B-01 Fits 68RFE
Includes checkball assembly and line-bored bushing.

- Rolled splines for increased durability
- Specially heat-treated and processed for maximum toughness and straightness
- Manufactured from 300M ultra high-strength steel for maximum strength and resistance to fracture

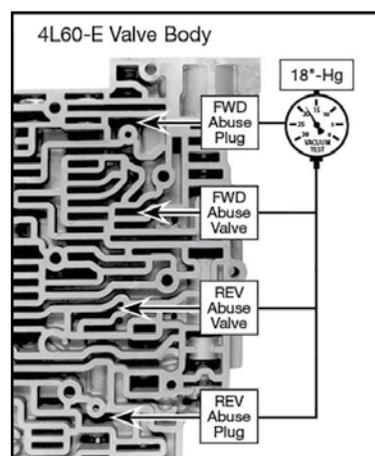
need of some more TLC than drop-in parts to keep them road-worthy. Vacuum testing at the noted plug and valve locations helps determine if the new oversized forward and reverse abuse valve kit **77754-58K** is required. If these locations aren't holding the recommended vacuum with the Sonnax drop-in components, choose the new oversized kit to ensure best drivability and performance for your customer.

Vacuum testing is the best way to decide what type of repair is needed to restore valve function. Use a small test plate or the complete Sonnax vacuum test plate kit **77754-VTP** with Sonnax test stand kit **VACTEST-01K** to test the locations shown.

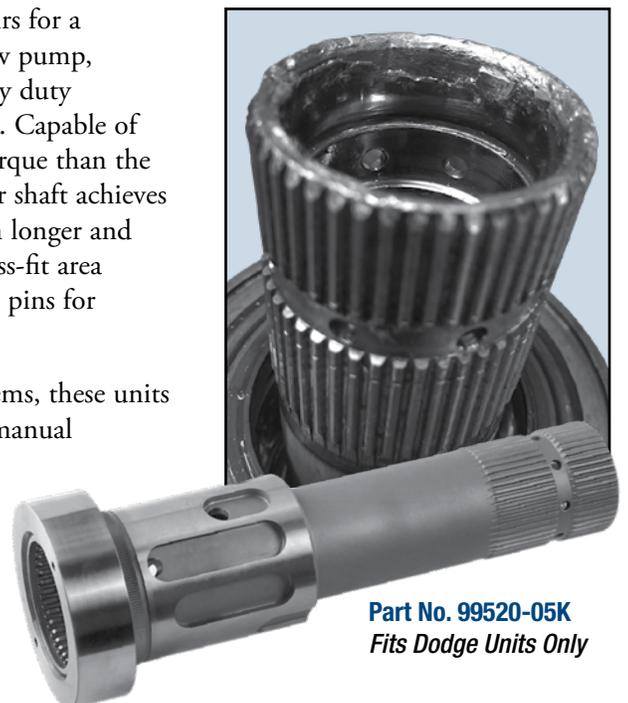
Part No. 99520-05K
Fits Dodge Units Only

To help you complete repairs for a fraction of the cost of a new pump, Sonnax has developed heavy duty stator shaft kit **99520-05K**. Capable of withstanding 15% more torque than the OE shaft, the Sonnax stator shaft achieves reliable holding power with longer and deeper serrations at the press-fit area than OE, coupled with roll pins for added security.
