Transmission Report

Volume 1, No. 2

October 2010

Brains vs. Brawn Introducing the Sonnax SmartShell™

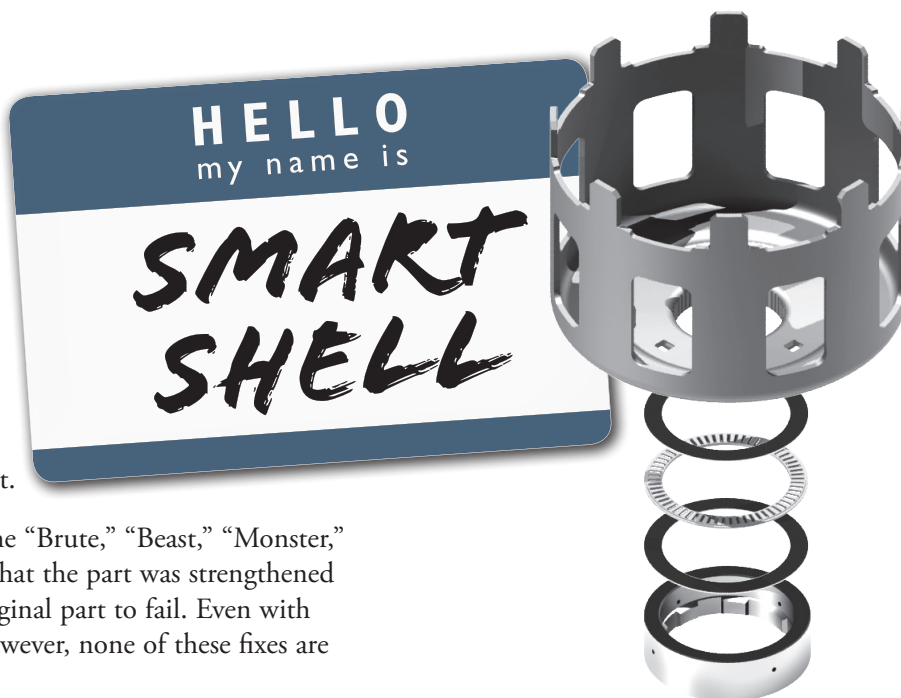
Complaints about the GM 4L60 sun gear shell are well documented all the way back to the introduction of the TH700-R4 in 1982. Whether a cracked spline hub or stripped splines, the failure results in the same familiar complaint: no reverse, no 2nd or 4th.

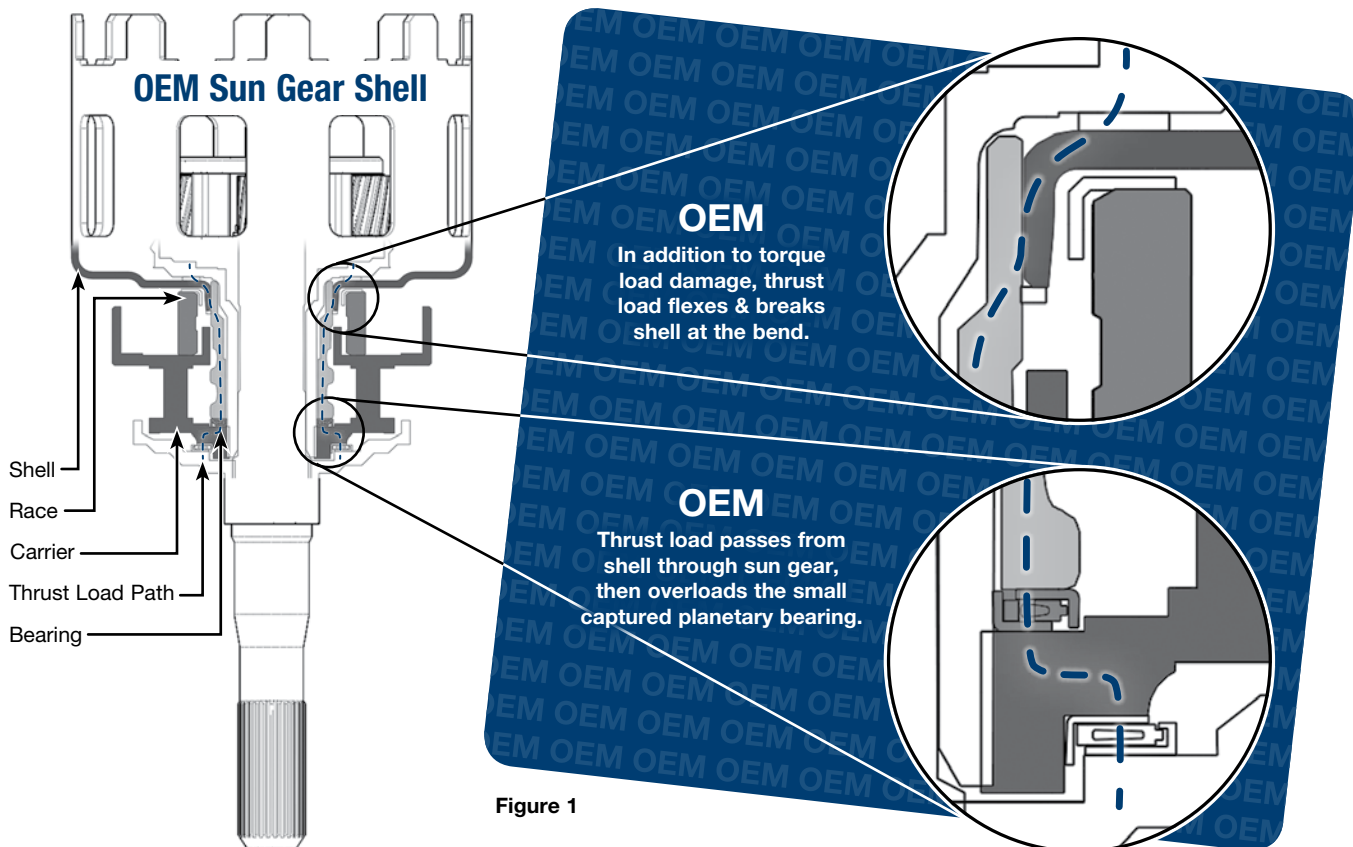
Figure 1

Another “top five” complaint with the GM 4L60 is the damage to the small captive bearing in the rear planetary assembly. The bearing cannot be replaced without disassembling the carrier, and even then it cannot be replaced with a larger bearing...there just isn't room. This small bearing takes a beating from the thrust load transferred through the sun gear to this location (Figure 1).

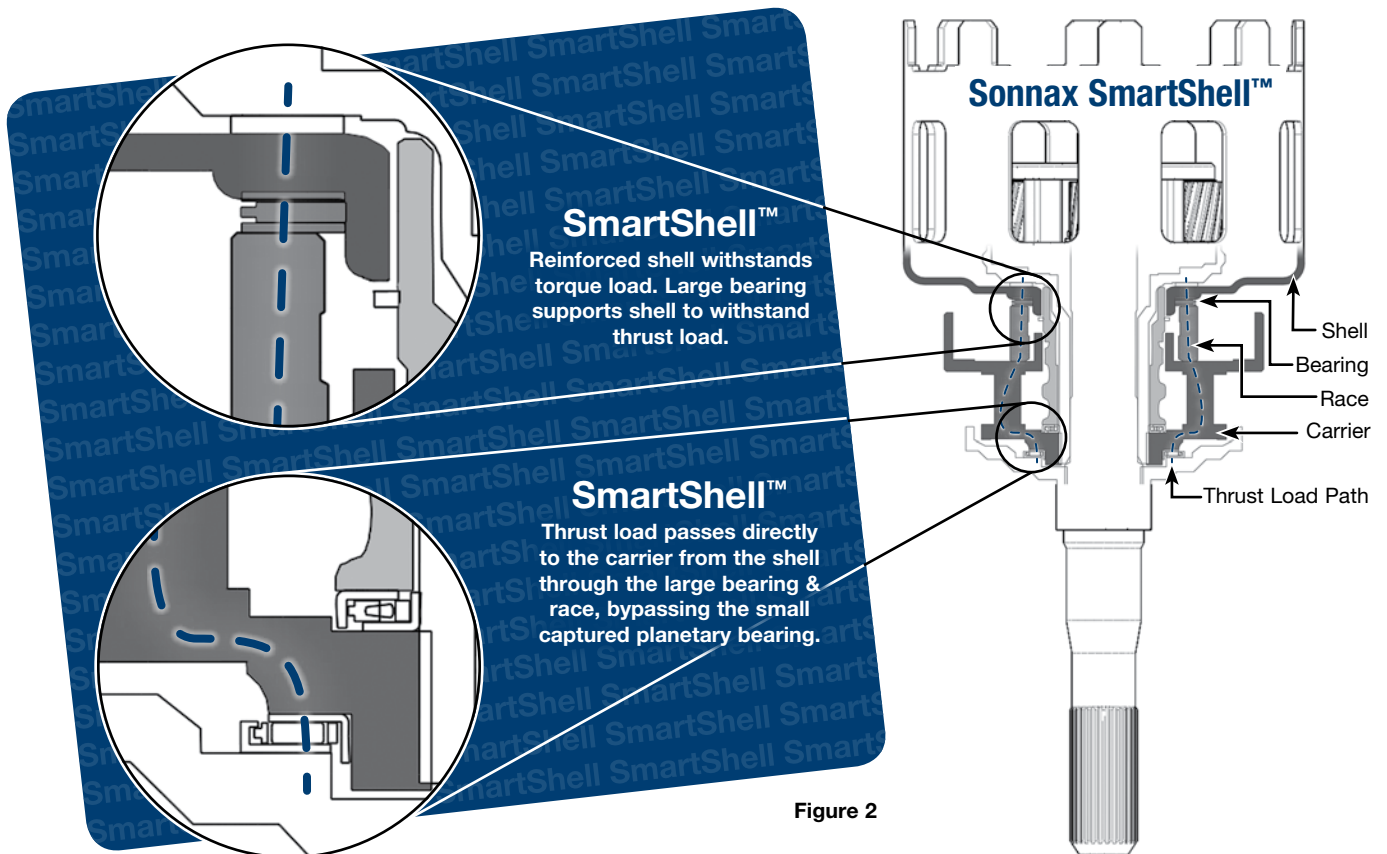
By adding our bearing and controlling the height of the modified OEM race included with the Sonnax SmartShell, we reroute the thrust load from the sun gear and the captive bearing. This moves the load to the new large bearing and modified race directly to the rear planet carrier, completely bypassing the vulnerable captive bearing (Figure 2).

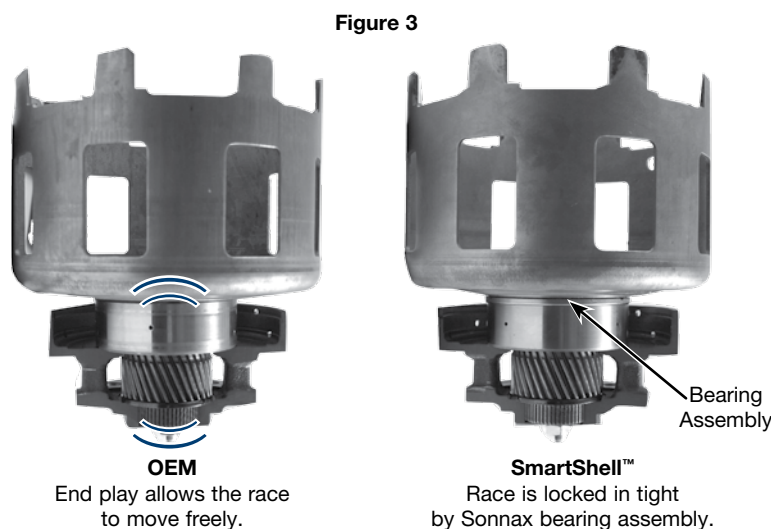
In the OEM setup, the end play allows the race to move freely and locks the sun gear and the thrust load into the captive bearing. In the SmartShell setup, the race is locked-in tight, allowing end play (of about .025") in the sun gear. This moves the thrust load from the small captive bearing to the much larger bearing supplied with the SmartShell (Figure 3).

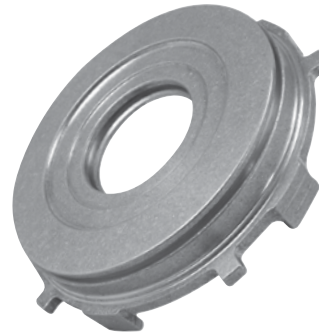
Part No. 77733-01K

Input Drum Reinforcement Kit

- Sleeve made from hardened Chrome-moly steel
- Includes a reworked OEM piston and O-ring
- Sleeve design will not block clutch feed oil

*Note: Will not repair a cracked drum. Late-model stamped forward pistons must be replaced with early-style cast-aluminum forward pistons.

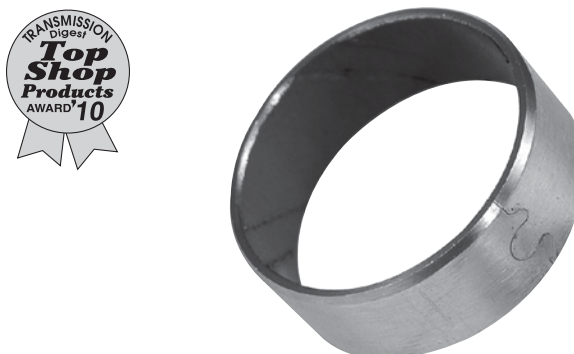
Part No. 77702BT-01

Kryptonite™ Rear Stator Bushing

- No machining required
- Wear resistant Teflon® lining
- Closely toleranced I.D. typically found in machined-in-place bushings
- Wider than OEM bushings

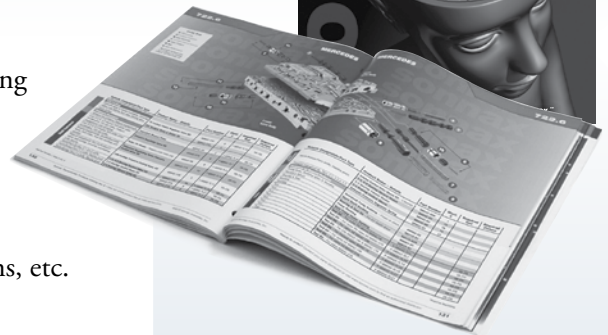
View Parts & Valve Bodies

Unit-specific product charts also are accompanied by our award-winning transmission layouts, a quick and easy way to see Sonnax parts "in action." Parts are identified by number for easy cross reference with product charts.

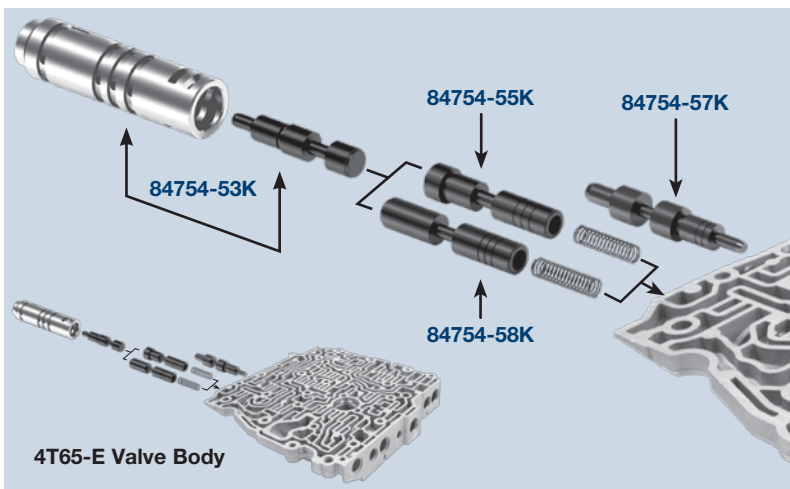
The accumulator valves respond to torque signal influence to feed accumulators and control clutch apply pressure and shift feel. Valve and bore wear can allow torque signal, accumulator or line pressures to exhaust, resulting in various shift complaints. The improved designs of Sonnax replacements for 4T65-E accumulator valves establish the optimum shift control, using upgraded material to prevent wear.

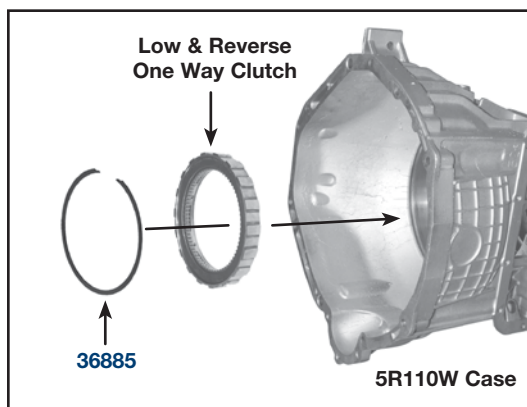
5R110W low/reverse retaining rings often “pop out” of the case groove, causing slips in reverse and severe damage to the case lugs. When moving in reverse, radial movement of the pressure plate walks the retaining ring out of its groove. Sonnax retaining ring **36885** is wider and slightly thicker, providing more outward tension and stiffness to help keep the ring seated securely in the case groove. This retaining ring can be used in both gas and diesel applications.

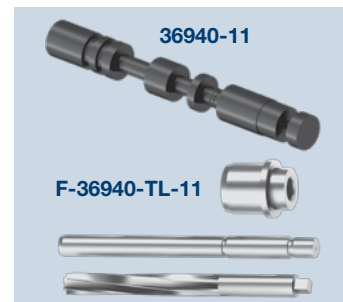
Oversized Manual Valve

Loss of valve body cores due to worn valves and valve body bores. The Sonnax “F-Tool” kit **F-36940-TL-11** oversized the bore, restoring the tight bore-to-valve clearances when used with Sonnax oversized manual valve **36940-11**.

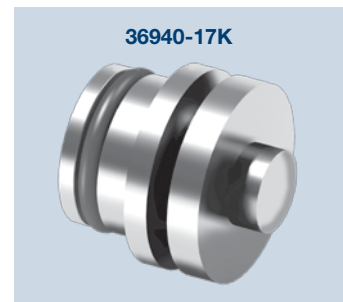
Pressure Switch O-Ringed End Plug Kit

The original design of 5R110W units included five hydraulic pressure switches. Although these switches were never actually utilized, early valve bodies came through with switches installed only to seal up their circuits. Later valve castings were left un-bored and sealed in all locations except the direct clutch pressure switch, which still only served to seal the bore. With the excessive high line pressure that is a frequent problem in these units, it is common to find the OEM pressure switches leaking, causing loss of shift solenoid control pressure and shift complaints. Sonnax drop-in O-ringed end plug kit **36940-17K** includes an O-ring that provides a positive seal to prevent loss of shift control pressure.

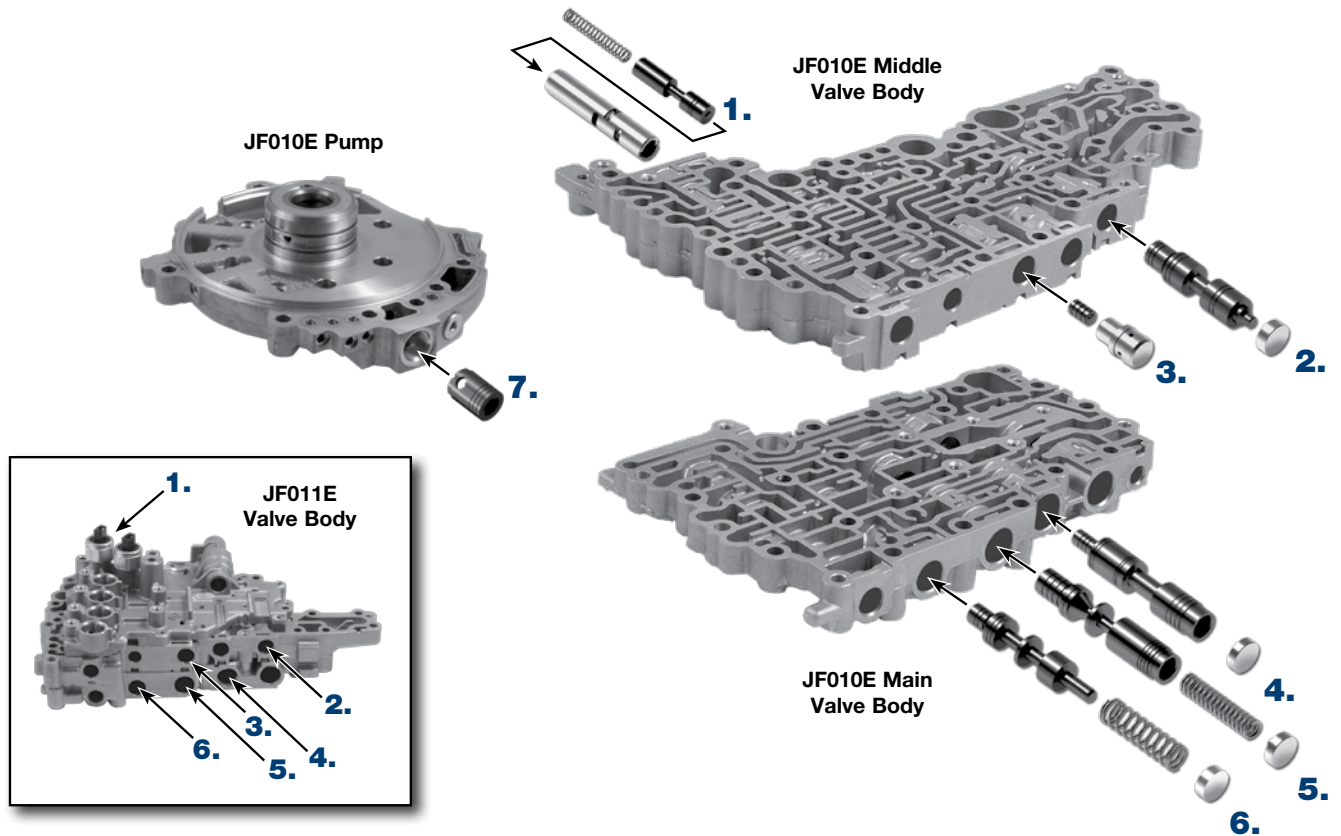
PROBLEM	SONNAX SOLUTION	Tool Required	Part Number
<ul style="list-style-type: none"> • Chatter/Noise on acceleration • Loss of ratio change 	1. Solenoid Regulator Valve Kit	—	113741-01K
<ul style="list-style-type: none"> • Chain slippage & pulley fracture • RPM surge/chatter on acceleration 	2. Oversized Secondary Pulley Control Valve Kit	F-113741-TL17 & VB-FIX	113741-17K* 113741-19K*
<ul style="list-style-type: none"> • Jerking on coastdown/harsh engagement • High engine RPM due to no lockup 	3. Lockup Control Sleeve & Plunger Valve Kit	—	113741-11K
<ul style="list-style-type: none"> • Chatter on acceleration • High/Low line pressure 	4. Oversized Primary Pressure Regulator Valve Kit	F-113741-TL9 & VB-FIX	113741-09K
<ul style="list-style-type: none"> • Chain slippage & pulley fracture • RPM surge/chatter on acceleration 	5. Oversized Secondary Regulator Valve Kit	F-113741-TL13 & VB-FIX	113741-13K* 113741-15K*

<ul style="list-style-type: none"> • Engine stalls on engagement • Loss of lockup 	6. Oversized TCC Limit & Lube Valve Kit	F-113741-TL4 & VB-FIX	113741-04K
<ul style="list-style-type: none"> • Slippage • Delayed engagement into forward & reverse 	7. Pump Flow Control Valve	F-113741-TL7C & VB-FIX	113741-07†
