Transmission Report

Volume 8, No. 1

March 2017

Outsmarting 4L80-E Overdrive Roller Clutch Failure

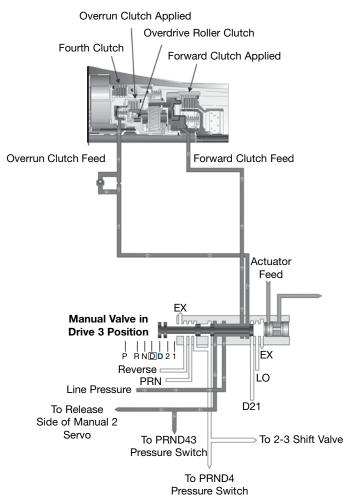
Manual Valve Partial Hydraulic Circuit Overrun Clutch Overdrive Roller Clutch Fourth Clutch Forward Clutch Applied Overrun Clutch Feed Forward Clutch Feed Actuator Feed EX **Manual Valve** in OD Position | | | | | | | R N D D 2 1 ĚΧ Reverse LO PRN Line Pressure To Release D21 Side of Manual 2 Servo To 2-3 Shift Valve To PRND43 Pressure Switch To PRND4 Pressure Switch

Figure 2 – OE Drive 3 1st Gear Manual Valve Partial Hydraulic Circuit

selected, the overrun clutch drum is applied through a passage connected by the manual valve, which provides engine braking and also backs up the roller clutch, providing a stronger connection to the OD planetary driving the forward drum (**Figure 2**).

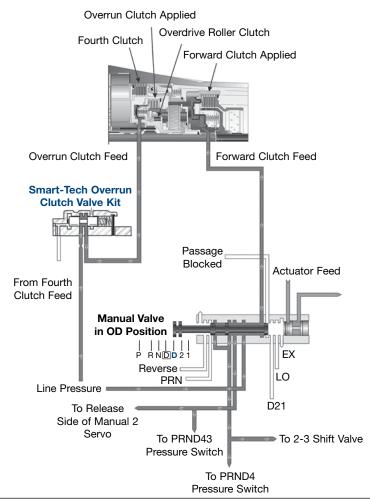
Figure 3 – Overdrive Range 1st Gear Manual Valve Partial Hydraulic Circuit with Smart-Tech Overrun Clutch Valve Kit

With the Smart-Tech kit installed, the overrun clutch is applied in the OD position in 1st through 3rd Gears as well, so it is not necessary to pull the manual valve to a manual position for extra pulling power. **Figure 4** shows the hydraulic function of the kit when the overrun clutch is on and when the overrun clutch is off. Note that the valve position is controlled by the presence of 4th clutch pressure; so in essence, the overrun clutch is on in every gear other than 4th Gear. Fourth clutch pressure strokes the valve to the right and exhausts the overrun clutch. This provides a stronger connection to the forward drum through the OD planetary assembly that helps prevent OD roller clutch failure.

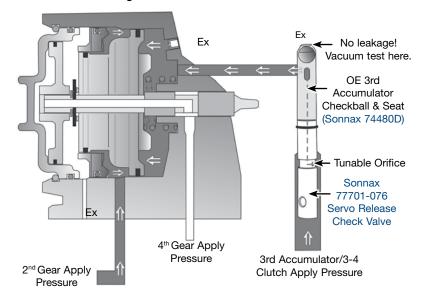
Figure 1 - 3rd Accumulator Oil Circuit

Ensuring the sealing integrity of the OE 3rd accumulator checkball is critical, as it seals 3rd accumulator/3-4 clutch apply pressure from exhausting into the case. **Figure 1** shows the 2-4 servo being released in 3rd Gear. Unwanted leakage past the 3rd accumulator checkball means loss of 2-3 accumulator pressure, which allows the band to drag (2-3 bind-up, 2-3 flare, 2-4 burnt band issues) and loss of 3-4 clutch apply pressure (3-4 clutch burned, no 3rd Gear issues). Accumulator pressure is present here in 4th Gear as well, and leakage will continue to result in diminished 3-4 clutch apply pressure.

The patented Sonnax servo release check valve kit 77701-076 provides better synchronization of the 2-4 band release and the 3-4 clutch apply, helping to prevent 2-3, 3-2 shift complaints. Figure 1 shows how the 3rd accumulator oil is now metered through an orifice in the servo release check valve, reducing flow to the release side of the 2nd apply piston, which provides better timing between release of the 2-4 band and apply of the 3-4 clutch. This orifice can be tuned to a specific size best suited to the particular servo piston size variation in the transmission. During a 3-2 downshift, full flow of 3rd accumulator oil is allowed out of the servo release check valve as its internal checkball unseats, allowing proper timing for the 3-4 clutch release and the 2-4 band apply.

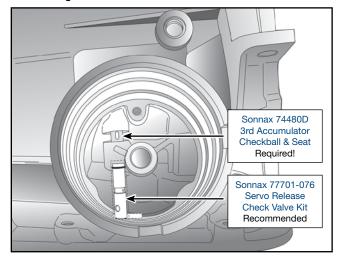
Figure 3 - Sonnax Parts Installed in Case

Because these two parts serve different functions, it is always mandatory to have a fully functioning 3rd accumulator checkball and seat in the transmission. For best results, though, Sonnax recommends that this dynamic duo (74480D and 77701-076) be used together. The components installed in series in the same case passage as illustrated in **Figure 3**. With this team working on your side, those dreaded 3-4 clutch failures and 2-3, 3-2 shift concerns will be held further at bay. ◀

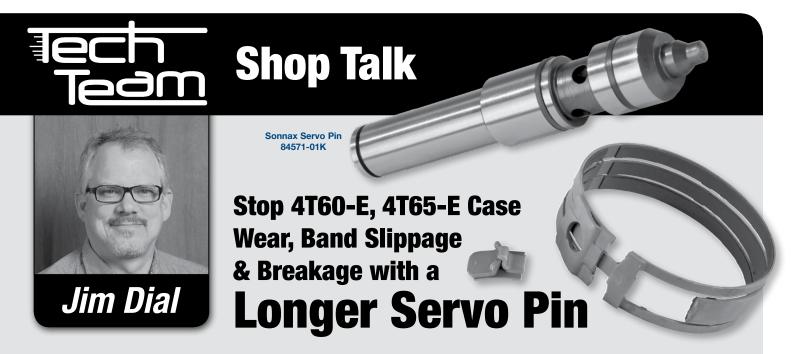
Typical Forward Band Clearance

There is one other area that needs attention, though, and that is the forward servo pin length. I am sure that many rebuilders have looked at the band clearance after installing a new band and noticed that it was quite large. To help close this gap, Sonnax now offers an extended length forward band servo pin, Part No. 84571-01K, for use in both 4T60-E and 4T65-E applications. Typical servo pin stroke is approximately .400", so the Sonnax servo pin (coming in at approximately .200" longer) will cut this in half, greatly helping to take up the extra band clearance.

Addressing pressure control issues and installing the new Sonnax servo pin will help speed up the engagement into Drive, as there will be much less travel for the forward servo to fully apply the band. Focusing on these two areas will help prevent customer complaints and repeat broken or burnt-up forward band issues.
