Front Cover Hub

MB-HB-1K

Mercedes 722.6, 722.9

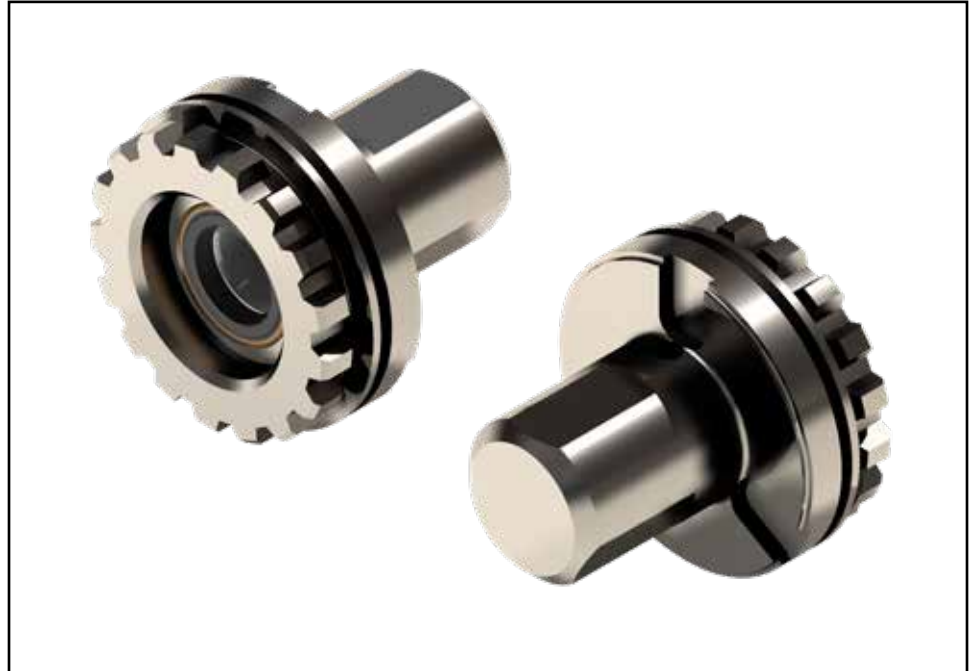
Figure 1

- Hold the cover in a three- or four-jaw lathe chuck (preferably four-jaw) by the O.D. of the pilot. If the cover insert is broken (**Figure 1**) place a dial indicator against the face of the cover adjacent to the broken insert and adjust until the cover runs true. If the insert is not broken, place your indicator against the bearing surface of the insert and adjust for trueness.

- Place a #7 center drill in the tail stock lathe chuck and bore through the end of the pilot.
 - Enlarge the hole using a .650" diameter drill, then follow up with a 1" drill bit.

- Install a boring bar in the tool holder on the cross-feed of the lathe (**Figure 2**). Enlarge the bore until the boring bar contacts the three stakes used to retain the OE insert. Use a bushing cutter to remove any remaining parts of the OE insert, being careful not to remove the three OE stakes.
