Mercedes 722.6

Front Cover Hub Assembly

MB-HB-1K

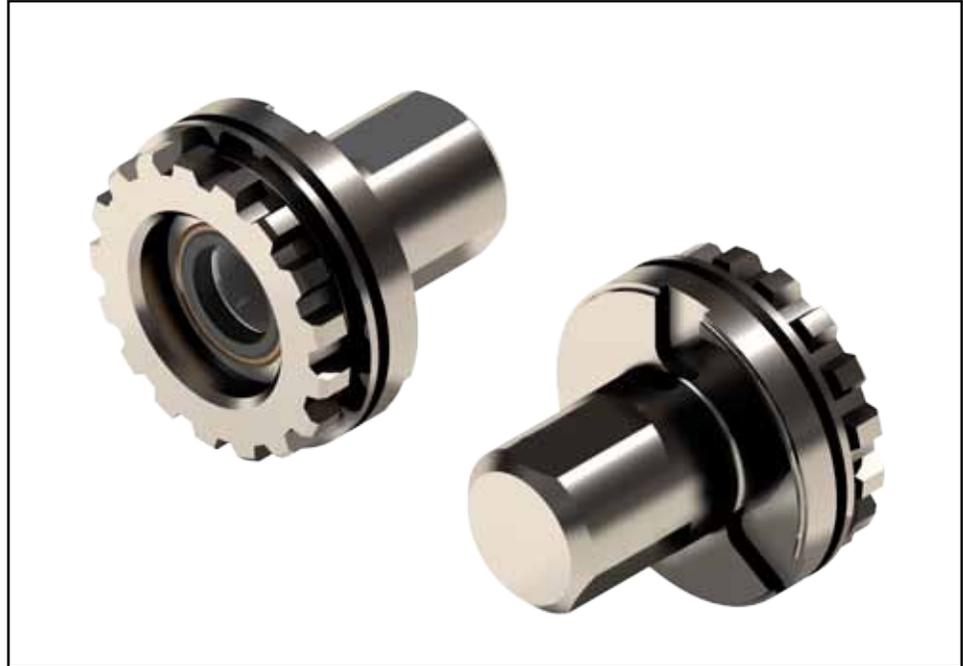
- Hold the 722.6 cover in a three- or four-jaw lathe chuck (preferably four-jaw) by the O.D. of the pilot. If the cover insert is broken as in **Figure 1**, place a dial indicator against the face of the cover adjacent to the broken insert and adjust until the cover runs true. If the insert is not broken, place your indicator against the bearing surface of the insert and adjust for trueness.

IMPORTANT: Use caution when performing the boring process to preserve as much of the original bore as possible. The original I.D. bore of the pilot is used to center the repair hub.
