## C1/K1 Clutch Control Valve Kit

## Aisin AW TF-60SN, TF-80SC, TF-81SC; Mini 6F21WA; VW/Audi 09G, 09K, 09M

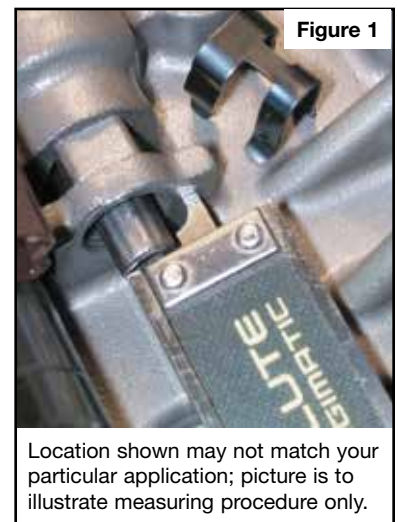
Location shown may not match your particular application; picture is to illustrate measuring procedure only.

- Take and record a reference dimension from the end of the spring adjuster to the casting (**Figure 1**). This measurement will be required when assembling the new valve assembly.
- Remove the OE retaining pin, solenoid, valve, spring, adjuster clip and the adjuster.
- Discard OE valve and spring.

- After reaming, remove OE retaining clip and adjustment plug from the bore for a thorough cleaning.
- Reinstall OE spring adjuster and adjust to the reference dimension noted in disassembly procedure, then reinstall OE retaining clip.

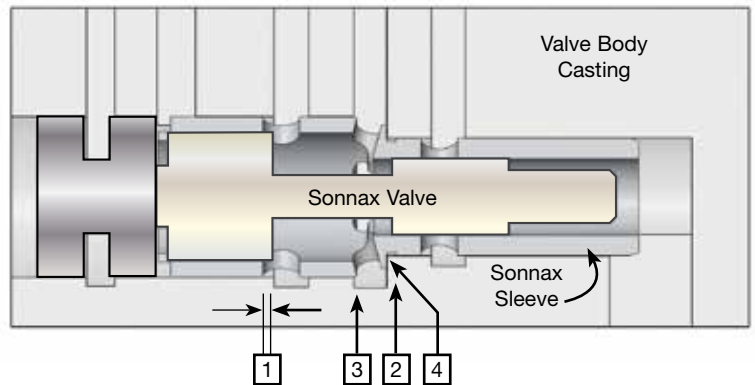
Figure 4

### Part Misalignment - Sleeve Too Far Outboard

1. This condition can occur due to reamer not traveling deep enough into the bore.
2. Casting variance and "valley-flashing" also can short-stop reamer travel.
3. To correct this and move sleeve to the right, remove material from the casting face and valley. A Dremel® 194 cutter works well.
4. In some situations, remove material from edge stop on sleeve.

Ensure the sleeve ports align correctly with the valve body ports (Figures 3 and 4). If significant misalignment is noted ( $= .015"$ ), shimming or sanding of components may be necessary.
