48RE Converted Valve Body

CHR135

- Converted Valve Body
- Detent Ball .363" dia.
- Manual Valve

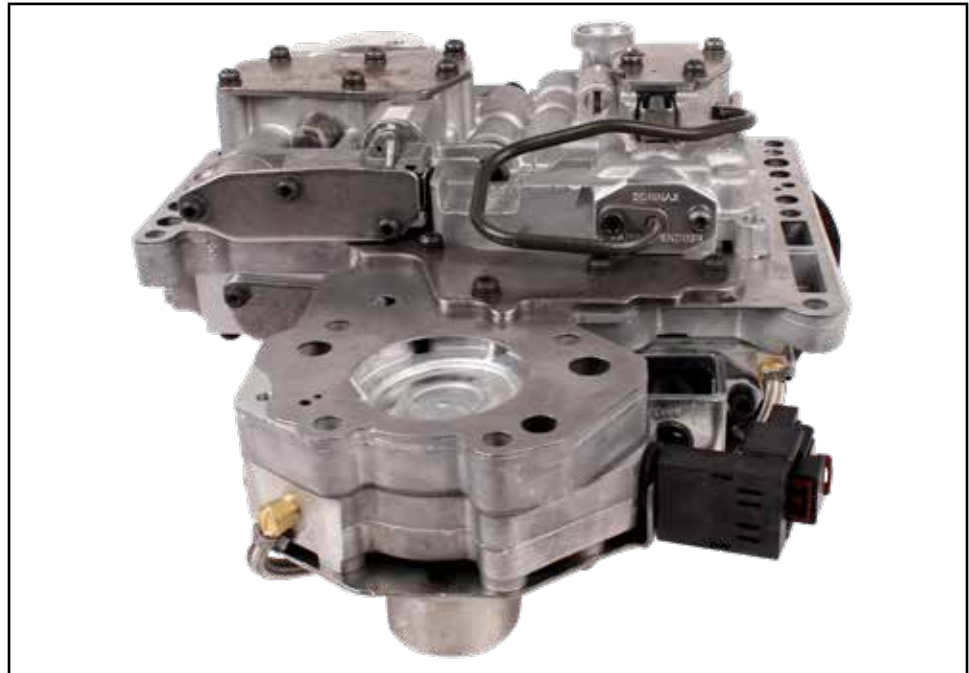
NOTE: The bolt beside the converter clutch solenoid (**Figure 1**) will require a thin-walled socket for proper installation and torquing.

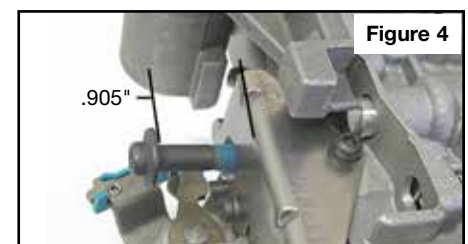
The distance between the bracket and the inside edge of the adjustment bolt head (**Figure 4**) should be .905". The TTVA motor will re-calibrate to this setting at every start up.

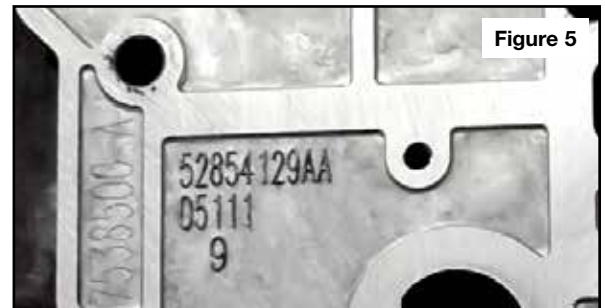
Figure 5

NOTE: See Figures 5, 6 and 7 for proper core identification numbers and locations.

Upper Valve Body (PR) Casting #	Channel Casting #	Lock-Up Casting #	Number Stamped in Main Plate
4617003	52854129AA	52118502AB	27
