**Aisin AW TF-60SN, TF-80SC, TF-81SC;
Mini 6F21WA; VW/Audi 09G, 09K, 09M**

**C1/K1 Clutch Control
Valve Kit**

15741-25K

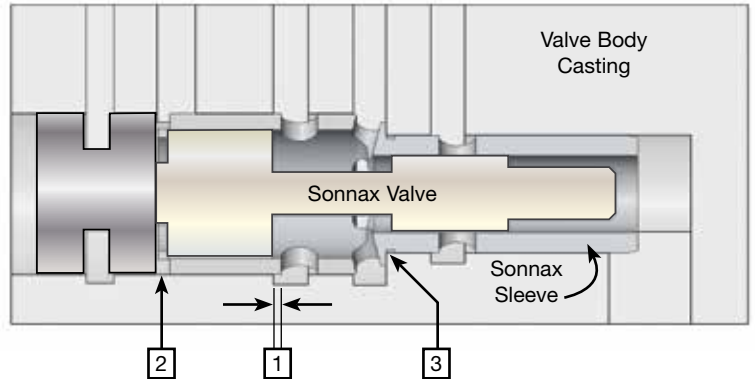
Figure 3

Part Misalignment - Sleeve too far Inboard

1. Note how the ports are positioned. A portion is under the casting, shifted right. This is incorrect; shift sleeve **left** by this distance.
2. Material will need to be removed from either this end of the sleeve or from the inboard of end plug.
3. Once material has been removed and sleeve is shifted left, the holes in sleeve should align with casting. The sleeve must be shimmed or Loctited at this location. Shim can be made from coil wire cut from spring.

Ensure the sleeve ports align correctly with the valve body ports (Figures 3 and 4). If significant misalignment is noted ($= .015"$), shimming or sanding of components may be necessary.
