## Front Servo Piston Cover Kit

**22827-01**

### Chrysler 46RE, 46RH, 47RE, 47RH, 48RE, A727

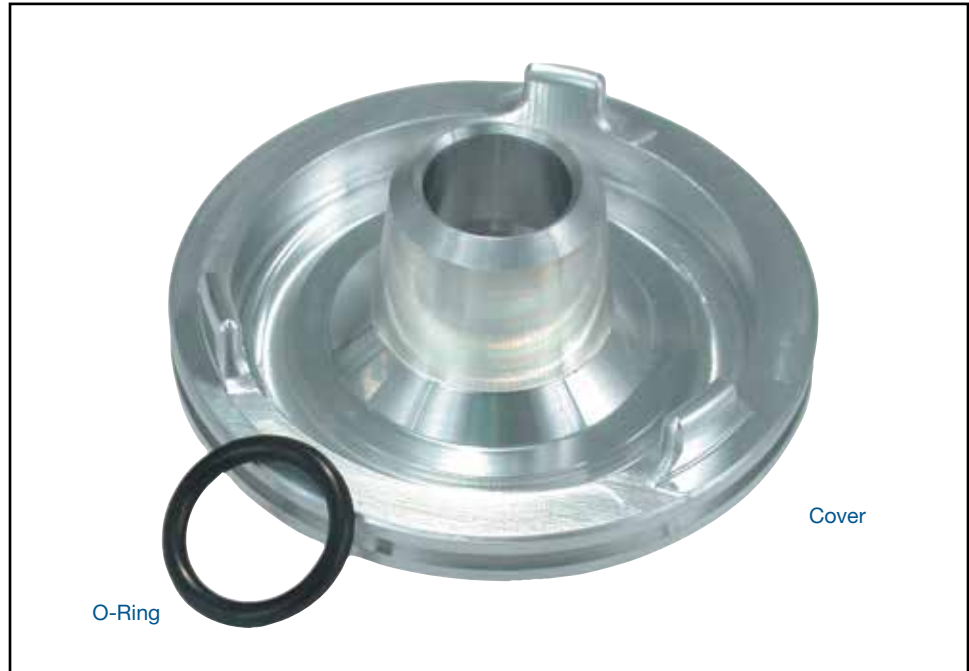
- Cover
- O-Ring

- Remove OE retaining ring and outer seal to save for reuse.
- Remove OE servo piston cover and discard.
- Buff off any servo pin scoring with 400-grit emery cloth followed by Scotch-Brite®.

- Install Sonnax front servo piston cover with O-ring.
- Reuse or replace OE outer seal on Sonnax cover. Cover will work with either steel or PTFE seal.
- Reinstall OE retaining ring.

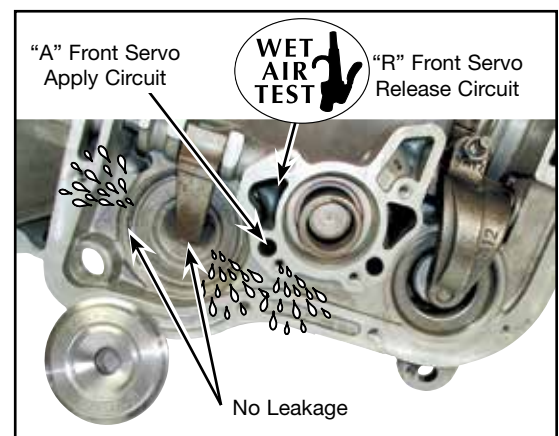
- Place a small amount of oil into the front servo release port "R" and follow with 30-40 psi of air pressure.
- Verify that there is no leakage at the servo cover.
- Oil leaking into the servo apply circuit indicates cross leakage at the servo piston. This means lost clutch oil and can result in direct clutch failure.
