Input Drum Reinforcement Kit

Part No.
77733-02K

GM 4L60, 4L60-E, 4L65-E, 4L70-E

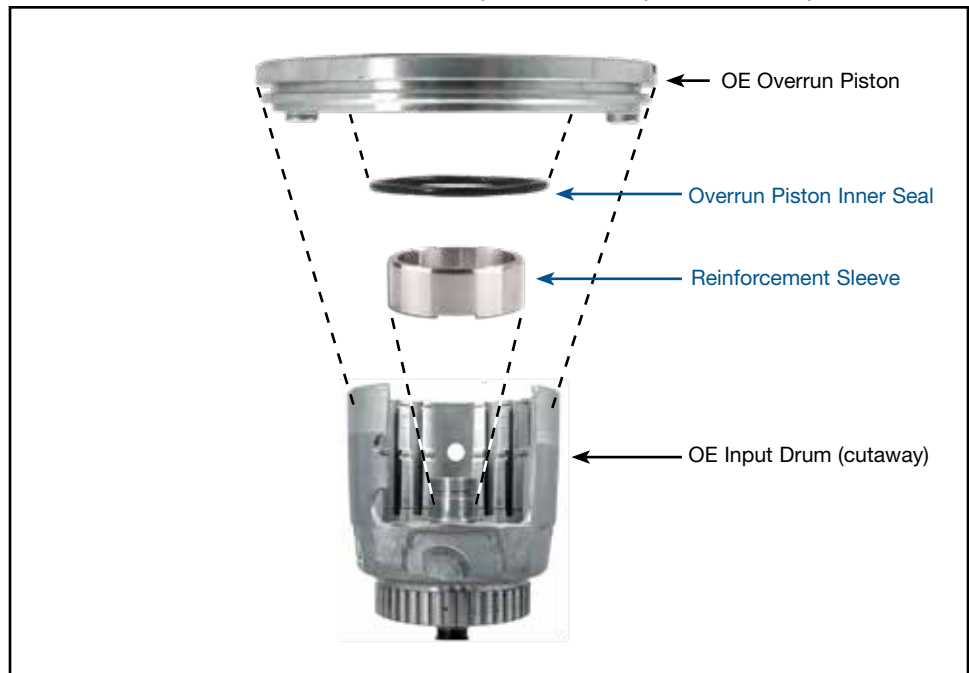
- Refer to photo above. Clean the reinforcement sleeve area and take note of the overrun clutch feedhole location.
- Thoroughly clean the reinforcement sleeve.
- Coat the inside of the sleeve with green Loctite® 609. Align the notch in the sleeve with the overrun feedhole in the housing (**Figure 1**). Set the sleeve into position on the input drum, keeping the notch in the sleeve aligned with the overrun feedhole in the housing.

- Inspect the drum for cracks or damage. This sleeve will not repair a cracked drum. Set the input drum into a hydraulic press (or arbor press). Use an appropriate sized tube or a spare (not to be reused) 4L60 stator shaft with the selective spacer (with bearing left out) to support the aluminum housing directly under the area being pressed on. A 4L60-E rear sun gear works well to drive the sleeve on.

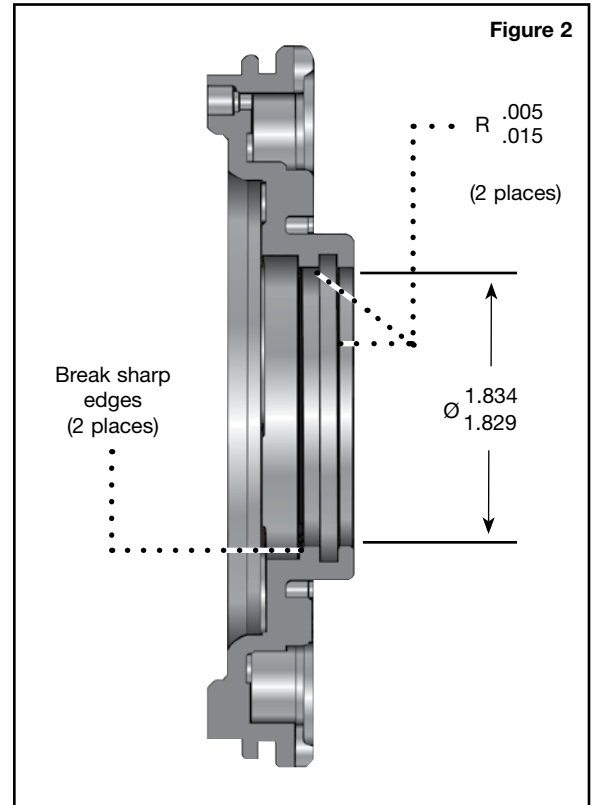
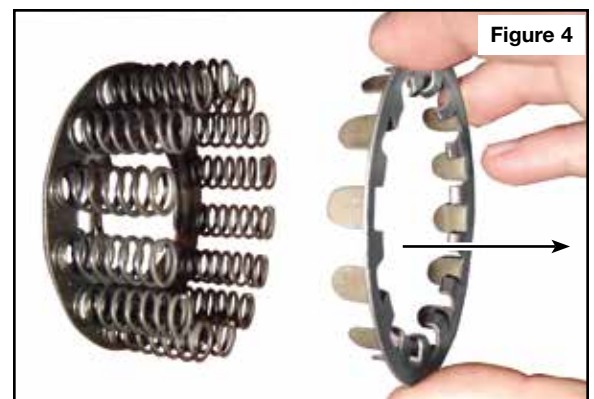
- a. Use the modified early-style cast-aluminum OE overrun piston with an early-style cast-aluminum forward piston. The late-model stamped steel forward piston cannot be used (**Figure 3**). If you are rebuilding a late-model unit that has a stamped steel forward piston you must obtain an early-style cast-aluminum forward piston.

- b. If using a late-model return spring assembly (identified by two spring retainers on both ends of the springs) remove and discard the lower spring retainer (**Figure 3**). Although not required, the early-style return spring used with OE aluminum pistons is about 10% stronger and is preferred for high RPM applications.
- c. Assemble input drum as usual.

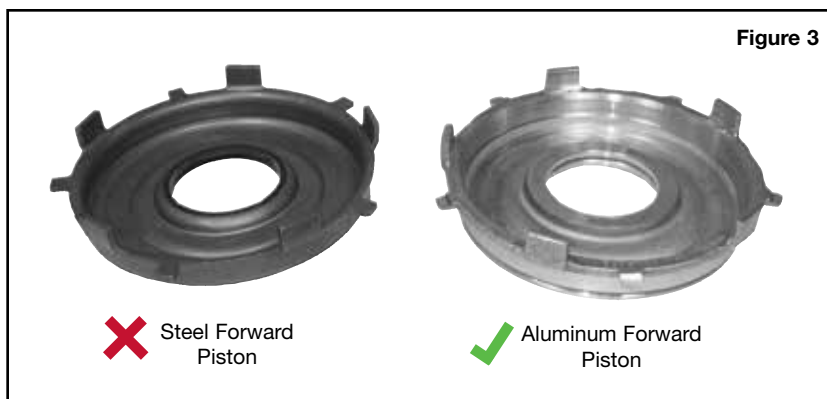
- b. Fixture the overrun piston in a lathe and indicate the I.D. so it is running true.
- c. Bore the I.D. out $\text{Ø}1.834\text{--}1.829$ ". Radius both sides of the seal groove with $R.005\text{--}.015$ " radii. Make sure to deburr both outer edges (**Figure 2**).
- d. Thoroughly clean the piston of any chips, debris or cutting fluid.
