## Hyundai/Kia A6GF1, A6LF1/2/3, A6MF1/2

# TCC Pressure Control Plunger Valve Kit

## Part No. 102741-01K

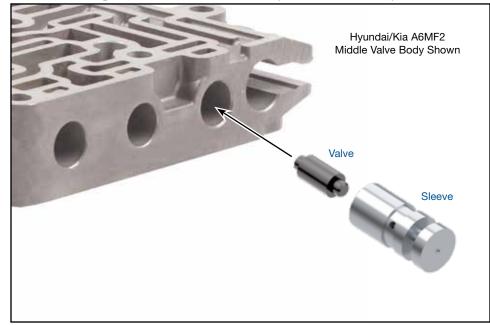
- Valve
- Sleeve

- a. Remove OE retainer and set aside for reuse.
- b. Remove and discard OE TCC pressure control sleeve and plunger valve.

- a. Install Sonnax TCC pressure control plunger valve and sleeve.
- b. Reinstall OE retainer.
