48RE Converted Valve Body

CHR135

- Converted Valve Body
- Detent Ball .363" dia.
- Manual Valve

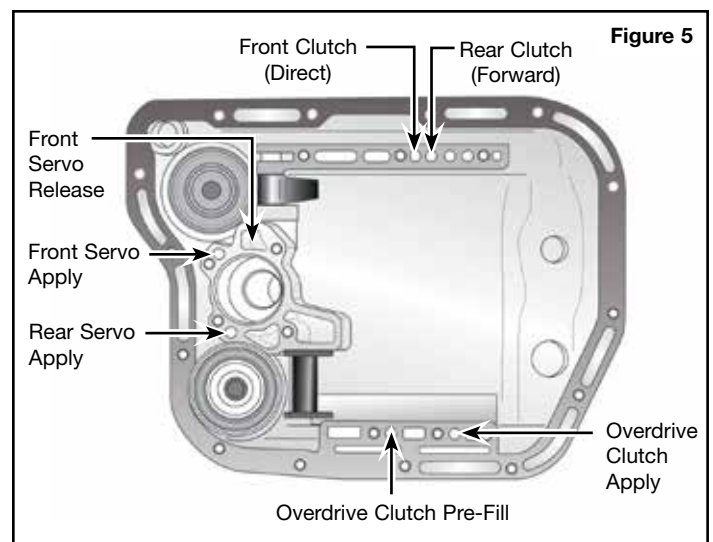
This family of transmissions commonly exhibits the symptom of late shifting into 3rd gear. Recommend air-testing front clutch circuit to verify there are no leaks before replacing valve body for this concern (**Figure 5**). Historically, many technicians have replaced valve bodies unnecessarily for this issue when in fact there was a leak somewhere in the front clutch circuit that was responsible.
