## 1-2 Accumulator Valve Spring Kit

**36946-05K**

## Ford C6

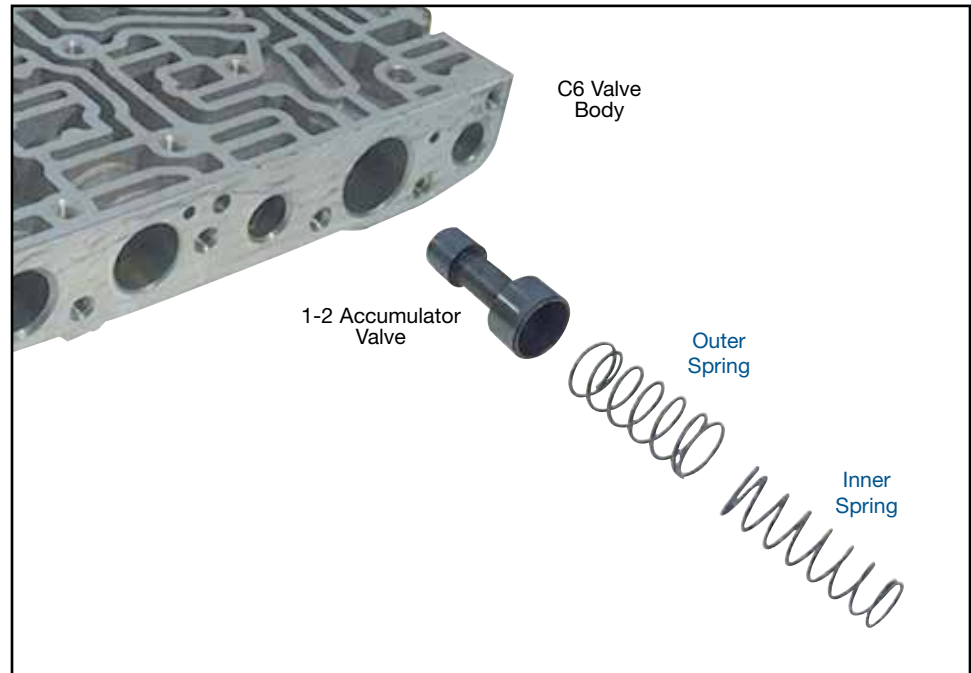
- Outer Springs (5)
- Inner Springs (5)

- Inspect 1-2 accumulator springs. If either are broken or measure less than  $1\frac{5}{16}$ " long, then the spring set needs to be replaced. Stretching out existing springs isn't an option since they will quickly collapse again in service.
- Discard the damaged springs

Replace damaged springs with Sonnax 1-2 accumulator spring set.
