Hyundai/Kia

A6GF1,

A6LF1/2/3, A6MF1/2

sonnax®

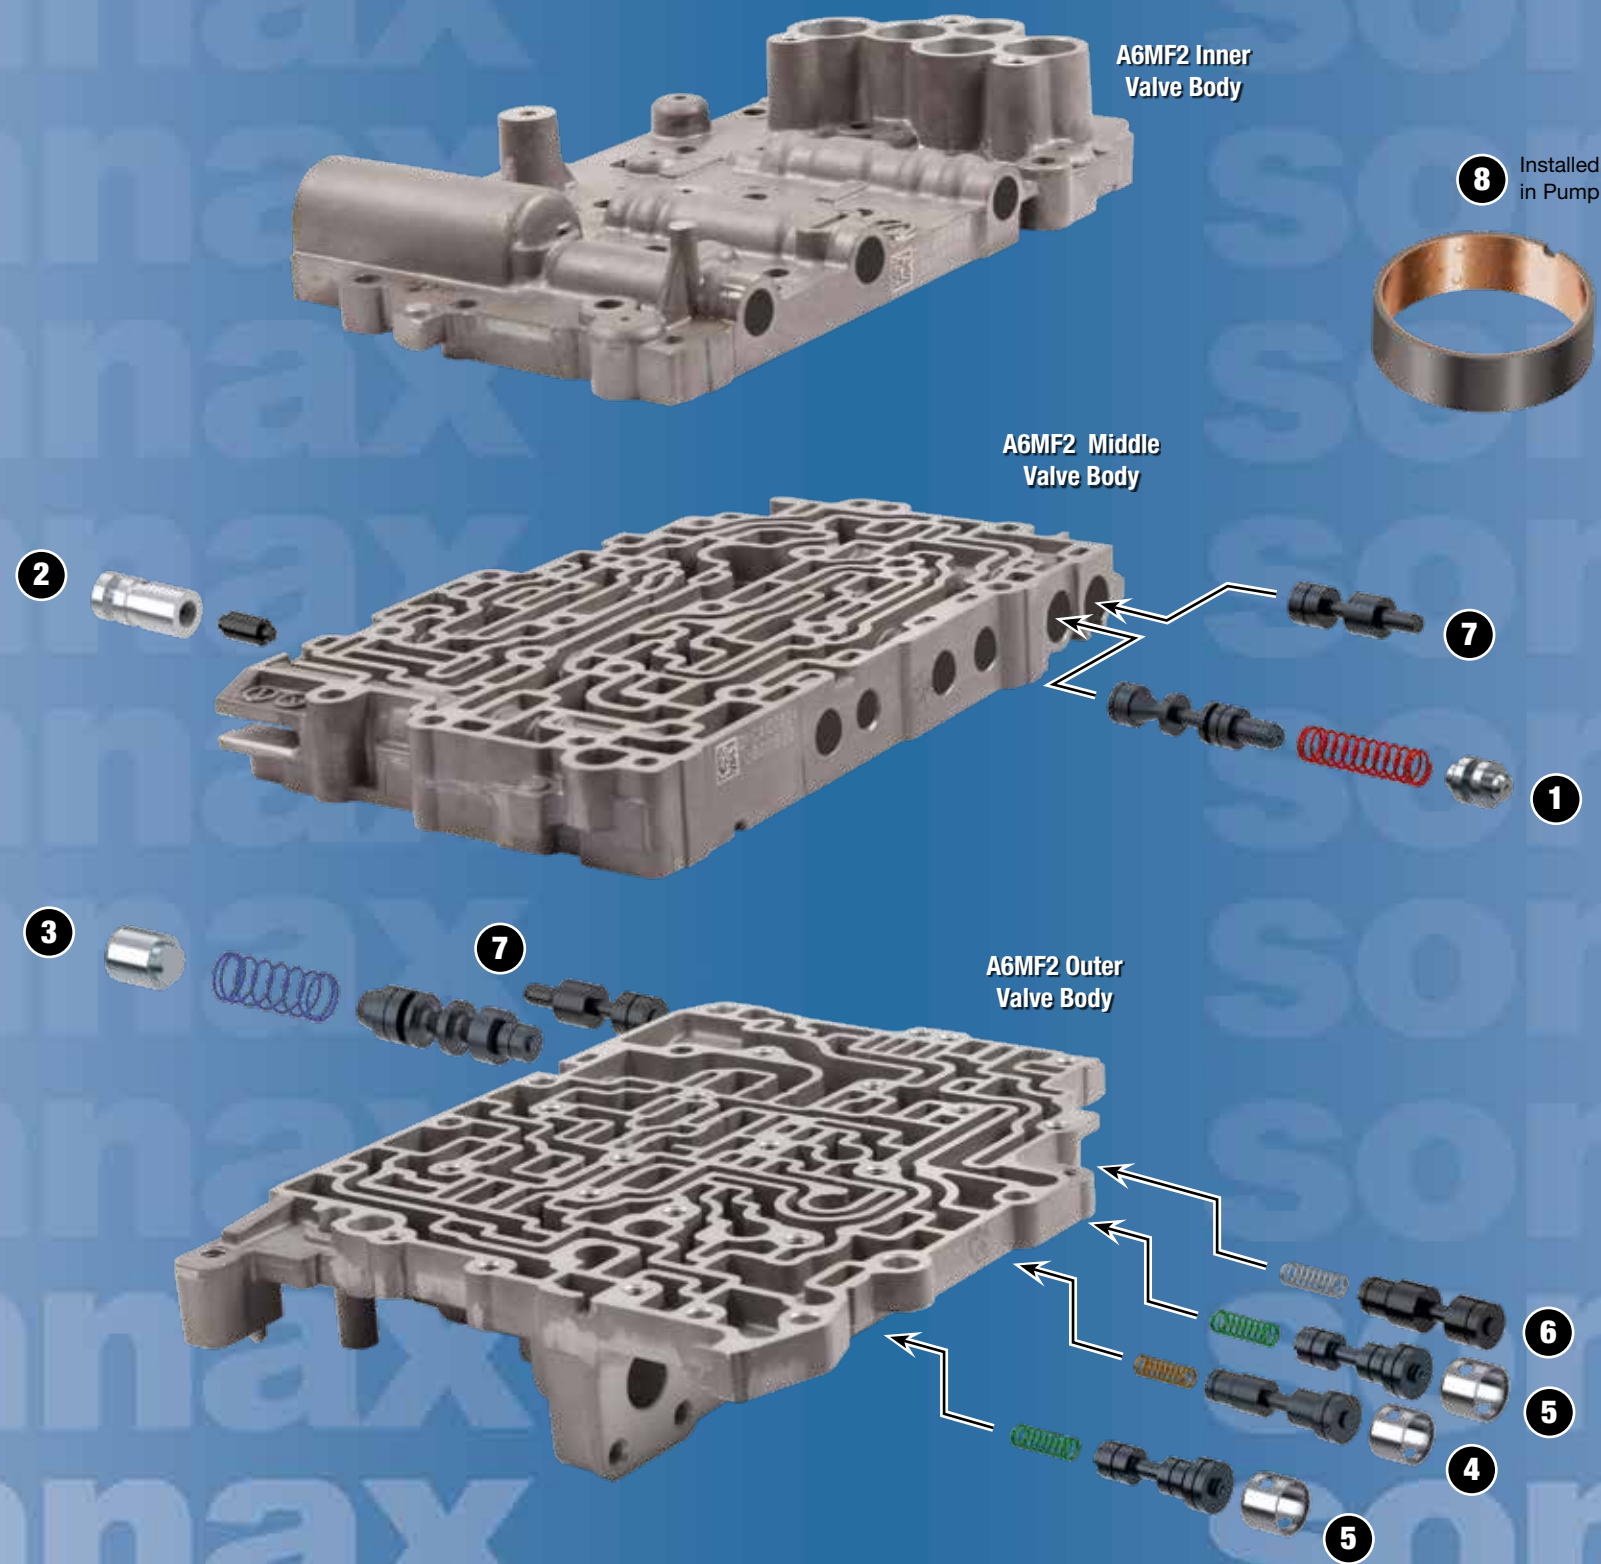
1 102741-11K

Oversized TCC Control Valve Kit

2 102741-01K

TCC Pressure Control Plunger Valve Kit

3 102741-08K

Oversized Pressure Regulator Valve Kit

4 102741-16K

Oversized 2-6 Pressure Control Valve Kit

5 102741-13K Fits Either of 2 Locations

Oversized 3/5/Reverse & Underdrive Pressure Control Valve Kit

6 102741-18K Oversized Overdrive Pressure Control Valve Kit

7 102741-07 Fits Either of 2 Locations

Oversized Pressure Reducing Valve

8 102034-01 Fits A6MF1/2 Only

Pump Bushing
