ZF6HP19/26/32 (Gen. 1) without 053 Separator Plate

These parts fit both M-shift and E-shift valve bodies as well as Ford 6R60, 6R75 and 6R80 (2009-2014).

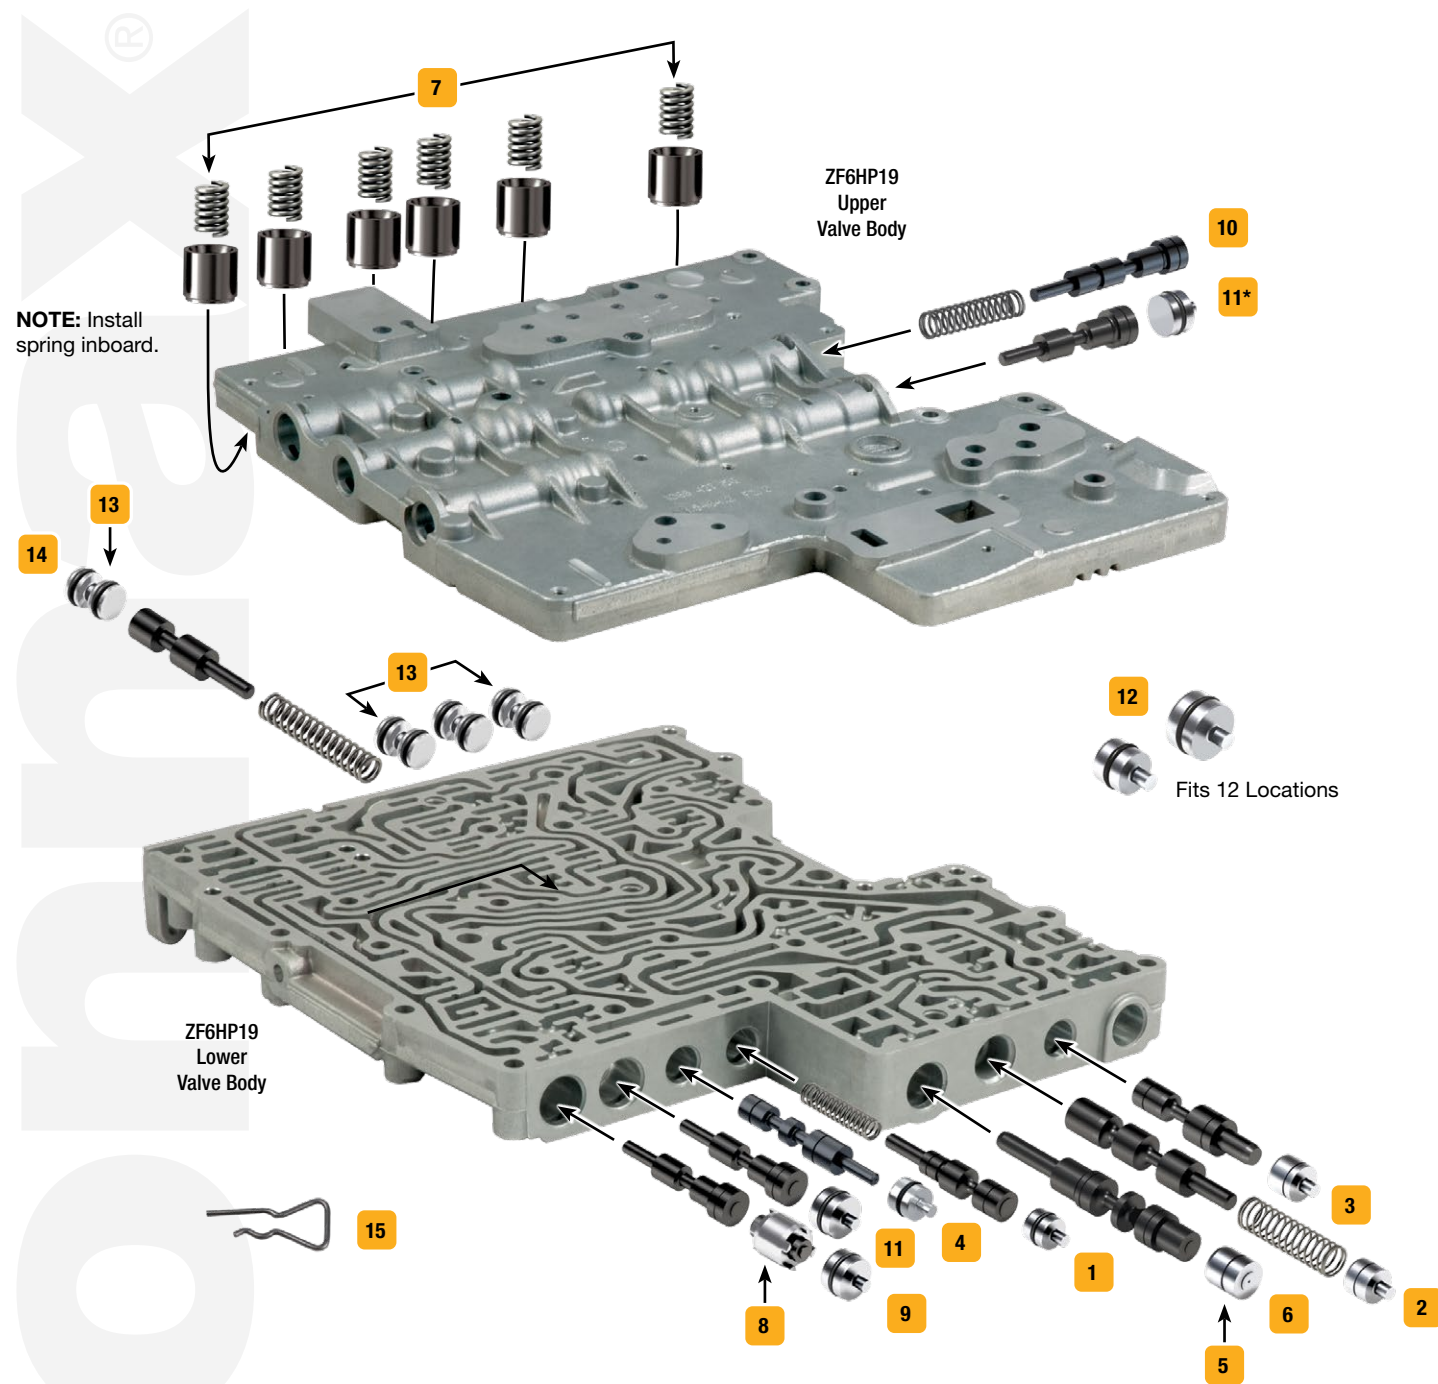
Symptoms/Part Type	Product Name	Part No.	Details	Tooling
Multiple Symptoms				
The first step in correcting common shift problems	Zip Kit®	ZF6-6R60-ZIP	ZIP	
TCC/Lockup Symptoms				
TCC codes, Excess TCC slip, Cycling RPM, Low TCC release pressure, Flare shifts, Harsh shifts	Oversized Bypass Clutch Control Valve Kit	1 95740-13K		F-95740-TL13*
Excess TCC slip RPM & related codes, Harsh TCC apply & release, Low TCC release pressure	Oversized Converter Release Regulator Valve Kit	2 95740-05K		F-95740-TL5*
Planetary failure, Bushing failure, Lube failures, Overheating, Low converter pressure	Oversized Lubrication Control Valve Kit	3 95740-11K		F-95740-TL11*
Pressure Problems				
3-4 Bump, 3-4 Flare, 3-4 Late, Gear ratio & solenoid codes, No 4th, No 5th, No 6th	Oversized "E" Latch Valve Kit	4 95740-80K	ZF6HP26 only, replaces OE valves with .180" long center spools	F-95740-TL80*
Broken parts due to excessive line pressure, High line pressure, Erratic line pressure	Pressure Regulator Sleeve	5 95740-03	ZIP Replaces OE sleeve with .629" outer dia. & .645" length

Poor shift quality, Flare shifts, Harsh shifts, Erratic line pressure, Delayed Reverse	Oversized Pressure Regulator Valve Kit	6 95740-01K	Replaces OE sleeve with .629" outer dia. & .645" length	F-95740-TL*
Shift/Engagement Concerns				
Downshift clunk, Firm shifts, Erratic EDS solenoid control and/or EDS codes	Accumulator Piston Kit	7 95740-15K	ZIP Includes 7 pistons & springs	
5-4 Flare, 5-4 Neutral, No 4-5, VFS 1/A solenoid control code, Delayed Forward, Harsh Forward	Clutch A Control Boost Valve Kit	8 95740-21K	ZIP	
Downshift bind-ups, Flare shifts, Excess clutch overlap & clutch distress	Oversized Clutch A Control Valve Kit	9 95740-09K		F-95740-TL8*
6th Slip, 2nd Slip, Clutch failure, Poor shift quality, Ratio errors	Oversized Clutch C Regulator Valve	10 95740-40K		F-95740-TL40*
Excess clutch overlap & clutch distress, Pressure control out-of-range codes, 3-2 Harsh	Oversized Clutch D1/E Control Valve Kit	11 95740-08K	*Does not fit 2nd, 3rd or 4th design 6R80. Fits either of 2 locations	F-95740-TL8*

Inconsistent shift quality	O-Ringed End Plug Kit	12 95740-19K	ZIP Includes 6 large & 6 small end plugs	
	O-Ringed Internal End Plug Kit	13 95740-25K	ZIP Includes 4 end plugs	
Flare shifts, Neutral shifts, Harsh upshifts, Harsh downshifts, Gear ratio codes, TCC slip	Oversized Solenoid Pressure Regulator Valve Kit	14 95740-17K		F-95740-TL17*
Component Damage/Failure				
Lost or damaged component	"Y" Shaped Valve Retainer	15 95740-04K	Includes 10 retainers	
Tools				
	Solenoid Test Manifold Kit	95430-VTK		VACTEST-01K
	Vacuum Test Plate Kit	95740-VTP1	Cannot be used on 053 separator plate applications	VACTEST-01K
