GM 6T30/40/45/50 (Gen. 1)

6T40 Gen. 1
Main Control
Valve Body

6T40 Gen. 1
Pump Assembly

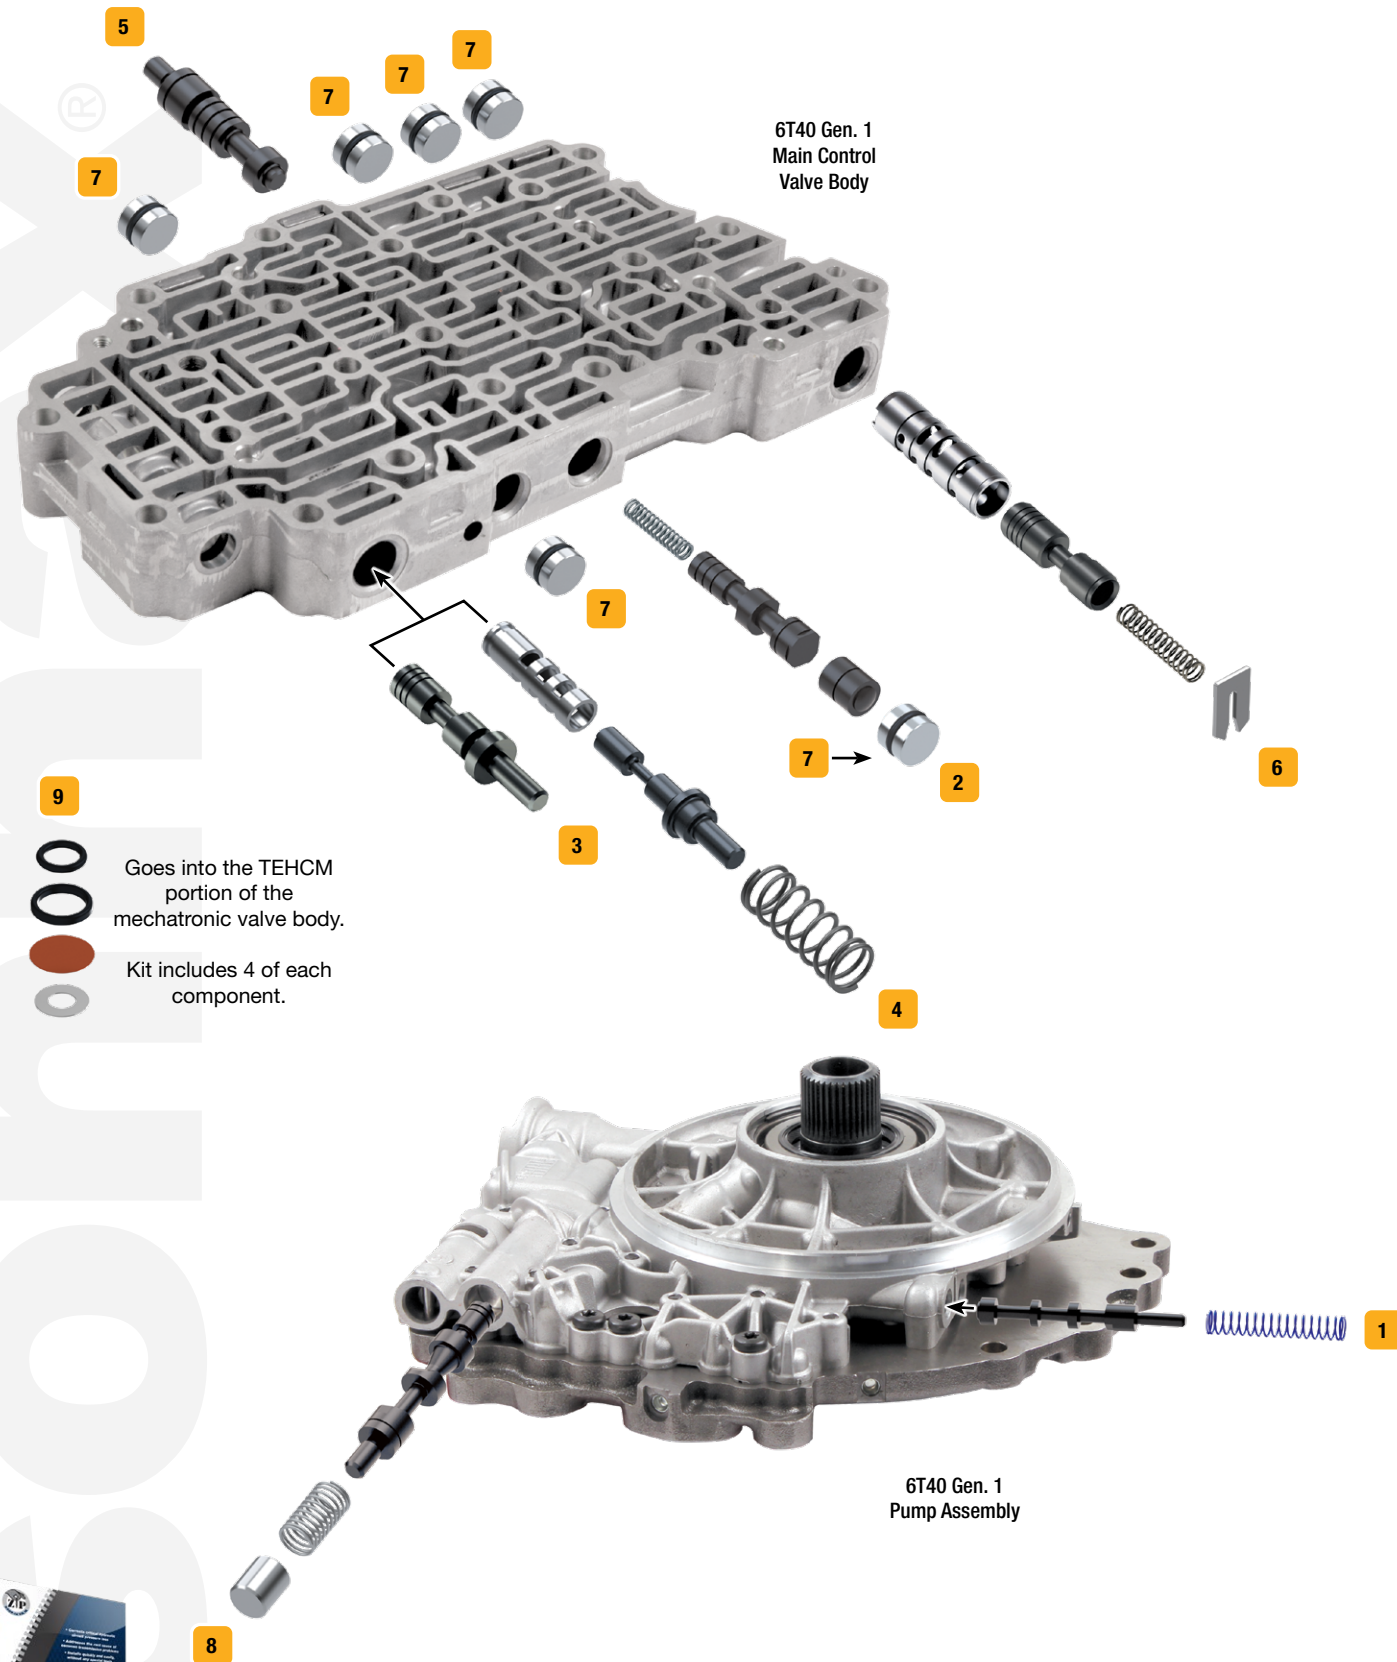
Symptoms/Benefits	Product Name	Part No.	Details	Tooling
Multiple Symptoms				
The first step in correcting common shift problems	Zip Kit®	6T40-ZIP	ZIP	
TCC/Lockup Symptoms				
Excess TCC slip, Low cooler flow, Overheating, Low converter & lube flow, TCC codes	Oversized TCC Control Valve Kit	1 144510-05K		F-144510-TL5C*
Code P0741, P0742, No lockup, TCC slip, Loss of fuel economy, Low TCC apply pressure	TCC Regulator Valve Kit	2 144740-38K	ZIP	
	Oversized TCC Regulator Valve Kit	2 144740-16K		F-144740-TL16*‡
Shift/Engagement Concerns				
No 4th, No 5th, No 6th, Low clutch oil pressure, Harsh shifts, Flare shifts	Oversized Actuator Feed Limit Valve	3 144740-01		144740-TL
	Actuator Feed Limit Valve Kit	4 144740-39K	ZIP	
Slip codes, Delayed engagement, 1-2-3-4 Clutch burned, Shift quality is not load sensitive	Oversized Clutch Boost Valve	5 144740-22		F-144740-TL22*
Harsh shifts, Downshift clunk, 3-4 Bump, Bump shifts, Flare shifts, Bind-up, Burnt clutches	Compensator Feed Regulator Valve Kit	6 104740-09K	ZIP

Pressure loss, Burnt clutches, Shift concerns, TCC apply concerns	O-Ringed End Plug Kit	7 144740-02K	ZIP Includes 6 end plugs	
Erratic line pressure, Burnt clutches, Poor shift quality, Low converter & lube flow	Oversized Pressure Regulator Valve Kit	8 144510-01K		F-144510-TLC*
Pressure switch codes, Pressure control out-of-range codes, Failsafe mode, Harsh shifts	Pressure Switch Rebuild Kit	9 144510-09K	Repairs 4 switches	
Tools				
	Vacuum Test Plate Kit	144740-VTP		VACTEST-01K
