Mercedes 722.9

sonnax®

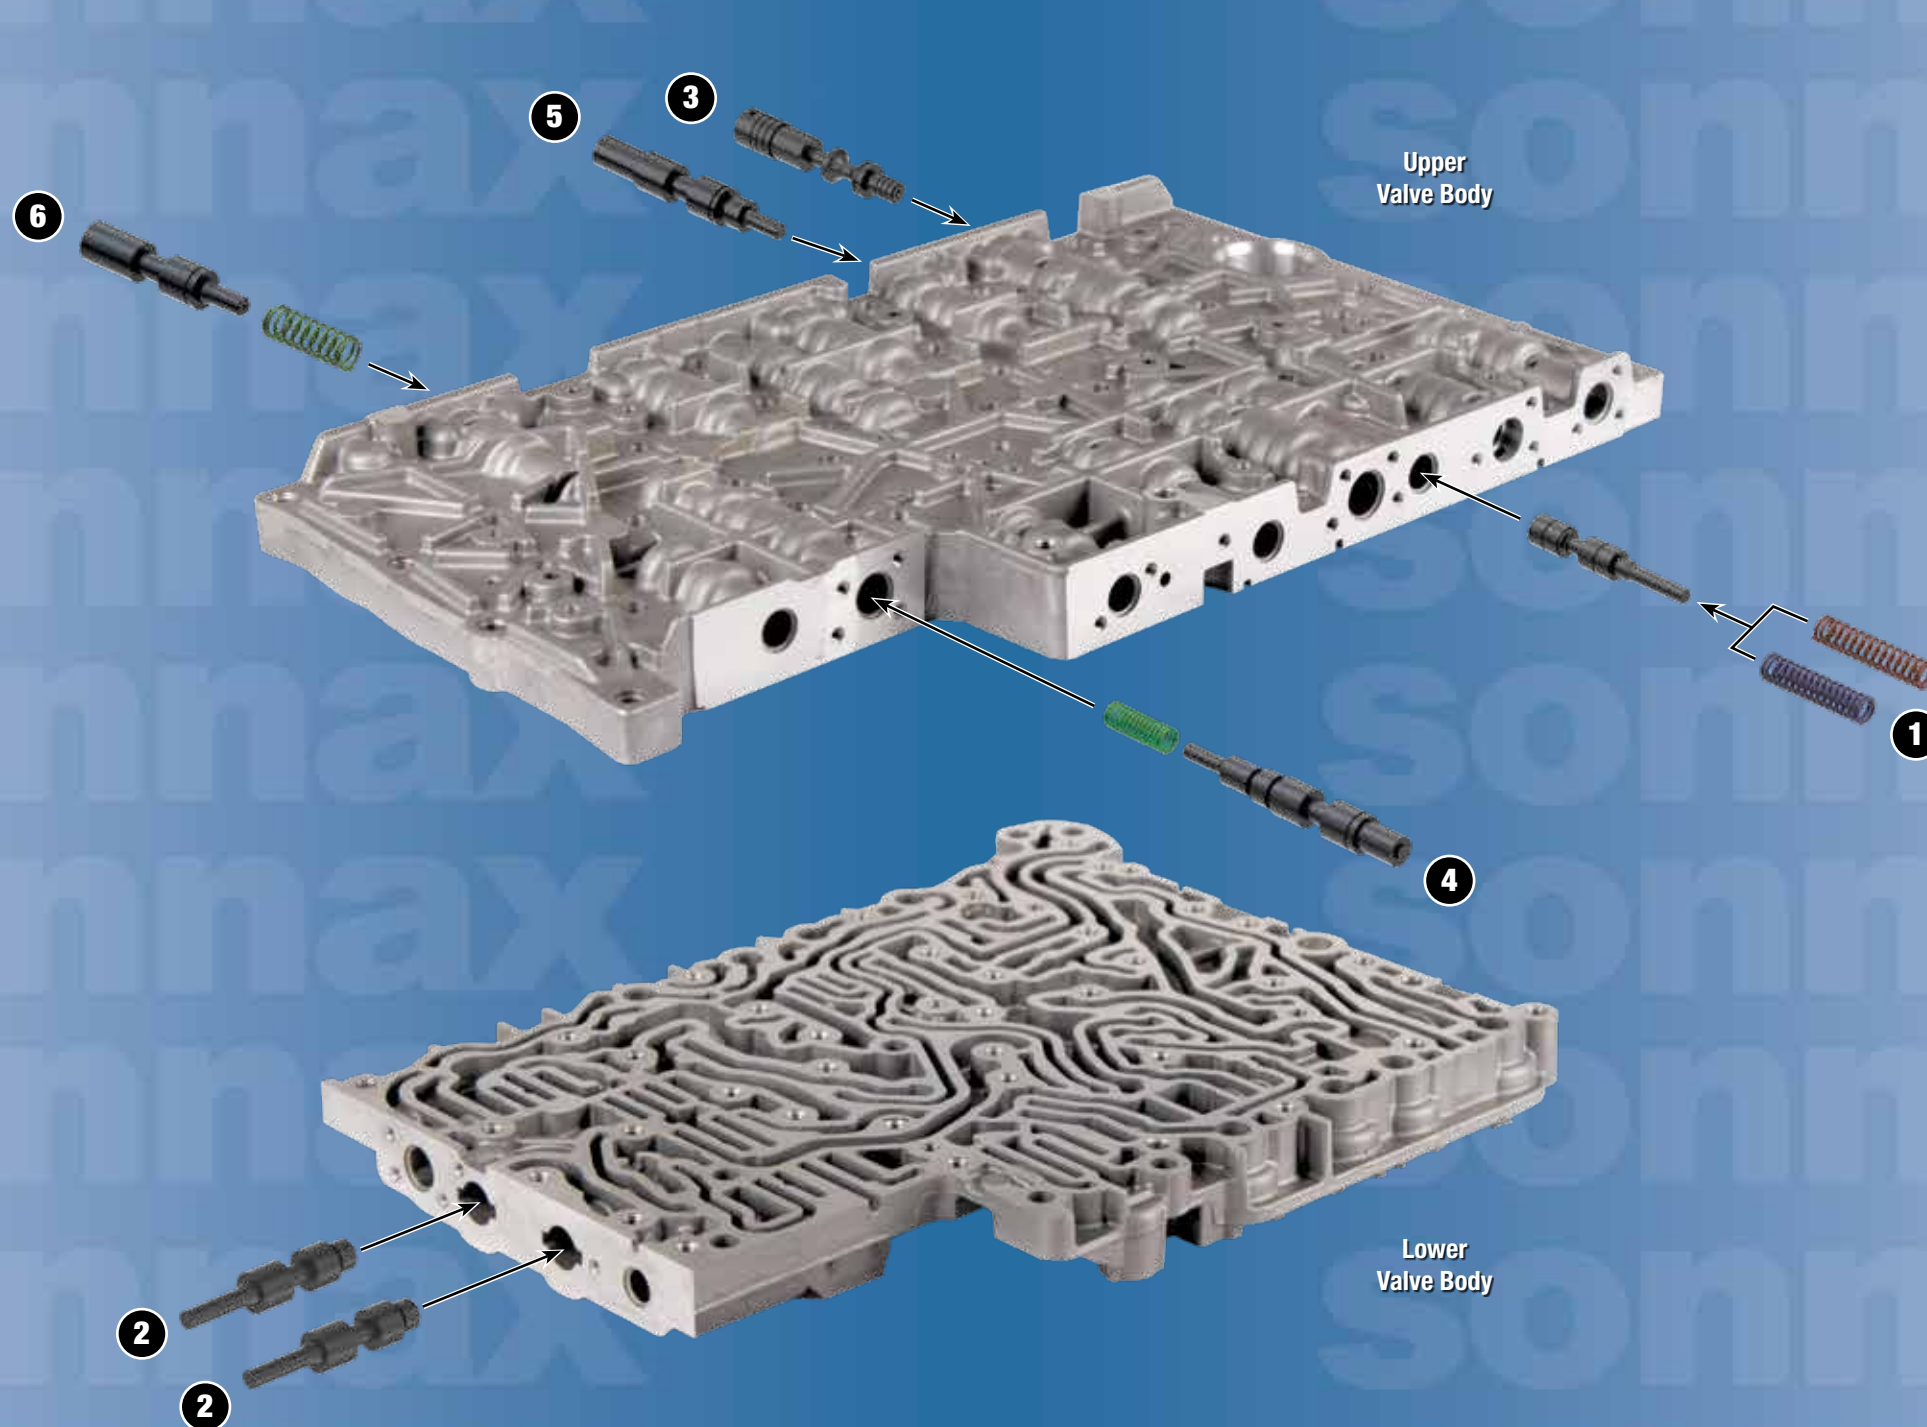
1 88740-09K Oversized Lubrication Pressure Regulator Valve Kit

2 88740-02 Oversized Supply Pressure Regulator Valve

3 88740-01 Oversized Working Pressure Regulator Valve

4 88740-04K Oversized B2/BR Regulator Valve Kit

5 88740-08 Oversized K1 Regulator Valve

6 88740-06K Oversized K3 Shift Valve Kit
