Ford 5R55N

sonnax®

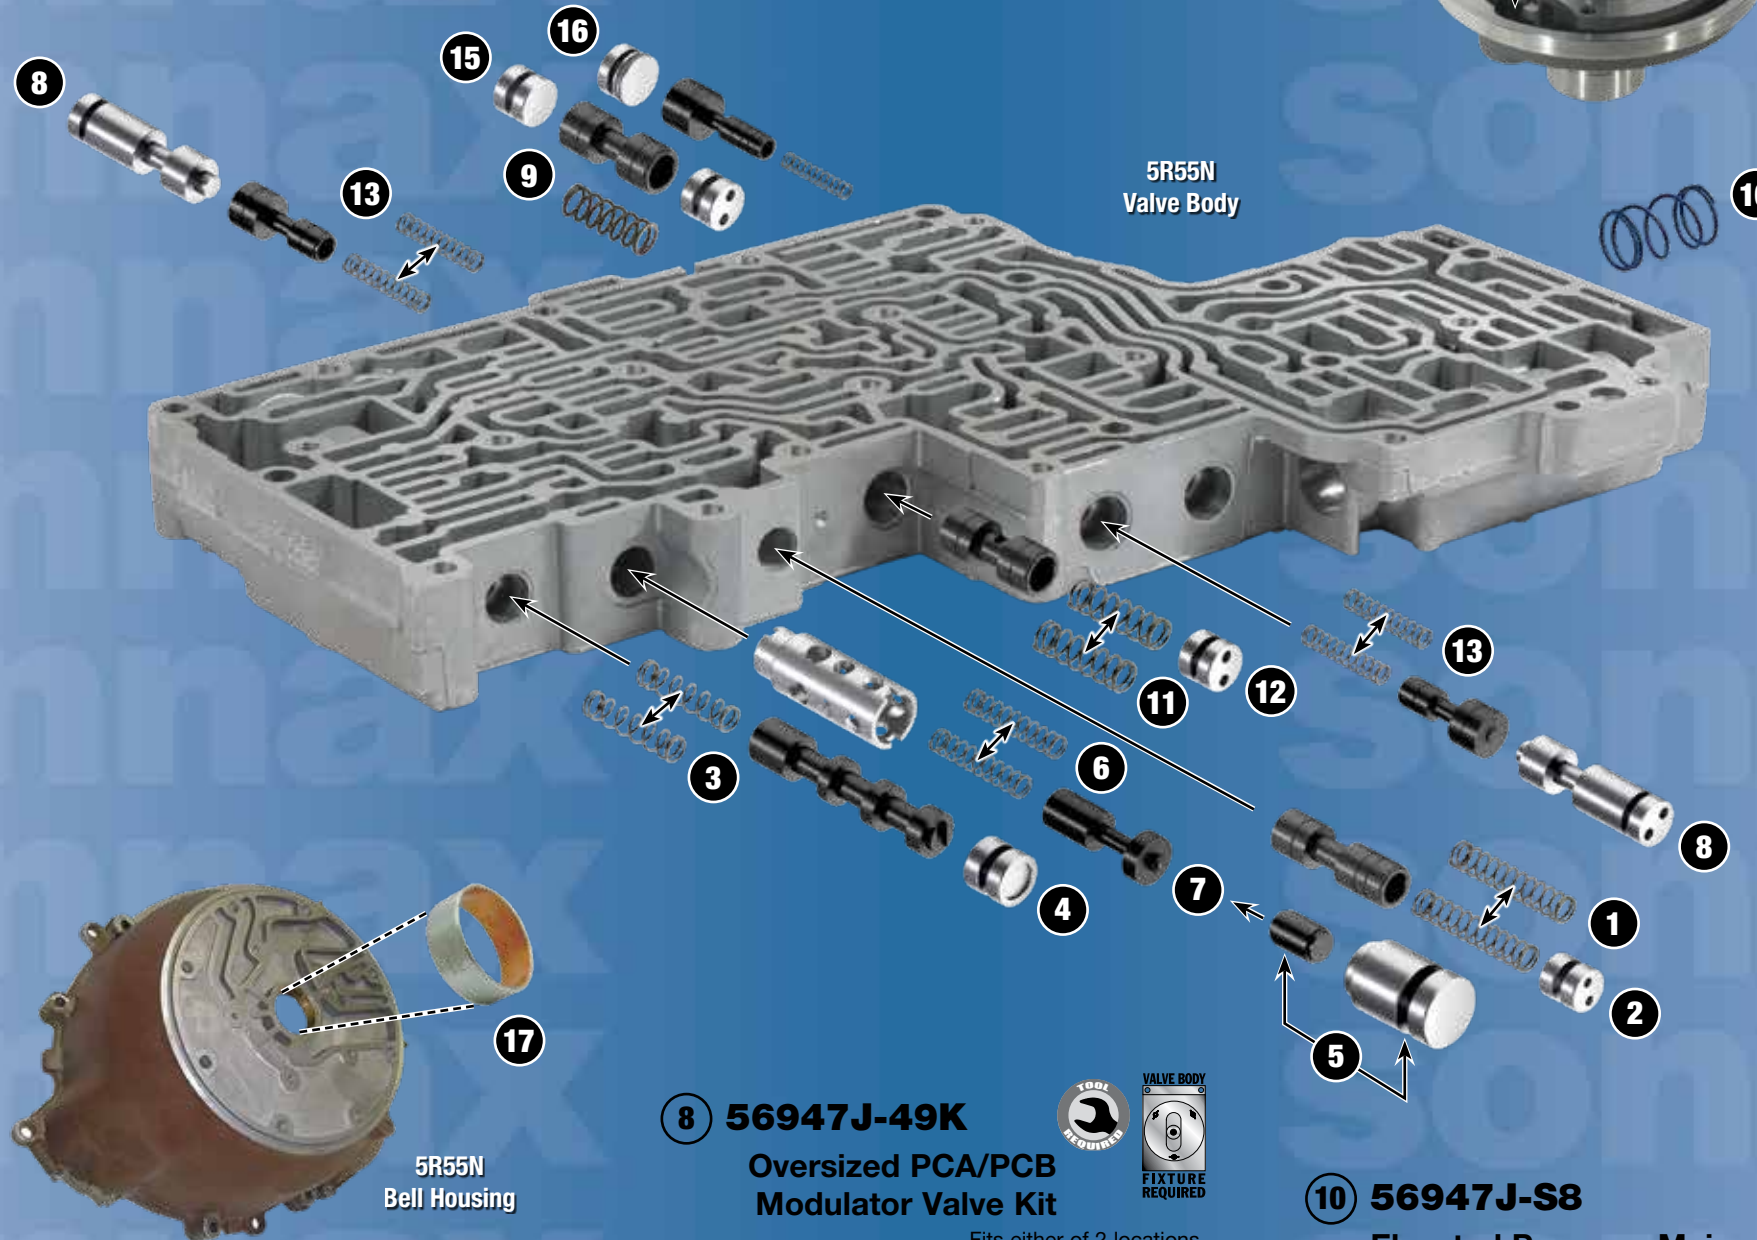
1 **56947J-S5** 5/Bag
TCC Back Pressure Spring
Helps cure:
• Harsh TCC apply • Excess TCC slip
• Low line pressure • TCC lining overheat

2 **56947J-63K**    
Oversized TCC Back Pressure Valve Kit
Helps cure:
• TCC apply concerns • TCC codes
• Delayed engagement • Burnt converter
Note: Requires tool kit **F-56947J-TL63** & the **VB-FIX** reaming fixture.

3 **56947J-S3** 5/Bag
TCC Control Valve Spring
Helps cure:
• Engine stall • No TCC release
• TCC cycling • Burnt converter

4 **56947J-05K**    
Oversized TCC Control Valve Kit
Helps cure:
• Code P0741 • TCC lining failure
• Excess TCC slip • Overheated converter
Note: Requires tool kit **F-56947J-TL2**, & the **VB-FIX** reaming fixture.

5 **56947J-32K**
TCC Modulator Plunger Valve Kit
Helps cure:
• Slip codes • Overhated fluid
• High TCC slip in RPM at increasing load

6 **56947J-S4** 5/Bag
TCC Modulator Spring
Helps cure:
• Harsh TCC apply
• TCC slip

TCC Modulator Valve Kit
Helps cure:
• Code P0741 • Excess TCC slip
• Code 1783 • High line pressure
Note: Requires tool kit **F-56947J-TL15** & the **VB-FIX** reaming fixture.

Oversized PCA/PCB Modulator Valve Kit
Fits either of 2 locations.
Helps cure:
• Delayed Forward • Delayed Reverse
• Low line pressure • High line pressure
Note: Requires tool kit **F-56947J-TL49** & the **VB-FIX** reaming fixture.

9 **56947J-S1**
4-3 Pre-Stroke Valve Spring
Helps cure:
• Code 734 • Code 735
• Solenoid C Code • No 4th • No 5th

10 **56947J-S8** 5/Bag
Elevated Pressure Main Pressure Regulator Spring
Helps cure:
• Soft shifts • Poor shift quality
• Delayed engagement • Low base line pressure

11 **56947J-S6** 5/Bag
Forward Engagement Control Spring
Helps cure:
• Delayed engagement • Burnt Forward clutch

12 **56947J-56K**    
Oversized Forward Engagement Valve Kit
Helps cure:
• Delayed Forward • Loss of Forward
• Slipping gears • Burnt Forward clutch
Note: Requires tool kit **F-27741-TL13** & the **VB-FIX** reaming fixture.

13 **56947J-S2** 5/Bag
PCA Modulator Valve Spring
Helps cure:
• Low line rise • 2-3 Quality poor
• Low intermediate clutch apply pressure

14 **56200-03K**
Pump Flow Control Valve Kit
Helps cure:
• Delayed engagement • Pump noise
• No movement until RPM increased

15 **56947J-59K**    
Oversized Reverse Engagement Valve Kit
Helps cure:
• Delay Reverse • No Reverse
• Direct clutch burned
Note: Requires tool kit **F-27741-TL13** & the **VB-FIX** reaming fixture.

16 **56947J-53K**    
Oversized Reverse Modulator Valve Kit
Helps cure:
• Delayed Reverse • No 4th
• No 5th • Direct clutch burned
Note: Requires tool kit **F-56947J-TL53** & the **VB-FIX** reaming fixture.

17 **56001X** Finish-in-Place, 5/Bag
Bell Housing/Pump Cover Bushing
Helps cure:
• Repeat front seal leakage
• Worn pump bushing • Worn converter hub
Note: Requires tool kit **F-27741-TL13** & the **VB-FIX** reaming fixture.
