5R55N Valve Body

Symptoms/Part Type	Product Name	Part No.	Details	Tooling
TCC/Lockup Symptoms				
Harsh TCC apply, Excess TCC slip, Low line pressure, TCC lining overheat	TCC Back Pressure Spring	1 56947J-S5	5/Bag	
TCC apply concerns, TCC codes, Delayed engagement, Burnt converter	Oversized TCC Back Pressure Valve Kit	2 56947J-63K		F-56947J-TL63*‡
Engine stall, No TCC release, TCC cycling, Burnt converter	TCC Control Valve Spring	3 56947J-S3	5/Bag	
Code P0741, Excess TCC slip, TCC lining failure, Overheated converter, Low cooler flow	Oversized TCC Control Valve Kit	4 56947J-05K		F-56947J-TL2*
Slip codes, High TCC slip RPM at increasing load, Overheated fluid	TCC Modulator Plunger Valve Kit	5 56947J-32K		
Harsh TCC apply, TCC slip	TCC Modulator Spring	6 56947J-S4	5/Bag	
Code P0741, Excess TCC slip, Code 1783, High line pressure, Overheated transmission	TCC Modulator Valve Kit	7 56947J-15K		F-56947J-TL15*
Pressure Problems

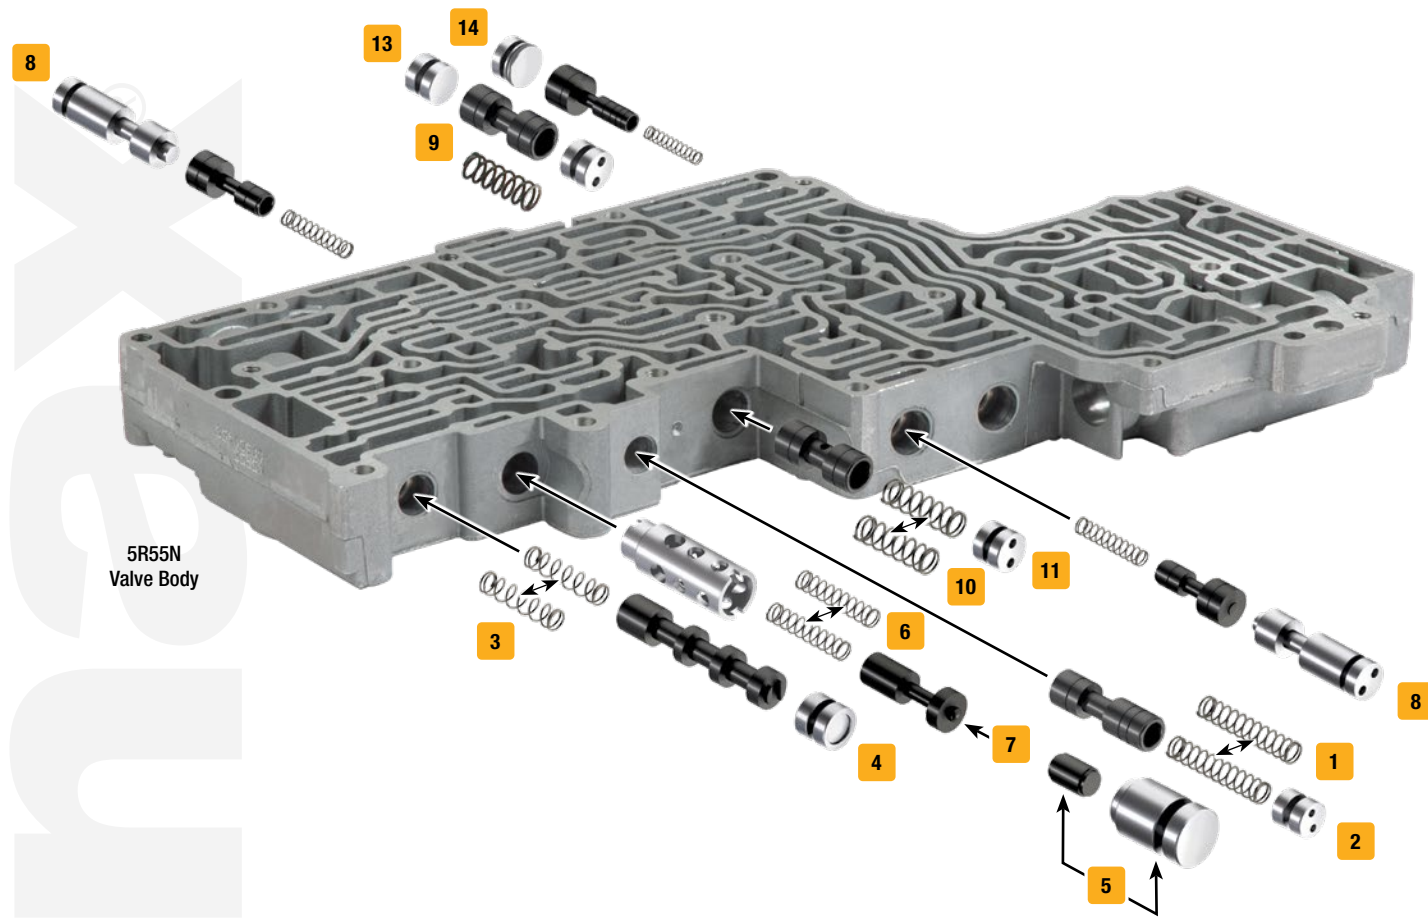
Delayed Forward, Delayed Reverse, Low line pressure, High line pressure	Oversized PCA/PCB Modulator Valve Kit	8 56947J-49K	Fits either of 2 locations	F-56947J-TL49*
Shift/Engagement Concerns				
Code 734, 735, Solenoid C Code, No 4th, No 5th	4-3 Pre-Stroke Valve Spring	9 56947J-S1		
Delayed engagement, Burnt Forward clutch	Forward Engagement Control Spring	10 56947J-S6	5/Bag	
Delayed Forward, Loss of Forward, Slipping gears, Burnt Forward clutch	Oversized Forward Engagement Valve Kit	11 56947J-56K		F-27741-TL13*
Delayed engagement, No movement until RPM increased, Pump noise, Low line pressure	Pump Flow Control Valve Kit	12 56200-03K		
Delayed Reverse, No Reverse, Direct clutch burned	Oversized Reverse Engagement Valve Kit	13 56947J-59K		F-27741-TL13*
Delayed Reverse, No 4th, No 5th, Direct clutch burned	Oversized Reverse Modulator Valve Kit	14 56947J-53K		F-56947J-TL53*
Component Damage/Failure

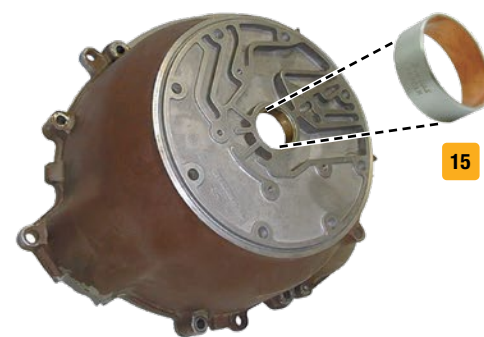
5R55N Bell Housing

Repeat front seal leakage, Worn pump bushing, Worn converter hub	Bell Housing/Pump Cover Bushing	15 56001X	Finish-in-Place, 5/bag
