SONNAX e[™] 6T70-G2-ZIP Zip Kit® Available

Critical Wear Areas & Vacuum Test Locations Zip

Upper Valve Body • 6T70 (Gen. 2)

Lower Valve Body • 6T70 (Gen. 2)

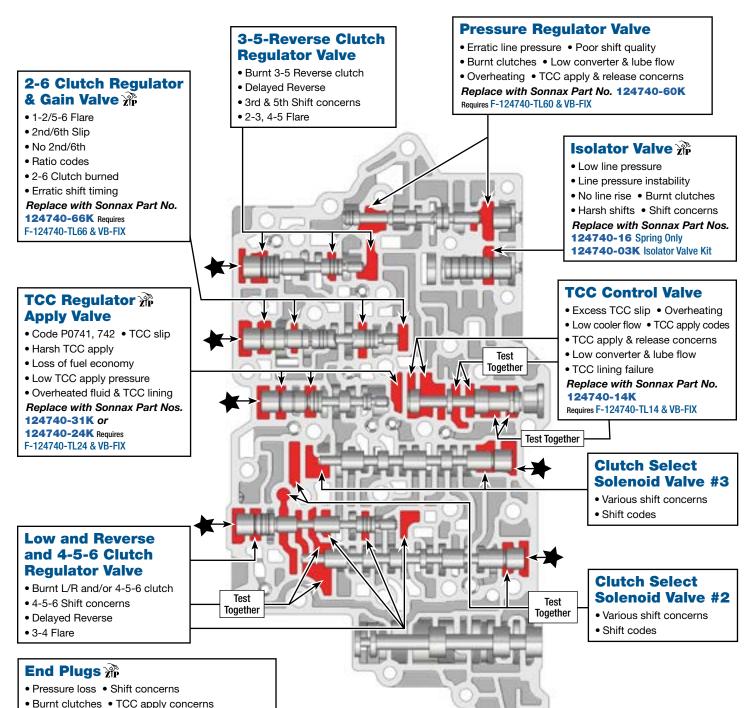
NOTE: OE valves are shown in rest position and should be tested in rest position unless otherwise indicated. Test locations are pointed to with an arrow. Springs are not shown for visual clarity. Low vacuum reading indicates wear and Sonnax parts are noted for replacement.

NOTE: Vacuum test end plugs at outboard port while sealing

Replace with Sonnax Part No. 124740-02K

bore opening with thumb.

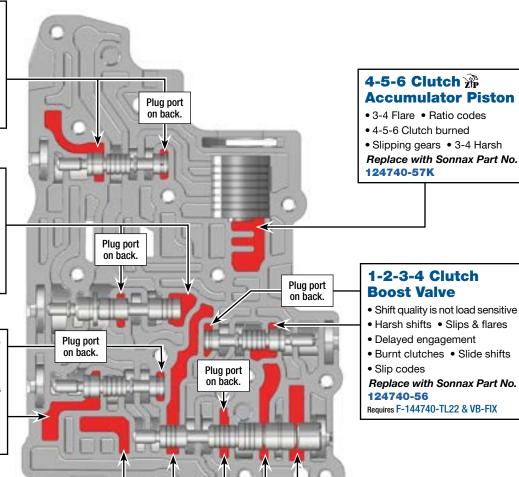
NOTE: OE valves are shown in rest position and should be tested in rest position unless otherwise indicated. Test locations are pointed to with an arrow. Springs are not shown for visual clarity. Low vacuum reading indicates wear and Sonnax parts are noted for replacement.

3-5-R Clutch Boost Valve

- Shift quality is not load sensitive
- Harsh shifts Slips & flares
- Delayed engagement Burnt clutches
- Slide shifts Slip codes

Actuator Feed 🄏

- Solenoid performance codes
- Wrong gear starts Clutch failure

4-5-6 Clutch Boost Valve

1-2-3-4 Clutch Regulator Valve

- Burnt 1-2-3-4 clutch
- Delayed Forward
- 1-2-3-4 Shift concerns

Replace with Sonnax Part No. 124740-56

Replace with Sonnax Part Nos.

124740-33K or

124740-48K Requires F-124740-TL48 & VB-FIX

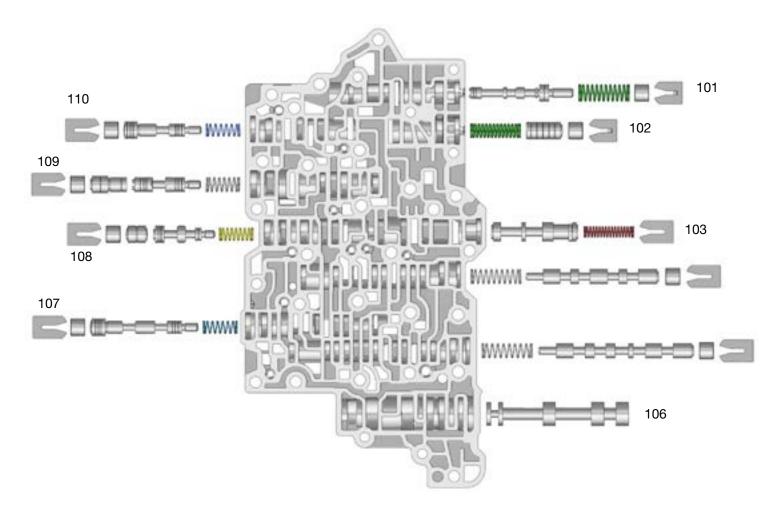
Upper Valve Body • 6T70 (Gen. 2)

OE Exploded View

NOTE: Depending upon vehicle application, the OE springs shown may not be present.

6T70 (Gen. 2) Upper Valve Body Descriptions		
I.D. No.	Description	
101	Pressure Regulator Valve	
102	Isolator Valve	
103	TCC Control Valve	
104	Clutch Select Solenoid Valve #3	
105	Clutch Select Solenoid Valve #2	
106	Manual Valve	
107	Low and Reverse and 4-5-6 Clutch Regulator Valve	
108	TCC Regulator Apply Valve	
109	2-6 Clutch Regulator & Gain Valve	
110	3-5-Reverse Clutch Regulator Valve

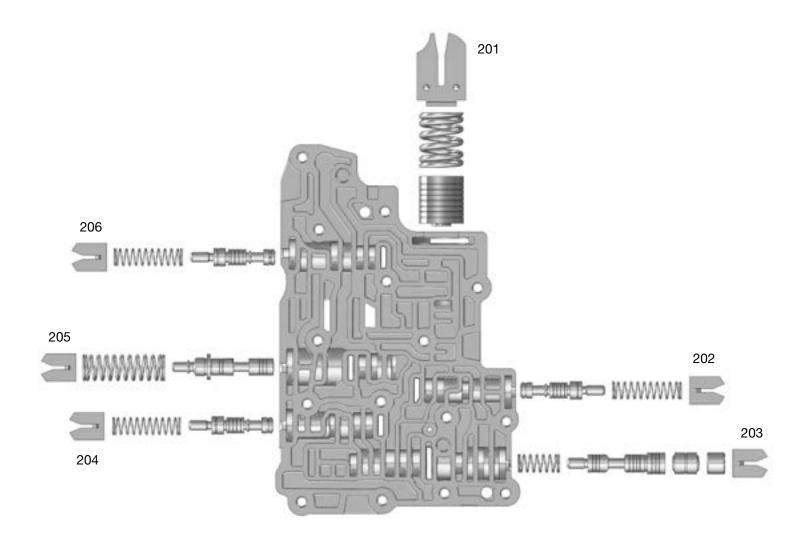
Lower Valve Body • 6T70 (Gen. 2)

OE Exploded View

NOTE: Depending upon vehicle application, the OE springs shown may not be present.

6T70 (Gen. 2) Lower Valve Body Descriptions		
I.D. No.	Description	
201	4-5-6 Clutch Accumulator Piston	
202	1-2-3-4 Clutch Boost Valve	
203	1-2-3-4 Clutch Regulator Valve	
204	4-5-6 Clutch Boost Valve	
205	Actuator Feed Limit Valve	
206	3-5-Reverse Clutch Boost Valve
