5R55W 2003 LINCOLN LS 3.9L

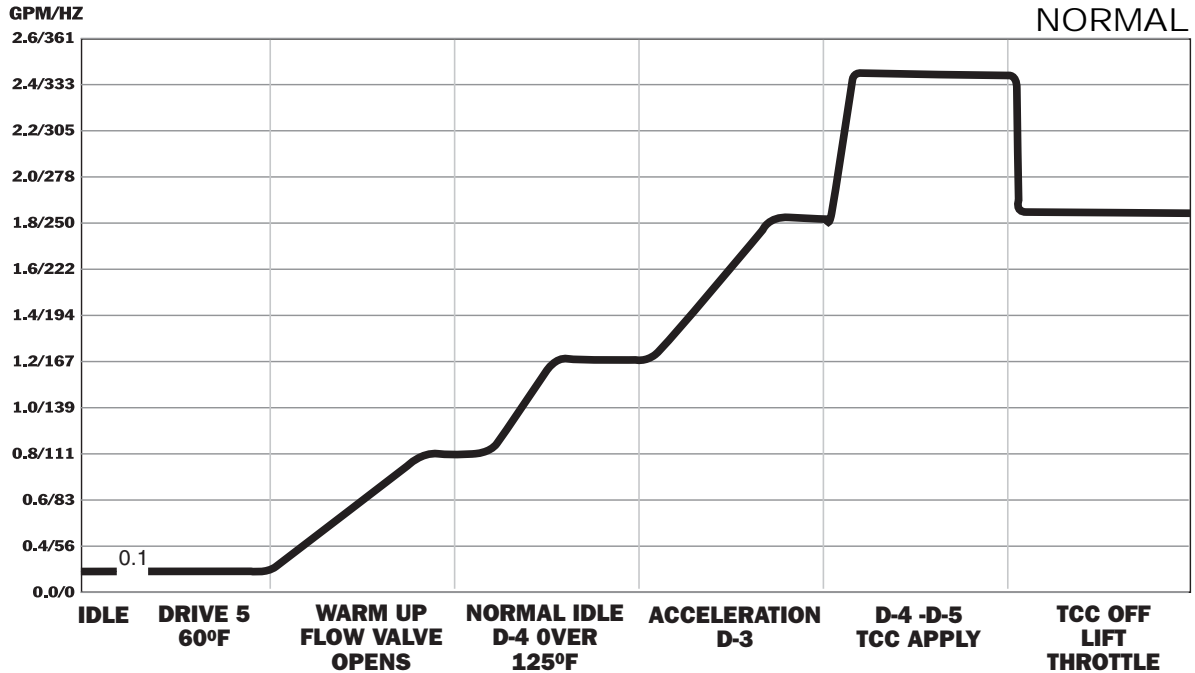
Condition: Normal operation.

Notes: Internal thermal bypass will not open until approximately 125 degrees F. Once open, flow to cooler results. 5R55N units have 1/2" O.D. cooler lines. Transmission lower cooler line is the return line and most accessible at the radiator.
