ANY GENERAL APPLICATION

Event: Inductive interference in digital graphing multimeter

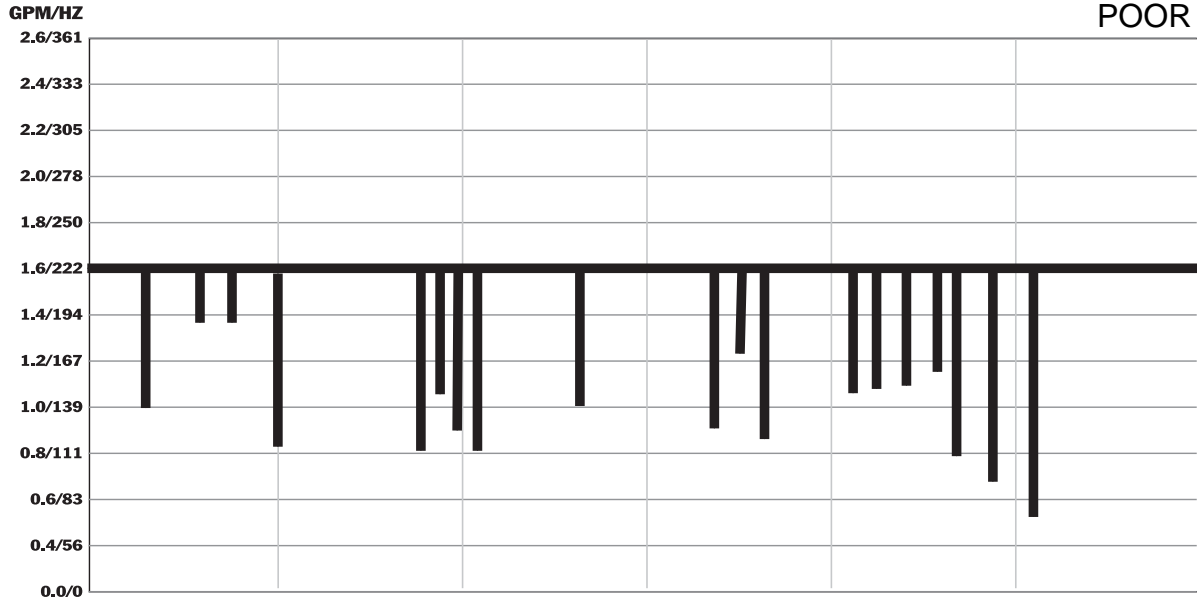
Condition: High underhood AC interference

Notes: Can be caused by poor connections, placing SonnaFlow cord over the alternator.
