Hyundai/Kia

A6GF1,

A6LF1/2/3, A6MF1/2

sonnax®

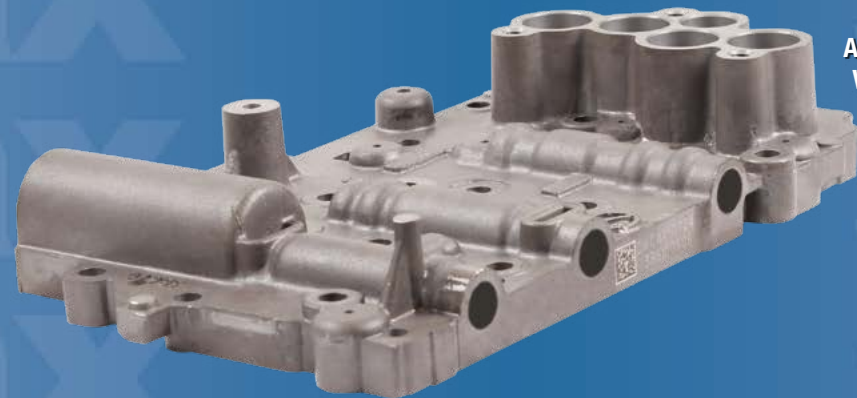
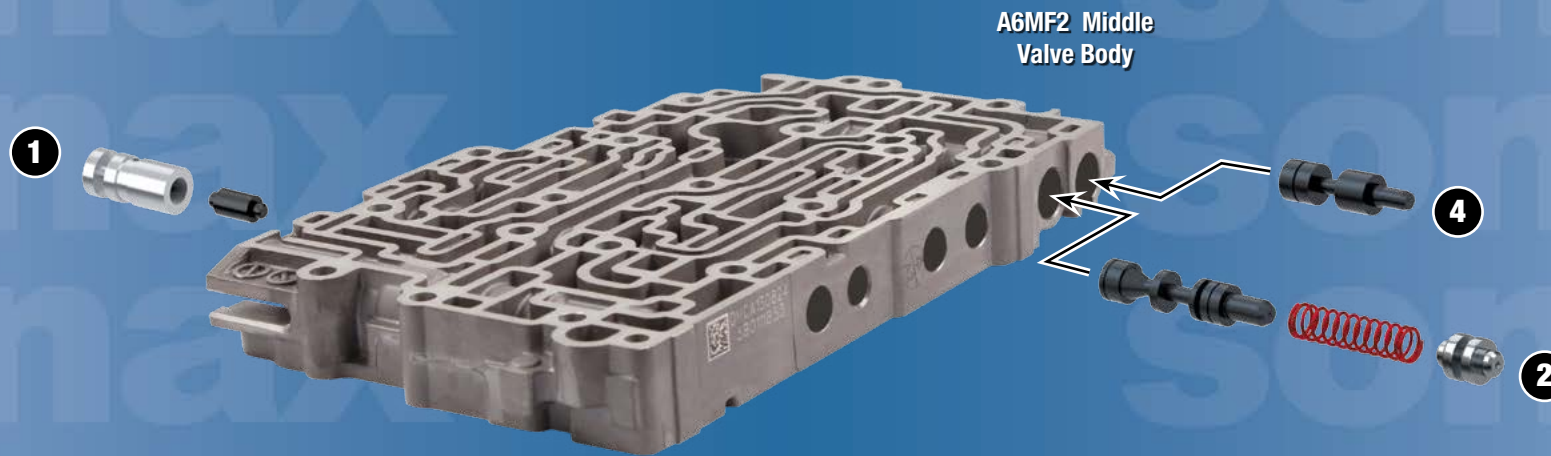
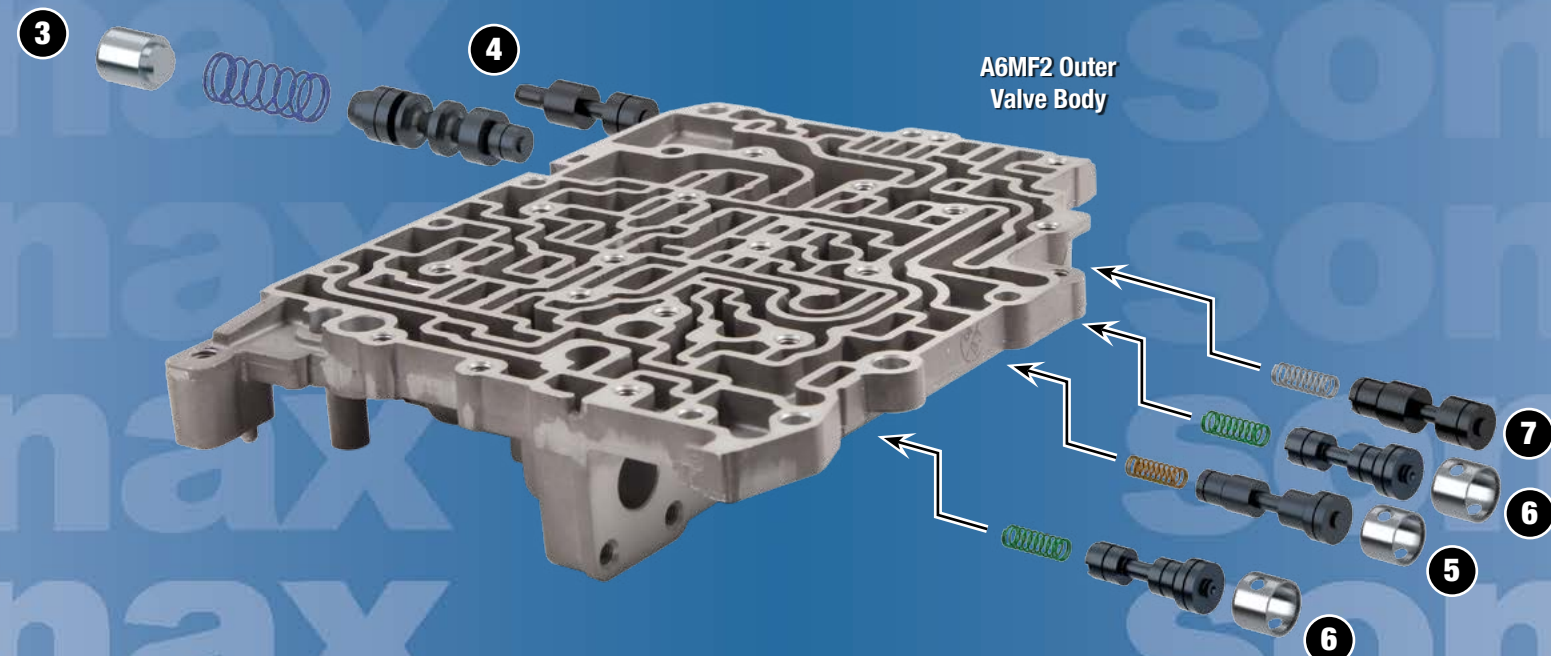
① 102741-01K

TCC Pressure Control  
Plunger Valve Kit

- Converter shudder & failure
- TCC codes
- TCC slip

② 102741-11K

Oversized TCC  
Control Valve Kit

- TCC apply/release concerns
- Excess TCC slip
- TCC codes

③ 102741-08K

Oversized Pressure  
Regulator Valve Kit

- Burnt clutches
- Erratic line pressure
- Poor shift quality

④ 102741-07 Fits either of 2 locations

Oversized Pressure  
Reducing Valve

- Burnt clutches
- Harsh/soft shifts
- Solenoid codes

⑤ 102741-16K

Oversized 2-6 Pressure  
Control Valve Kit

- 1-2, 5-6 Flare
- 2-6 Clutch burned
- No/Slipping 2nd, 6th gear

⑥ 102741-13K Fits either of 2 locations

Oversized 3/5/Reverse  
& Underdrive Pressure  
Control Valve Kit

- Slips, flares, bind-ups
- Underdrive brake clutch burned
- Erratic shift timing

⑦ 102741-18K

Oversized Overdrive  
Pressure Control Valve Kit

- 3-4 Flare
- 4-5-6 Slip

Note: Requires tool kit F-102741-TL11  
& the VB-FIX reaming fixture.

Note: Requires tool kit F-102741-TL8  
& the VB-FIX reaming fixture.

Note: Requires tool kit F-102741-TL7  
& the VB-FIX reaming fixture.

Note: Requires tool kit F-102741-TL16  
& the VB-FIX reaming fixture.

Note: Requires tool kit F-102741-TL13  
& the VB-FIX reaming fixture.

Note: Requires tool kit F-102741-TL18  
& the VB-FIX reaming fixture.
