Toyota /Lexus A750E/F Series

sonnax®

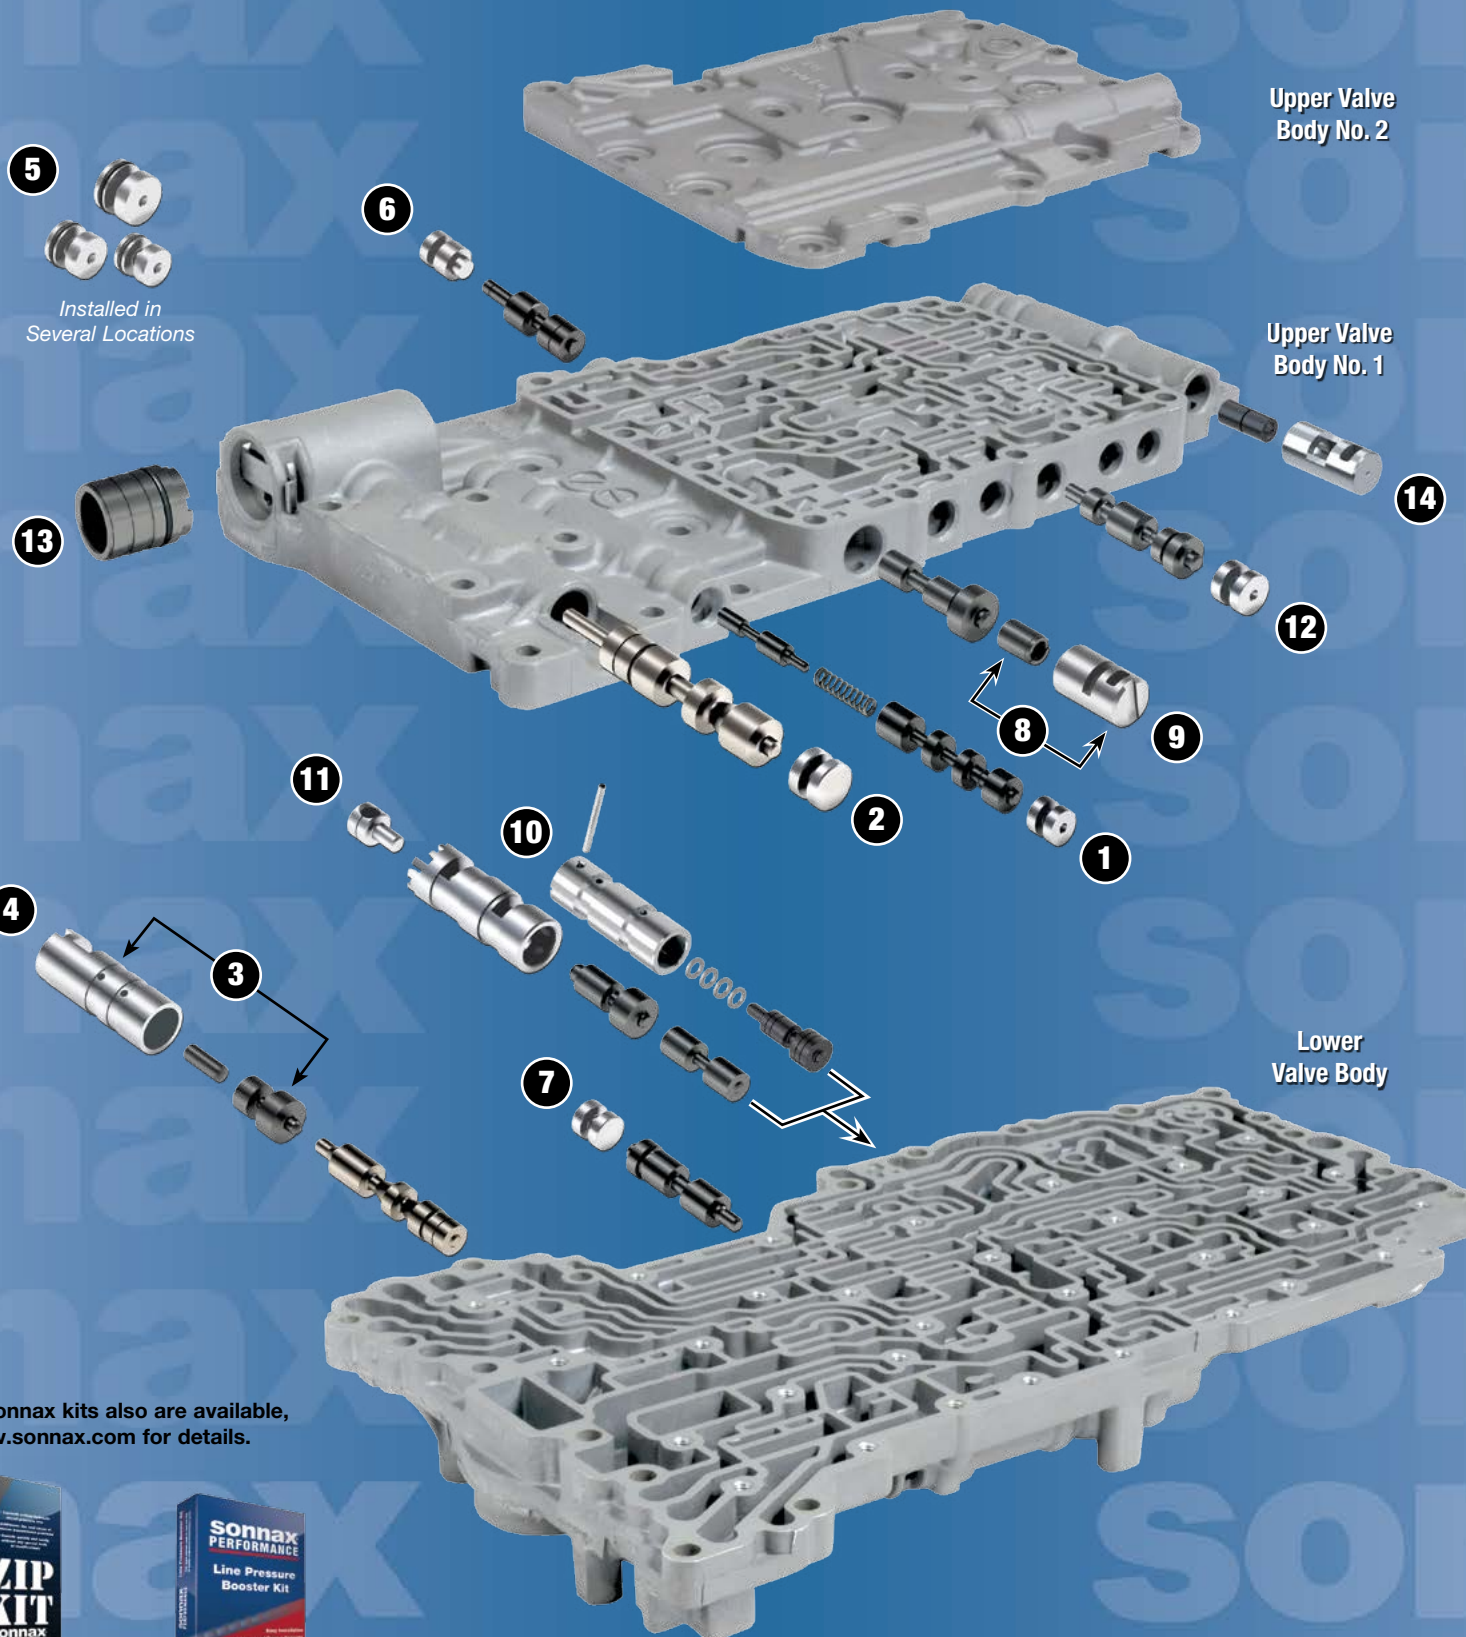
1 147741-07K Oversized Lockup Relay Valve Kit

2 147741-10K Oversized Secondary Pressure Regulator Valve Kit

3 147741-01K Boost Valve Kit

4 147741-04K Oversized Main Pressure Regulator & Boost Valve Kit

5 147741-31K O-Ringed End Plug Kit

6 147741-05K Oversized Solenoid Modulator Valve Kit
