Toyota/Lexus U341E/F

1 37740-08K Oversized Lockup Control Valve Kit

U341E Upper
Valve Body

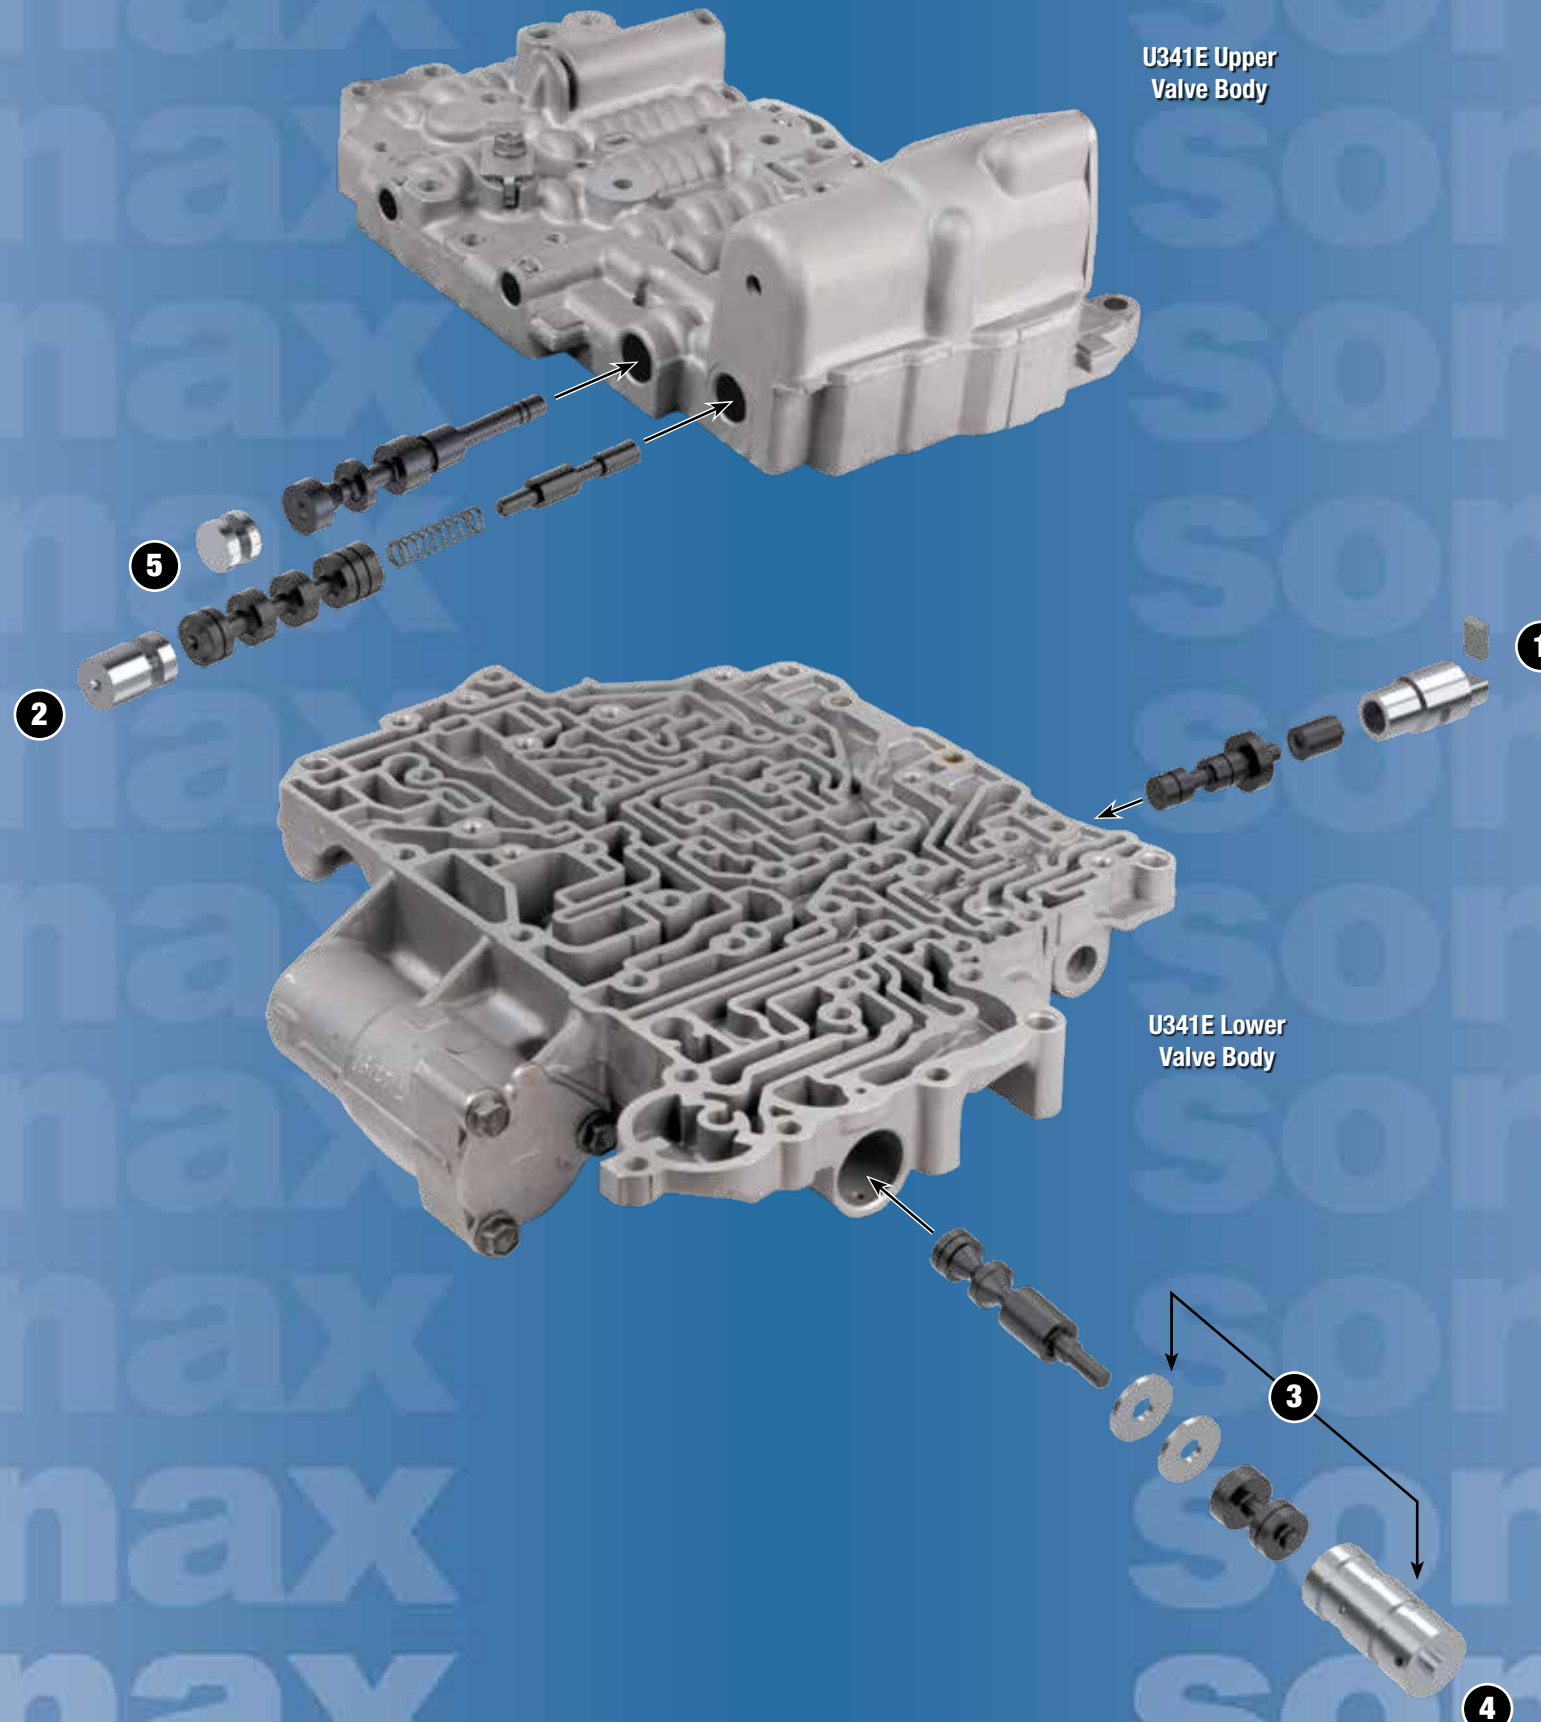
Helps cure:

- TCC apply & release concerns
- TCC codes
- No lockup
- Converter shudder & slip

2 37740-11K Oversized Lockup Relay Valve Kit

- Inadequate lubrication
- Overheating
- TCC apply & release concerns
- TCC codes

3 37740-01K Boost Valve Kit

- Harsh shifts
- Burnt clutches
- Delayed engagements
- Reverse slip

4 37740-03K Oversized Pressure Regulator & Boost Valve Kit

5 37740-07K Oversized Secondary Pressure Regulator Valve Kit

- Harsh TCC apply & release
- Excess TCC slip
- TCC codes
- Erratic TCC apply pressure
